**Geotechnical Study on  
Ground and Masonry Structures  
in Angkor for Safeguarding Monuments**

**September 2001**

**Yoshinori Iwasaki**

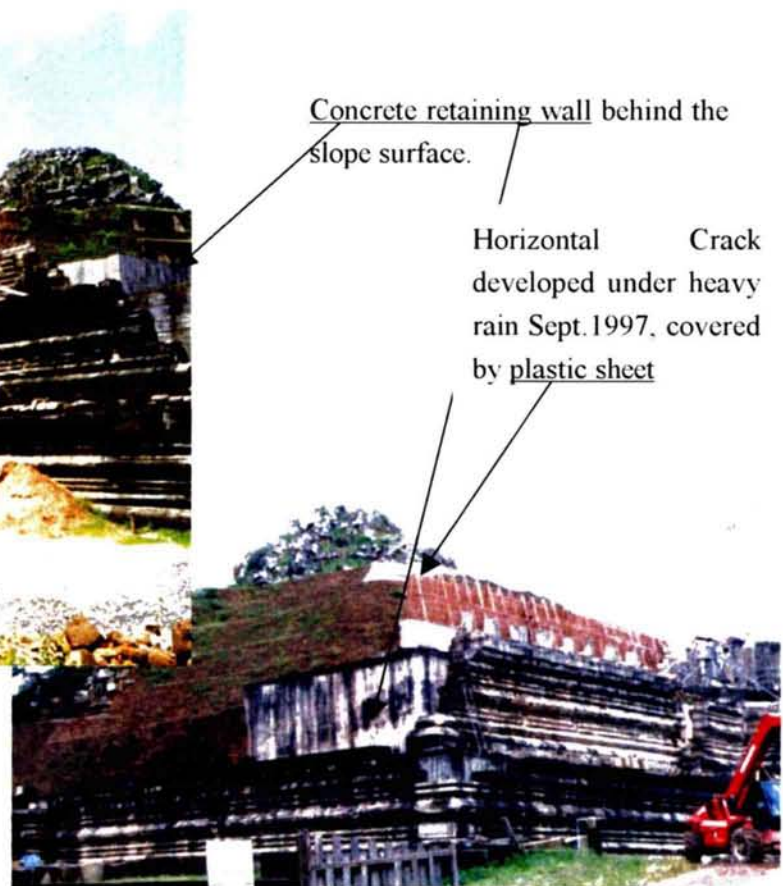
Photo 2-4 Crack appeared on top of the filling slope (photographed in October, 1997)

In September 1997, it was a heavy rain of about 200mm in one day, which caused not only a failure of embankment along the moat near the causeway to Angkor Wat but also resulted in horizontal crack of about 20m in length around top of the filling hill of Bapuhon. Fortunately, the width of the crack did not increase and the slope did not failed.

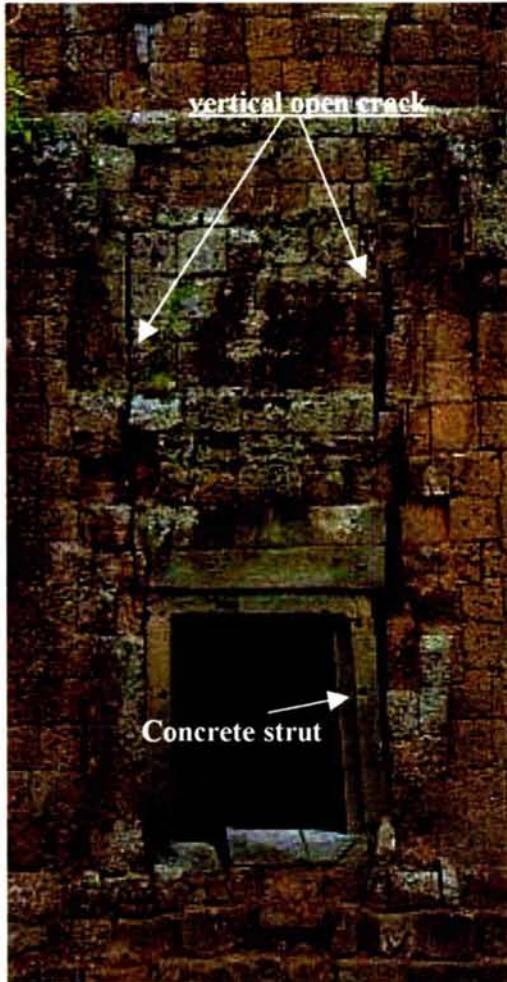
Photo 6-4 Vertical Opening above lintel

In Photo 6-4, two vertical open crack lines are extending from the each ends of lintel to the upper part of the 1<sup>st</sup> story. Whole weight of the laterite blocks between two cracks is supported by the lintel, which transmits this heavy load to the vertical columns. The both ends of the columns are further supported by horizontal bottom frame of stone beam as shown in Photo 6-4.

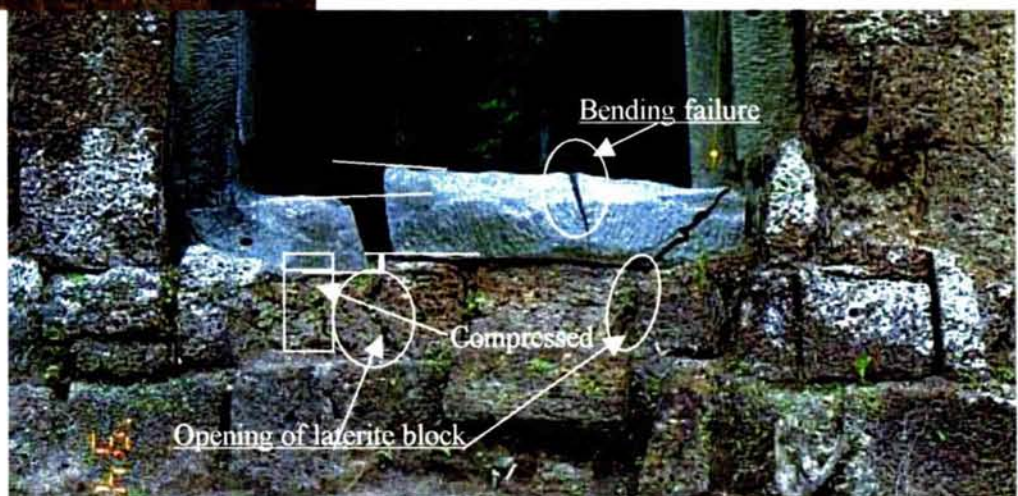
Photo 6-5 Compressed laterite block beneath horizontal beam sandstone

The horizontal base beam and laterite blocks beneath the beam are enlarged in Photo9-5. At the base of the wall opening, there is a horizontal stone beam, whose dimensions are 60cm in width, 30cm in thickness, and 170cm in length. The side vertical columns stand at the both end of the horizontal beam. The beam has broken at its center due to bending failure and split into four pieces and the both ends subsided against the central part. If we look the laterite blocks beneath the beam, it becomes clear that the laterite blocks have not only subsided but also compressed due to the excessive vertical load through columns. The right hand side laterite has been compressed about 4-5cm, which resulted in settlement of the column and had caused the shear failure of the horizontal base beam.

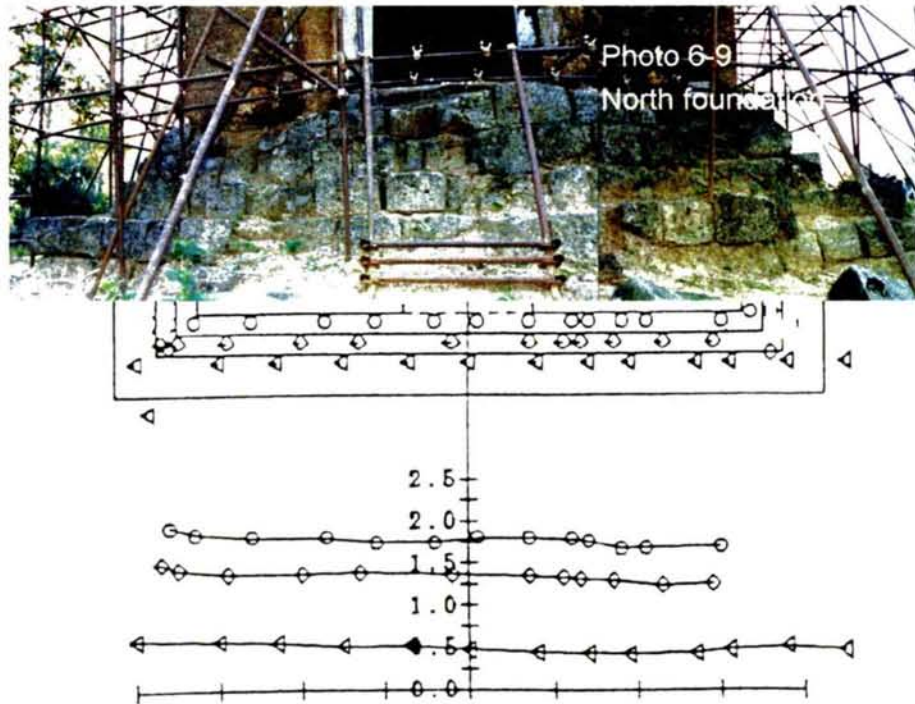
Photo 6-9  
North foundation

The maximum inclination of the foundation is north side foundation of about 40cm/10m, which is the same inclination direction as shown in Table 6-3. The inclination itself is one half of the inclination of the bottom beam of west opening.

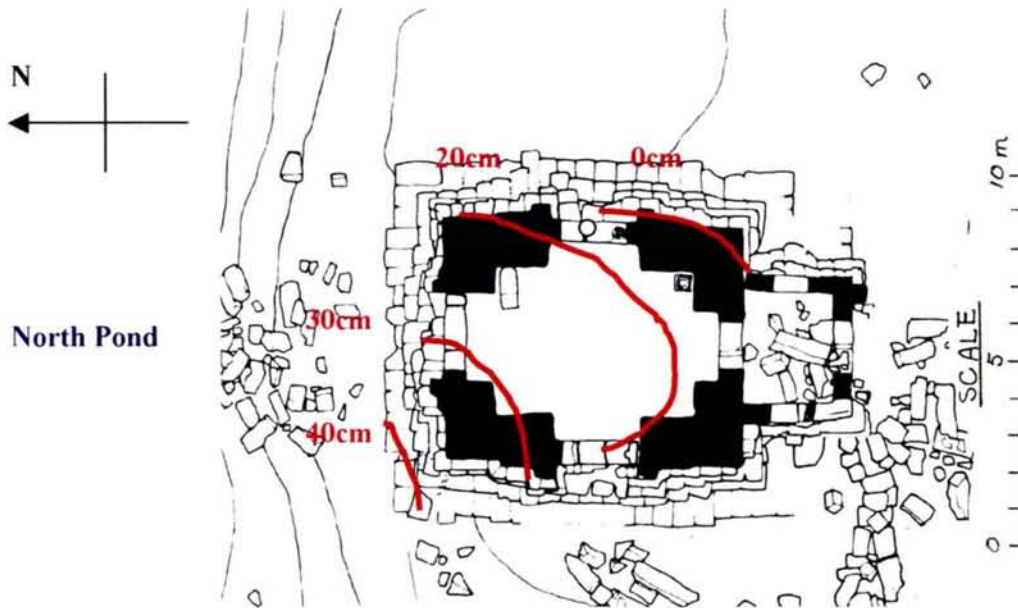
Fig.6-10 Estimated Relative settlement of N1, Prasat Suor Prat

Based upon these measurements, the inclinations of north and westwards are evaluated and drawn as equi-contour line of relative settlement contour lines as shown in Fig. 6-10.

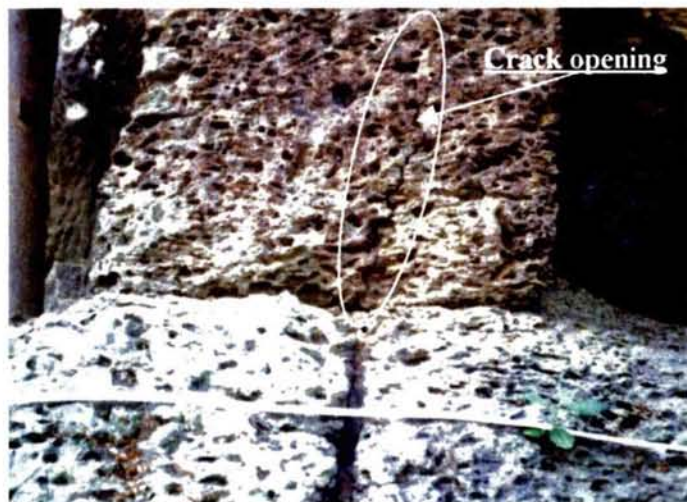
In the eastern face, there is a crack on east wall above an opening of stones in the upper level foundation. Since this crack is found rather fresh, the joint movement of the laterite blocks beneath the block might have caused the opening to begin and to continue to develop.

Photo.6-12 Fresh crack found at laterite block of East face (see Photo 6-10 white circle)

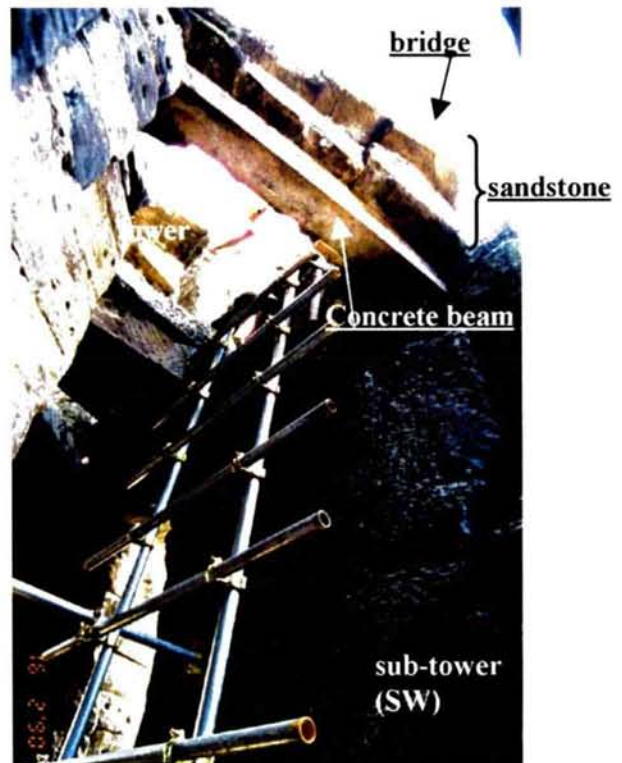
Openings are found between many neighboring stone columns and most these openings have caused large displacements of the top of the columns that caused damages of bridge elements.

Photo7-5 bridge between Central and sub Towers.

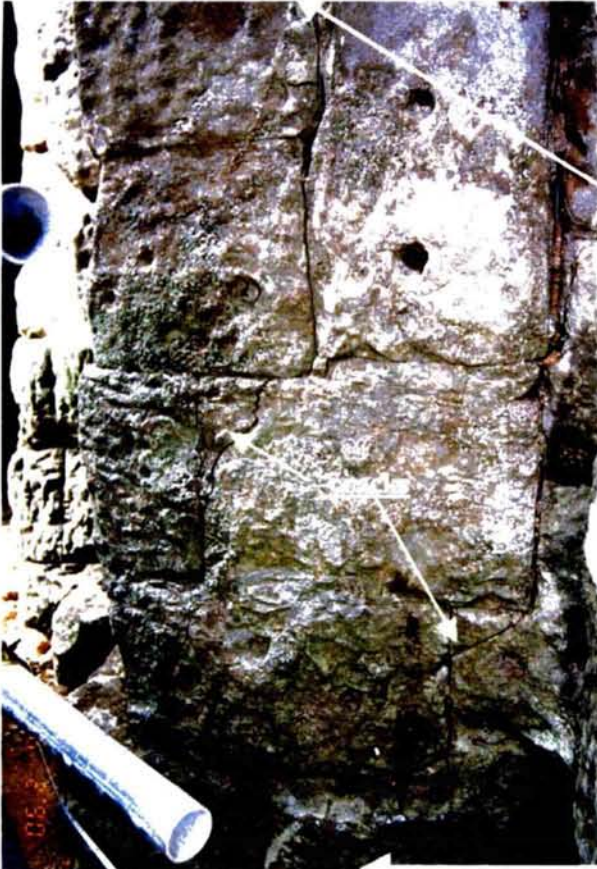
Photo 7-9 Enlarged bottom part

There is another example at the southwest corner of the Gallery that is shown in Photo 7-8 and 7-9. Two cracks are shown in the Photos and these cracks at the lower level in the blocks continue upwards with increasing opening width.

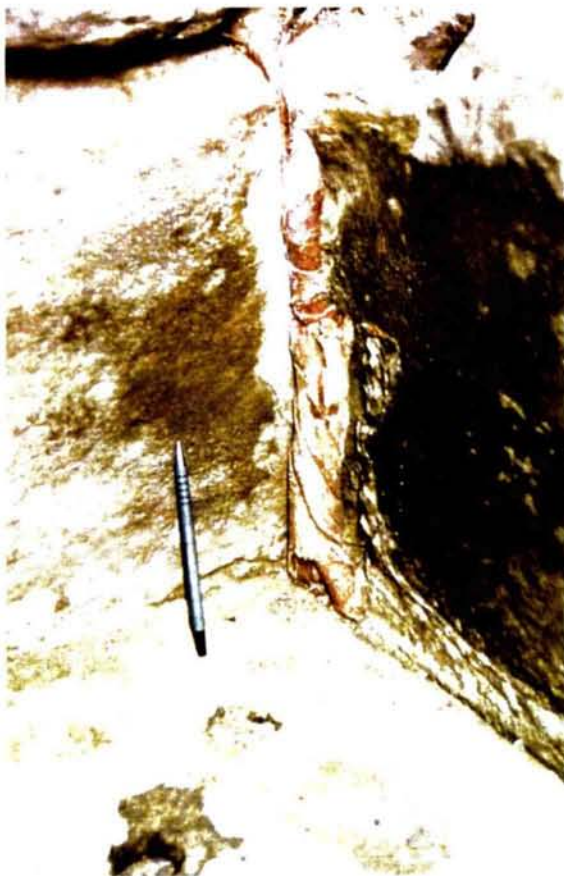
Plant root  
 Photo 7-10 Plant root between vertical gap (SE corner)

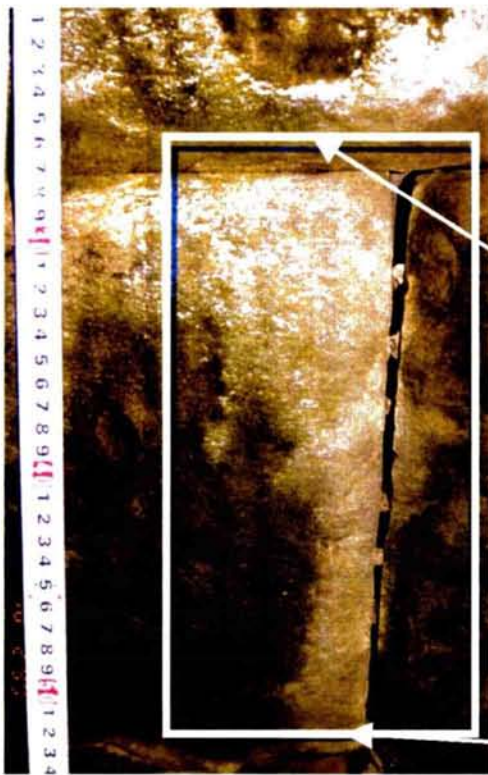
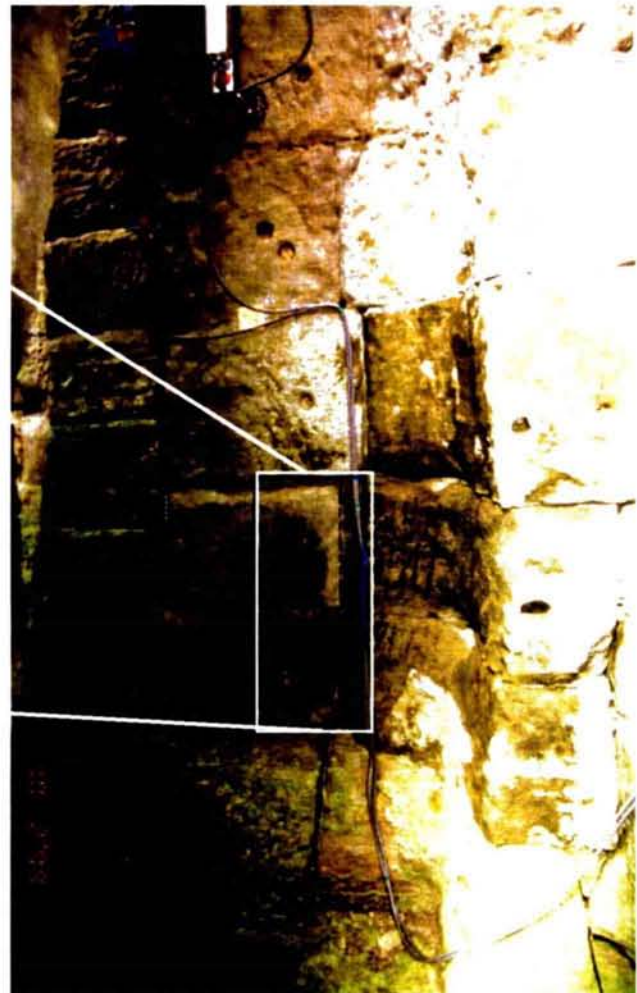
Photo 7-10 shows another example of space widening phenomenon. Several gravels are found in a space between stones. It is not known how these gravels had fallen and stayed, however, these gravels might have acted as non-reversible ratchet. Once the opening of the space increases by some reason, gravels fall down and keep the space wider than before.

Photo 7-11 Gravels fallen in space opening between stones

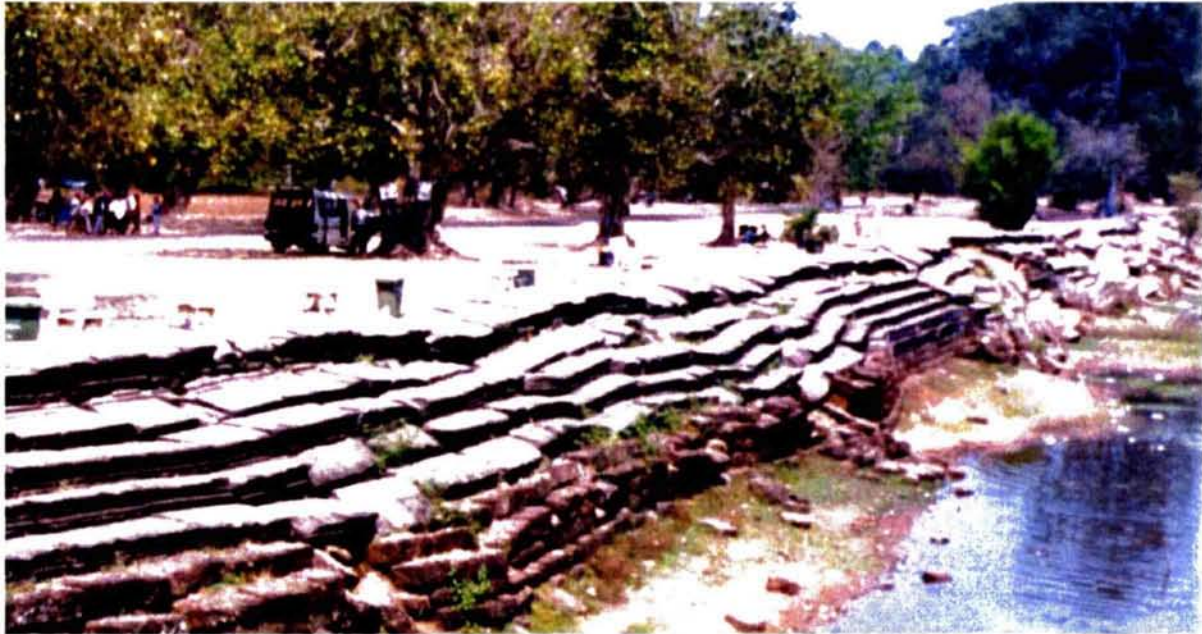
Photo 9-5 Inclination of embankment along moat of Angkor Wat
