Dynamic Analysis of Earth Dam Damaged by the 2011 Off the Pacific Coast of Tohoku Earthquake

This study examines possible failure mechanisms and dynamic behavior of the Fujinuma dam, which failed following the 2011 Off the Pacific Coast of Tohoku Earthquake. The study comprises two parts: an investigation through field and laboratory experiments, and a numerical simulation of the dam. Field measurements and laboratory experiments were conducted to acquire necessary information. Microtremor observations of the surviving portion of the failed dam were performed to extract data on its dynamic characteristics. Triaxial and other laboratory tests provided information required for the analysis. For the seismic analysis, a coupled solid-fluid finite element method was applied and observed and simulated motions of the 2011 Tohoku Earthquake used as input. Mechanical behavior of the dam material was described using the Mohr-Coulomb failure criterion. Frequency and dynamic analyses were performed and dam behavior and possible failure phenomena presented. Furthermore, a comparison between the simulation results and existing facts is discussed.

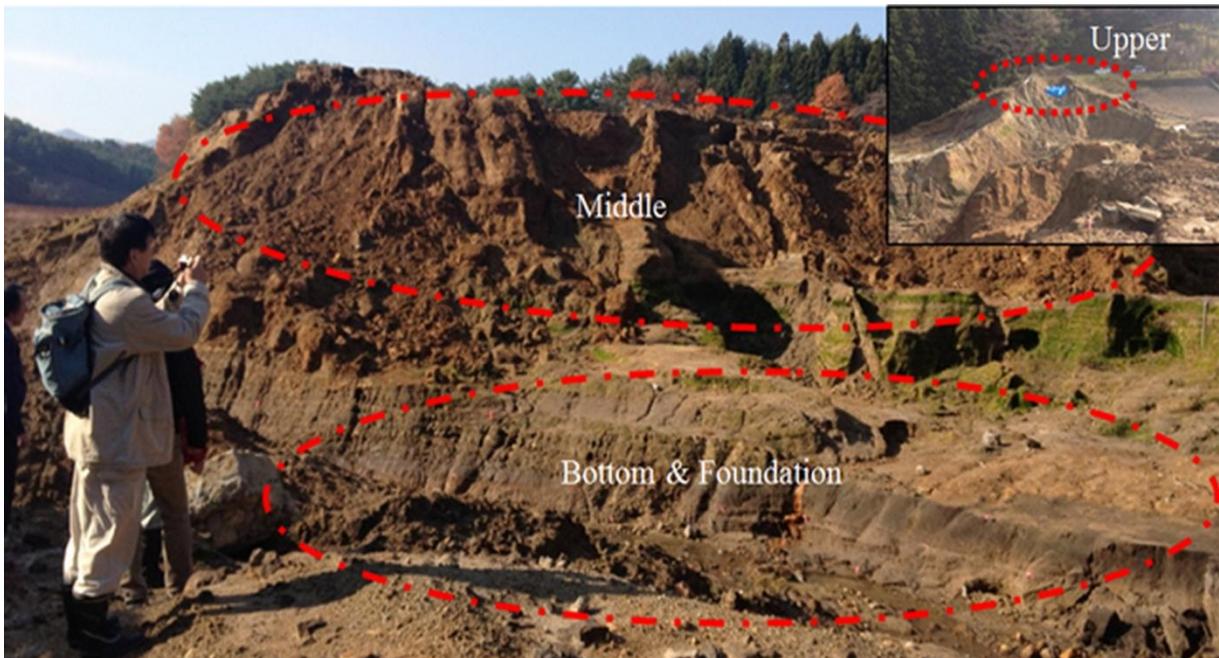
Photo1

Following the dam failure, most of the upper portion of the dam was washed away; the severe damage or breach location can be observed at the maximum cross section near the left abutment from downstream. On the opposite side, the remaining dam body consisted of the compacted fill materials. The foundations of the dam were exposed to ground level on the downstream side. From visual inspection of its properties, the dam body can be classified into three parts: upper, middle, and bottom.

Photo. 1. Remaining portion of the failed dam.

The upper layer comprises the top 6–8 m to the dam crest. Unfortunately, most of the upper layer was flushed away when the dam failed. However, on the left abutment, a portion of the upper embankment remains. Visual observation was performed on this section, which revealed that the fill material consists mainly of coarse sand of light color varying from light brown to gray (Photo. 1).

The bottom layer is between 4 and 6 m thick. This portion consists mainly of layers of loam-type clay and humic silty sand ranging from black to dark gray (Photo. 1). In addition, previous investigators [23,24] have indicated that some parts of the bottom layer consist mainly of dark brown sand and gravel. The black foundation material of the dam consists of organic residuals mixed with clay and silt.

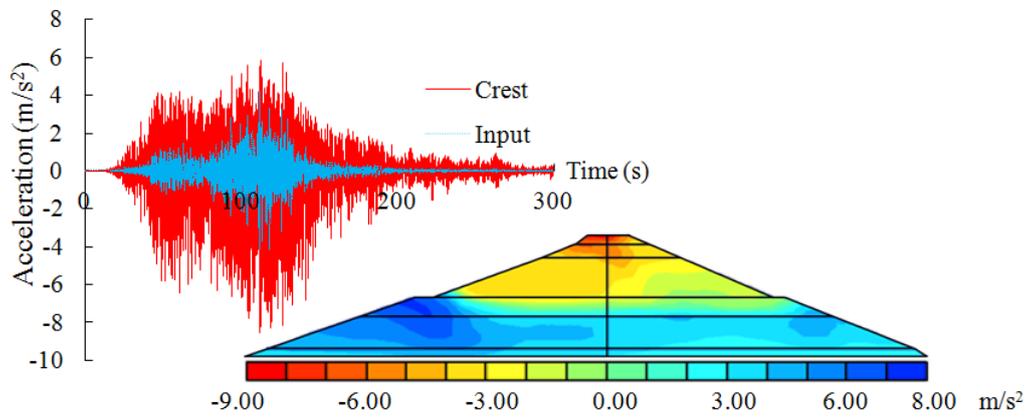
Fig12

Results show that larger maximum crest acceleration can be obtained using inverse phase of the observed and simulated motions. Therefore, the acceleration contours at the time when the maximum acceleration reached the dam crest are shown in Figs. 12 and 13 for inverse phase of the observed and simulated motions, respectively. By using the observed motion, the maximum crest acceleration is determined to be 7.42 m/s² and 8.56 m/s² accelerating towards the upstream direction at the time of 104.45 s and 111.60 s for normal and inverse phase motion (Fig. 12), respectively. For the simulated earthquake, the maximum crest acceleration is 7.60 m/s² acting towards the upstream direction at the time of 72.78 s. Similarly, for its inverse phase, the crest experienced the maximum acceleration moving towards the upstream side with a magnitude of about 7.65 m/s² at 71.24 s (Fig. 13).

Fig. 12. Acceleration contours (inverse phase of observed motion).

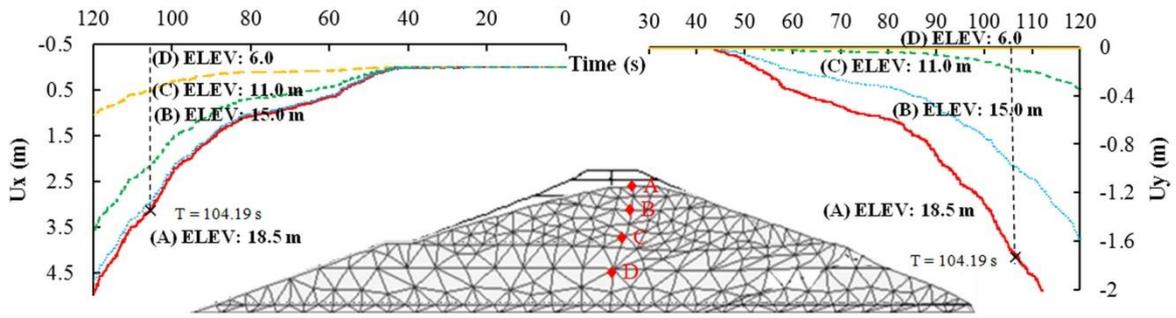
Fig14

Fig. 14 shows the deformed mesh at 104.19 s and its corresponding displacement curves when subjected to the observed motion. It can be seen that the entire dam body was moved in the downstream direction. As time increases, plastic deformations were accumulated. This caused the permanent horizontal displacement U_x of 2.95 m, and crest settlement U_y reached 1.80 m at 104.19 s; this is considered as the point of dam failure due to the loss of freeboard. Settlements at other observation points yield a similar tendency, but the settlements were less with decreasing dam height.

According to the facts, the dam experienced overflow and subsequent breach. The one possible cause is that the significant settlement of the dam body led to the loss of freeboard. Thus, the observed motion does reflect the actual failure mechanism of the dam, whereas the simulated motion does not. However, all cases show that settlement is high, especially in the upper portion of the dam owing to its softness. For the changed phase, the observed motions show the significant effect of creating the displacement obtained from the normal and inverse phase, to be in opposite directions.

Fig. 14. Deformed mesh at 104.19 s using observed motion.

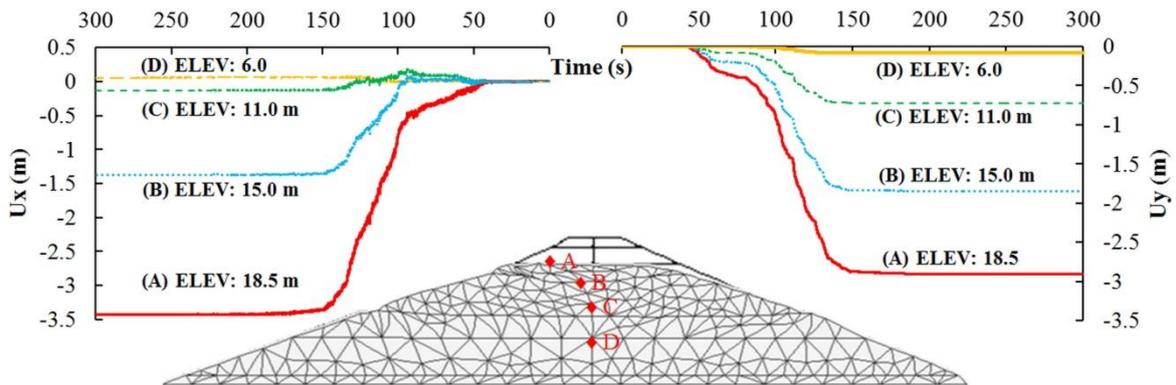
Fig15

In addition, the deformed meshes and deformation curves in both directions, at the end of the shaking using the inverse phase of the observed and simulated ground motion, are shown in Figs. 15 and 16. These indicate that both horizontal and vertical displacements fluctuated during the earthquake and settled continuously at a rapid rate, and then remained constant until the end of the excitation. The permanent horizontal displacement of the dam was 3.40 m (upstream side), 0.30 m, and 0.42 m for the inverse phase of the observed, simulated, and inverse phase of simulated motion, respectively. The vertical displacement at the dam crest reached 2.90 m, 0.63 m, and 0.60 m for the inverse phase of the observed, simulated, and inverse phase of simulated motion, respectively. As a result, by considering overtopping failure, the dam was able to withstand safely the simulated input motion except for the case of using the inverse phase of the observed motion, for which overflow is expected to occur.

Fig. 15. Deformed mesh at end of the analysis using inverse phase of observed motion.

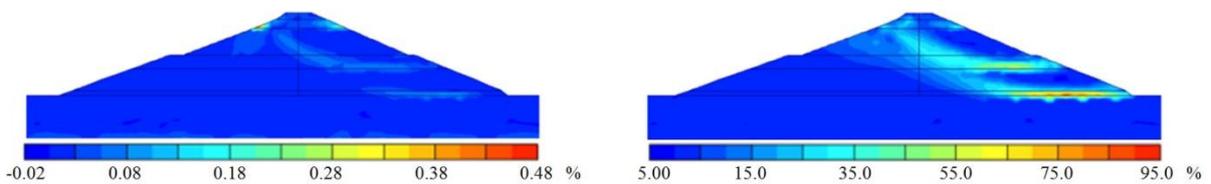
Fig17

Shear strain contours for various times obtained using the observed motion are shown in Fig. 17. Most of the dam body experienced an insignificant rate of shear strain. It can be seen that initially, large shear strains occurred in the upper portion, especially on the upstream side. Thereafter, the occurrences of large shear strain can be observed clearly on both sides of the dam in the middle and bottom portions of the downstream slope. This excessive level of shear strain may indicate a possible cause for the dam failure. Similarly, shear strain contours obtained from the remaining motions, yield almost the same pattern as the previous motion (Figs. 18 and 19). However, the exception is when using an inverse phase of the observed motion, for which large shear strains can be seen on the upstream slope instead of on the downstream slope.

The sequence of dam failure has been reported by previous researchers. Initially, the dam experienced excessive deformation or a slide on the upper portion of the upstream slope. This, together with a subsequent large slide that occurred on the downstream face, yielded a loss of freeboard and triggered the overflow that resulted in the breaching of the dam. Most numerical results show good agreement with this scenario, except for the case of using the inverse of the observed motion, which exhibited large strain appearing mainly on the upstream slope. The simulated motions also yield good agreement, but only with a smaller value of shear strain.

Fig. 17. Shear strain contours at 40 s and at 104.19 s using observed motion.

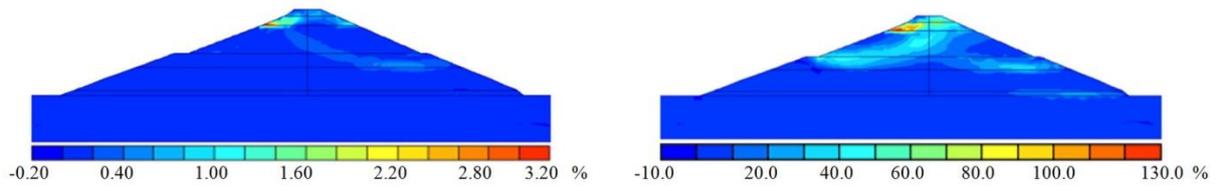
Fig18

Fig. 18. Shear strain contours at 40 s and at the end of motion using observed motion (inverse phase).

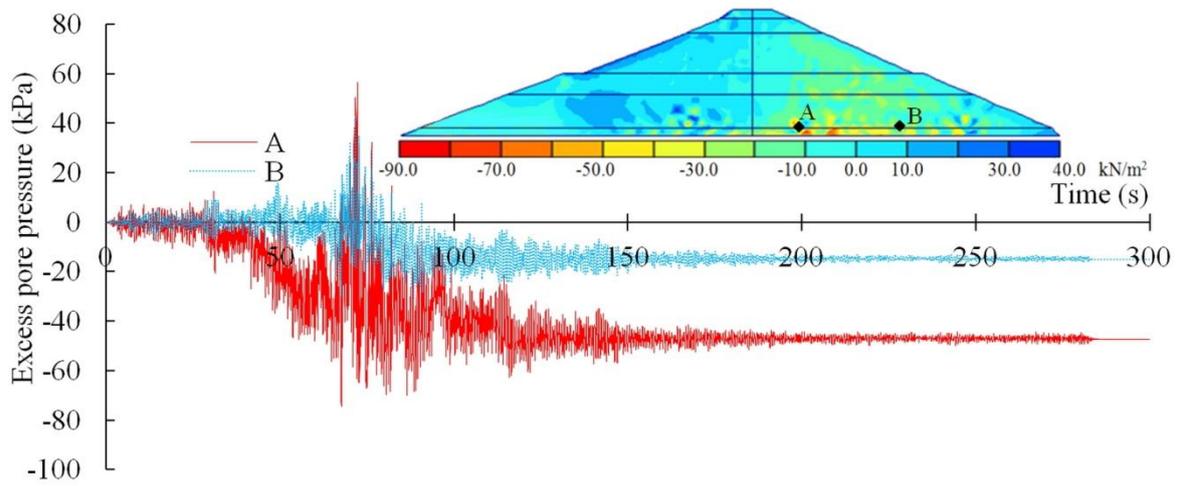
Fig20

The distribution of the excess pore pressure within the dam body and the records of the observation point A and B at 104.19 s using the observed motion are shown in Fig. 20. It can be seen that the excess pore pressure developed mostly at the downstream side. The maximum excess pore pressure was about 90 kPa and it can be found near the dam's base close to the dam center line. Besides, the suction or the positive excess pore pressure can be found on the upstream face and within dam's body on the upstream side. It can be seen that from the time history curves of the excess pore pressure at the

The results show that most of the dam body experienced the build-up pore pressure that was not high enough to equal the effective stress and trigger the total loss of the soil strength. However, in particular locations such as on the downstream side where the effective stress found to be small, the reduction of shear strength can be fairly high and led to significant permanent deformation on those areas. However, it must be noted that the Mohr-Coulomb model can only capture the excess pore pressure due to volumetric stress. Although, the excess pore pressure due to earthquake excitation was presented here, the actual phenomenon of cyclic mobility and liquefaction cannot be modeled and captured in this study.

Fig. 20. Excess pore pressure.

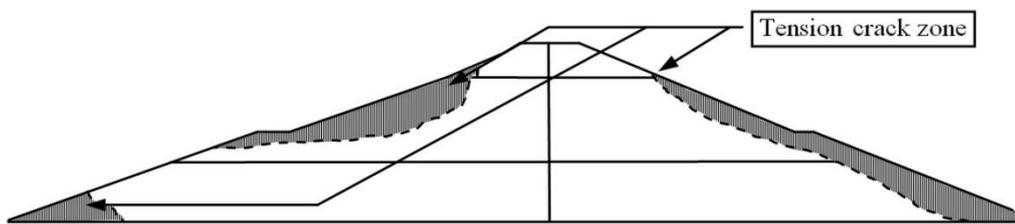
Fig21

In the analysis, it is possible to capture the tension crack during the shaking duration by illustrating the location in which the tensile stress does exceed the tensile strength. Fig. 21 summarizes the zone of the tension crack that occurred throughout the time of the analysis for both the observed and the simulated motion. It can be seen from both cases that the tension crack occurred similarly within the same location. This crack appeared clearly in the middle portion and at the toe for both sides. However, the tension crack on the upstream slope seems to penetrate deeper into the dam body. From this evidence, it would appear that sliding and internal erosion could be triggered, thereafter causing the failure of the dam.

Fig. 21. Tension crack zone.
