Global monitoring of large concrete structures using acoustic emission and ultrasonic techniques: case study.

Tomoki Shiotani¹, Dimitrios G. Aggelis² and Osamu Makishima³

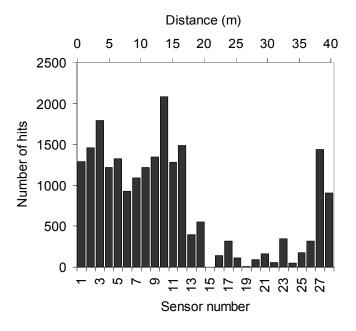
Fig. 3. Number of hits per channel and distance.

emissions. Specifically, channel #10 recorded the highest number of hits. This corresponds to the distance of 14 m from the starting point. It is well known that the AE activity is connected to the extent of damage through primary (crack growth) and secondary (frictions) mechanisms. Therefore, the area near the sensor which recorded the highest activity was the most likely to have sustained more serious damage than the rest of the structure examined. Consecutively, this area was selected for the more detailed monitoring using stress waves as described in the next section.

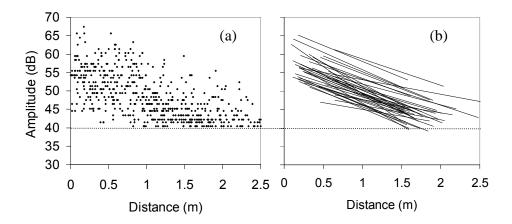
Fig. 4. (a) Hit amplitude vs. distance from event source, (b) individual attenuation slope for different events.

After location of the events, interesting conclusions can be drawn about the attenuation of the structure. In Fig. 4(a) the amplitude of the hits of all events is depicted vs. the distance from the source. The average first hit stands at an amplitude of 54 dB. In Fig. 4(b) the linear fits to the amplitude of each individual event are plotted. Attenuation can be calculated by the slope of each line. Averaging of the slopes of the events recorded from the whole structure results in -7.02 dB/m. It is seen that any "hit" propagates at least 1.5 m before being reduced below the threshold level (40 dB). Therefore, they are recorded by at least 2 sensors. This shows that the separation distance of the sensors is adequate for source location in this case. In any case, attenuation is a crucial parameter that should be seriously taken into consideration since in monitoring of most large structures, compromises must be made between the available number of sensors, time restrictions for measurement preparation and the desirable degree of detail of examination. Attenuation is a key parameter to make an adequate decision.

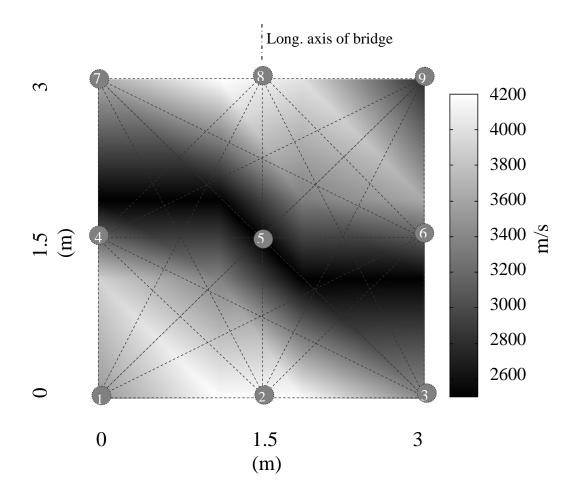
Fig. 6. Velocity structure visualization of the bottom surface of the bridge concrete. The positions of the transducers are indicated by (), and the examined wave paths by dashed lines.

The transit times of the individual paths and the geometry were supplied to suitable tomography program (Kobayashi et al., 2006). This way the visualization of the velocity structure was obtained, as seen in Fig. 6. The tomogram supplies the information of which parts of the surface area exhibit lower velocity than others. From this figure, it is seen that within the area of 9 m^2 , considerable discrepancies of wave velocity emerge. These discrepancies correspond to different degree of inhomogeneity. Specifically, a zone approximately in the center of the selected area exhibited velocity of less than 2500 m/s, indicating poor quality, while other parts exhibited velocity higher than 4000 m/s. As stated above concerning AE activity, the events may propagate through different parts of the structure or reinforcement and their exact source could be concrete cracks, delaminations of different layers (e.g. asphalt on concrete) or friction between the tendon ducts and matrix concrete. As to the velocity measurements though, propagation took place only through the surface layer of concrete. Therefore, the velocity is characteristic of the concrete material itself indicating low quality or extensive damage on that specific area. It is reminded that the general condition of the structure was considered satisfactory after visual observation. Therefore, the low velocity is attributed to a subsurface defect.

The depth cannot be easily determined though. Concerning Rayleigh waves, it is accepted that the penetration depth is approximately similar to the wavelength (Aggelis and Shiotani, 2007). In this case however, the first arrival used to measure velocity corresponds to the longitudinal wave which is in any case faster than Rayleigh or shear waves. Therefore, it is not straightforward how deep is the surface layer characterized by this velocity. Concerning Rayleigh propagation, typical velocities for the bottom part of Fig. 6 were around 2500 m/s, corresponding to longitudinal velocity certainly higher than 4000 m/s (assuming a typical Poisson ratio of 0.2). Although this implies good quality, the determination of Rayleigh velocity was not always possible due to severe attenuation and distortion of the waveform, especially for paths at the top of Fig. 6. This was because there was no characteristic point to use as reference
