Creep and Failure of Palaeozoic-Rock Slope

By Yoshimasa KOBAYASHI and Akira NAKAGAWA

Abstract

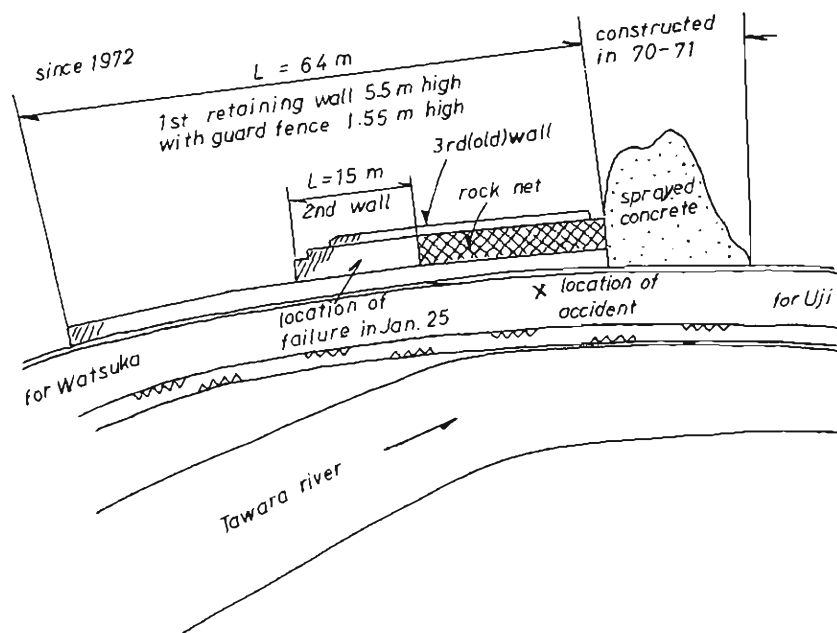
Fig. 1. Schematic representation of preventive works against rockfalls and slope failures at the site.

A retaining wall as illustrated in Fig. 1 had been nearly completed when the rockfall occurred, and some effect of the work on the accident was first suspected.

- 1) a wall 5.5 m high and 60 m long along the road,
- 2) stone guard (fence) 1.55 m high on the top of the wall 1),
- 3) a wall of 10 m high and 15 m long in the middle height of the slope, and
- 4) a rock net of 10 m wide and 20 m long on the right of the middle-height wall.

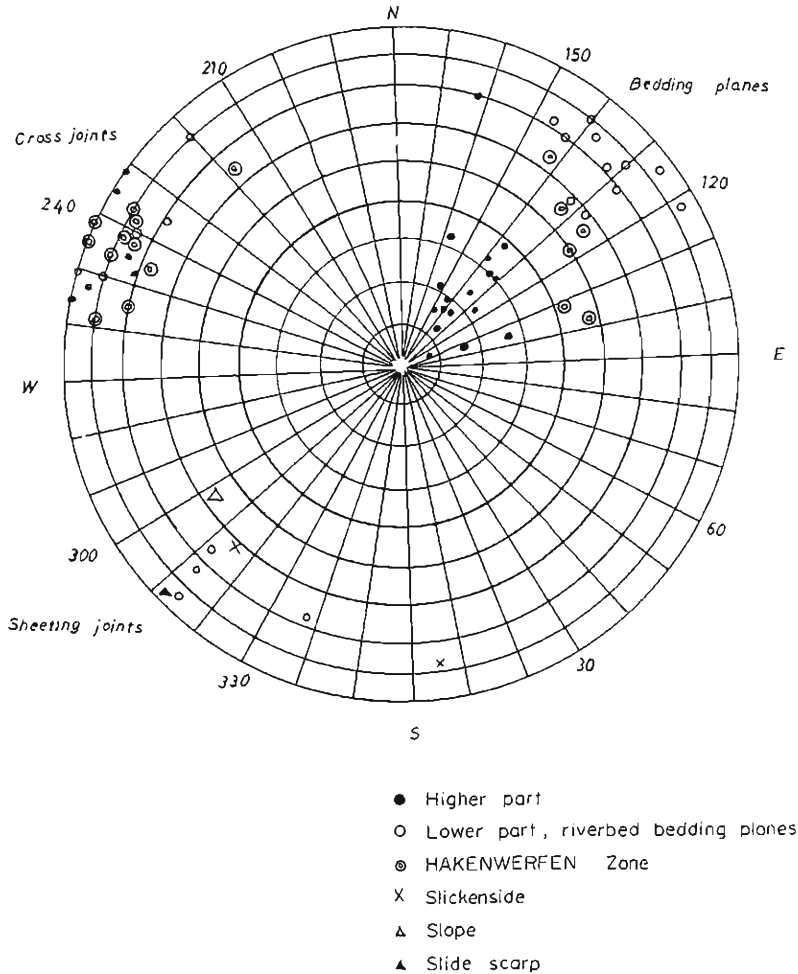
Fig. 2. Distribution of joint orientations in a higher and lower part of the slope.

A polar representation of the distribution of joints at an old slide scarp in the uppermost part of the slope and at the river bed is given in Fig. 2. In the figure the poles for the slope surface (N30W/55N) as well as for the old slide scarp (N55W/80N) are also given.

It is noted in the higher part of the slope that the orientation of the slide scarp is nearly coincident with the average of those of sheeting joint. The angle between the average orientations of sheeting joint and of the slope as a whole is about 20 degrees. The gaps between joint surface in the upper part are 5 to 15 cm for bedding joint, 1 to 25 cm for cross joint and 5 to 10 cm for sheeting joint.

In the river bed the bedding plane is more steeply inclined than in the higher part of the slope, and gaps between joints are 5 to 20 cm for bedding, 15 to 20 cm for cross joints and 10 to 20 cm for sheeting joints, respectively, which values are appreciably greater than those in the higher part.

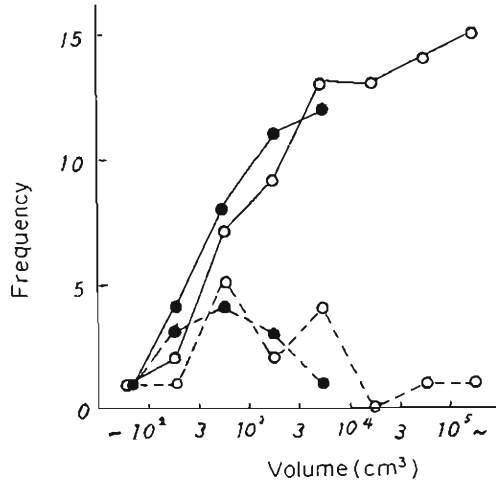
Fig. 3. Size distributions of debris; ○ sandstone, ● slate; size frequency curve, — size accumulation curve.

- in case of sandstone, 50 to 200,000 cm³ and
- in case of slate, 90 to 4,000 cm³ (see Fig. 3).

The most frequent sizes correspond to the class 300 to 1,000 cm³ for both types of rock.

The volumes of the rock blocks having fallen prior to the slides are 310,000 and 225,000 cm³, which belong to the class of the biggest size. The debris are in general angular and the angle of friction of the aggregate is estimated to be higher than

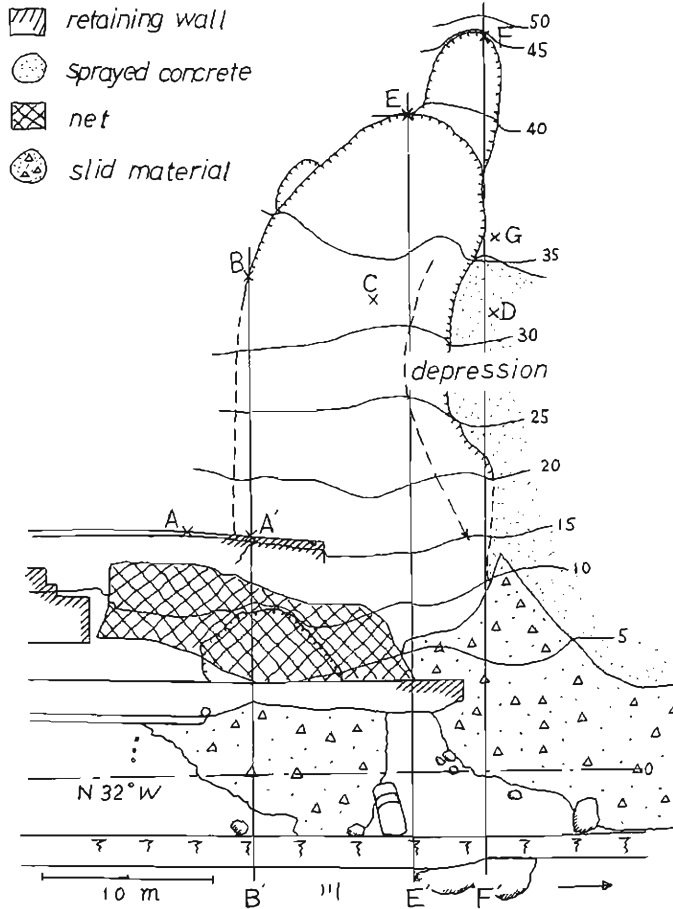
Fig. 4. Plan of the site.

As a result of site investigation it was found out that a larger area including the two present slides is moving downhill. Its upper end is bounded by an old slide scarp, the northern side by a boundary of sprayed concrete, and the southern side by a line which coincides with a fresh crack found in the existing old retaining wall (Fig. 4, 5). The scarp exhibits a height difference of 2 to 3 m across it and is accompanied in the northern half by another smaller slide of 5 m long, which also is bounded by a scarp of 5 m high. Also the southern periphery of the main slide is accompanied by a small slide of about 1 m width. After the accident a new

The longitudinal section of the slope through the point E is shown in Fig. 7, from which the average inclination of the slope is revealed to be about 40 degrees in the upper half and 60 degrees in the lower half. On the main sliding mass there is a channel-like depression, which begins at about 35 m height and comes down curving gradually to left as shown schematically in Fig. 4. The depression seems to be the space from which the main larger slide originated.

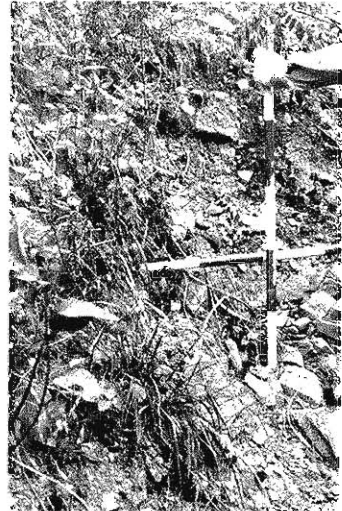
Fig. 6. A trace of slip amounting to about 25 cm.

trace of slip amounting to about 25 cm was observed along the boundary of the integrated sliding mass (Fig. 6).

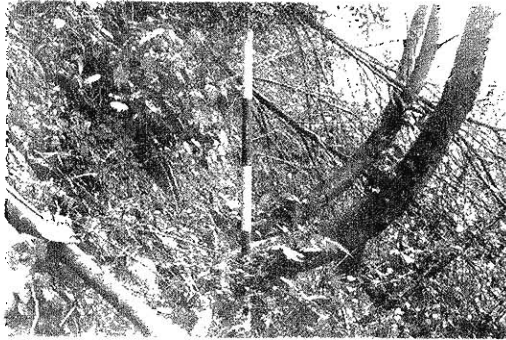
Proceeding creep can be presumed also by curving tree trunks (Fig. 8). Vines which extend from the bedrock over slide scarp to the sliding mass are in tension,

Fig. 8. Curving tree trunks.

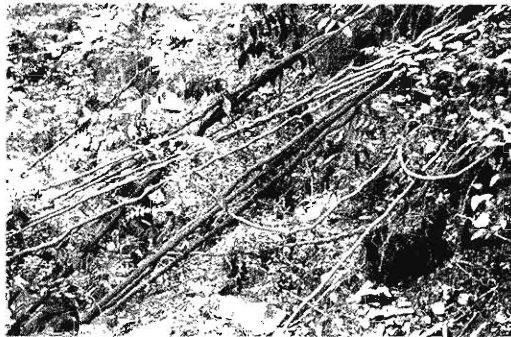
Fig. 9. Vines in tension due to differential displacement of ground.

suggesting a recent downhill displacement of the mass (Fig. 9).

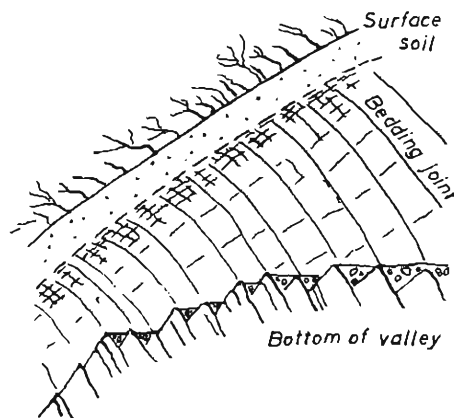
Fig. 10. Hakenwerfen or gravitational deformation of rock mass near slope surface.

A Hakenwerfen (gravitational deformation)^{3,4)} phenomenon is observed at a valley cutting normally into the slope at some tens of meters north from the site (Fig. 10). This phenomenon also indicates a proceeding downhill creep under the effect of gravity. Warping of the discontinuity develops as deep as 5 m into the rock mass, and above this depth the rock is appreciably loose because of toppling blocks⁵⁾ and

opening joints. The rock condition is similar at this point and in the slide site so the phenomenon may probably be assumed also to have existed in the slope concerned.

The steeper dip of bedding at the river bed than at the scarp may be attributable to this phenomenon, being assumed that a loosened portion has been taken off by flowing water in the river bed, while that portion remains still in the scarp.
