Reconnaissance report of the 2004 Great Sumatra-Andaman, Indonesia, Earthquake – Damage to geotechnical works in Banda Aceh and Meulaboh –

Tetsuo TOBITA¹, Susumu IAI¹, Banta CHAIRULLAH² and Wimpie ASPER³

¹ Disaster Prevention Research Institute (DPRI), Kyoto University

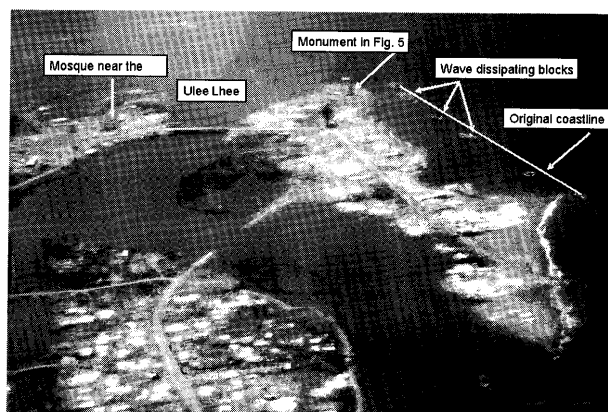
The coastlines of Banda Aceh receded several hundred meters after the tsunami (Fig. 4). Houses located on sand dunes near a small fishery port at Ulee Lheue were completely swept away from their foundations, and only wave-dissipating blocks remained about 20 m off the seashore (Fig. 4). Based on measuring the difference in the water mark heights on the front and rear walls, the current speed was estimated to be 25.2 km/h (Matsutomi *et al.*,

Fig. 4 Aerial view of lost coastline near Ulee Lheue (taken on March 4, 2005)

Results of the reconnaissance indicate that the loss of land along coastlines submerged into the sea was mainly due to erosion by the hydrodynamic force of tsunamis; however, liquefaction also likely contributed. According to the witness accounts of residents, liquefaction occurred before the tsunami struck. The sites consist of clean sand with an average particle size of 0.2 - 0.3 mm (Fig. 6). The epicentral distance of the liquefied site in Banda Aceh, although it might not be the farthest site for this event, can be plotted in the figure developed by Ambraseys (1988) from the worldwide database of shallow earthquakes (Fig. 7). As seen in Fig. 7, the distance between Banda Aceh and an epicenter of 250 km for an earthquake of M_w 9.3 is consistent with existing findings.

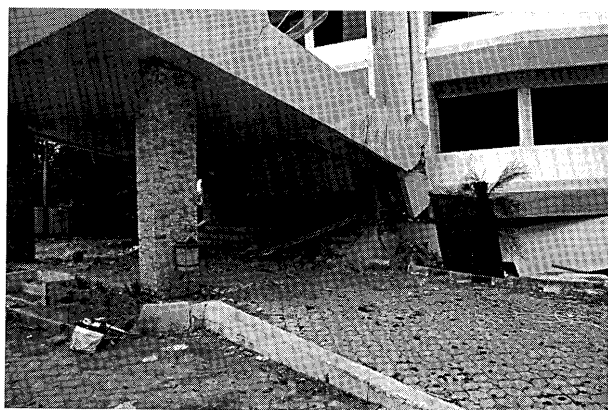
As the city was built on predominantly soft soil, large RC structures such as government and private buildings, shopping centers, hospitals and hotels (Fig. 3), whose natural period was relatively long, were damaged by strong motion. However, it should be noted that damage to those buildings varied from total collapse to minor damage depending on the type of foundation, local ground conditions and spatial variation of strong ground motions. The sharp contrast in the damage that occurred in the coastal and inland hilly area indicates that the soft ground conditions might have been a significant factor in the damage to buildings in the coastal area of Banda Aceh.

Fig. 3 Soft-story (1st story) collapse of a 5-story building

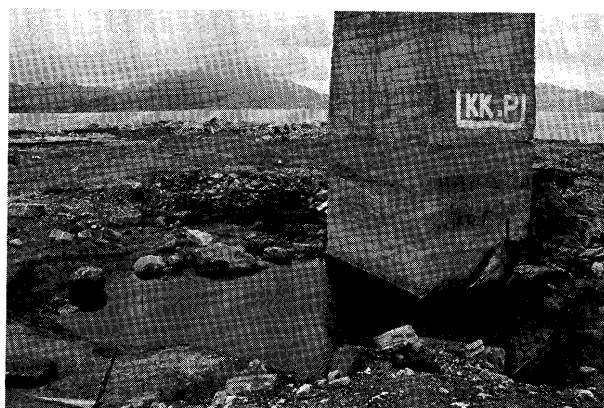
Fig. 5 Erosion behind the monument located at Ulee Lheue

2005). The inundation height of wave at Ulee Lheue Port was 12.2 m above the sea level. There was a local scour behind a monument standing near the fishery port and that might indicate the speed of waves (Fig. 5).

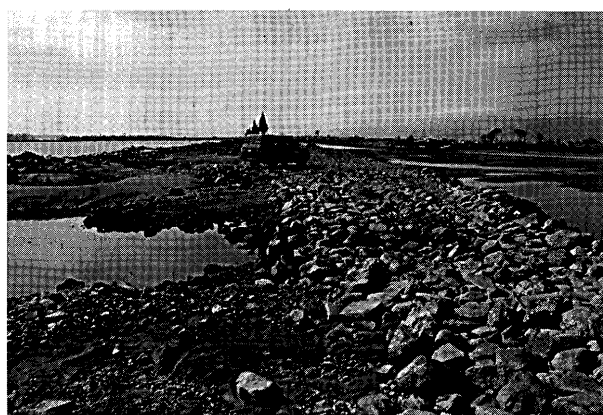
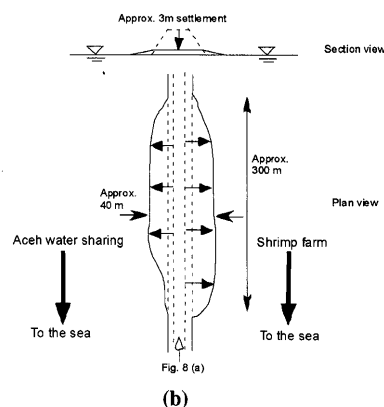
witched by the water channels, i.e., the Aceh River and the straight channel that connected the marshlands of shrimp farms to the sea. Significant damage was found on the left bank of the channel about 1 km from the river mouth (Fig. 8), where marshland and the straight channel merged. The levee's body was laterally expanded in the transverse direction with remaining slope-protection stones, and its crown settled near the water surface (Fig. 8b). Taking account of its failure mode and the ground water depth at the site, the damage could be due to loss of bearing capacity with liquefaction.

Considering that the right bank near the river mouth was more eroded than the left bank, the tsunami waves might have initially struck the right bank and then been reflected to the left bank. This may indicate a north-west incidence of tsunami waves at this location. The wave velocity was estimated from the collapsed bridge at the river mouth of the Aceh Water Sharing. Its bridge girder was supported by U-shaped concrete slabs attached on to the top of piers. When the tsunami struck the bridge girders, they pushed the upstream side of the U-shaped slabs and as a result girders fell. Based on the dimensions and strength of the concrete, the wave velocity was estimated to be 12 km/h (Scawthorn *et al.*, 2005).

Fig. 8 (a) Collapsed levee (left bank of the Aceh Water Sharing), (b) Schematic view

- (2) Considering the failure mode and surrounding environment, liquefaction might be the primary cause of damage to the embankments of the Aceh Water Sharing. The occurrence of liquefaction at the distance of 250 km away from the epicenter is consistent with the existing data.

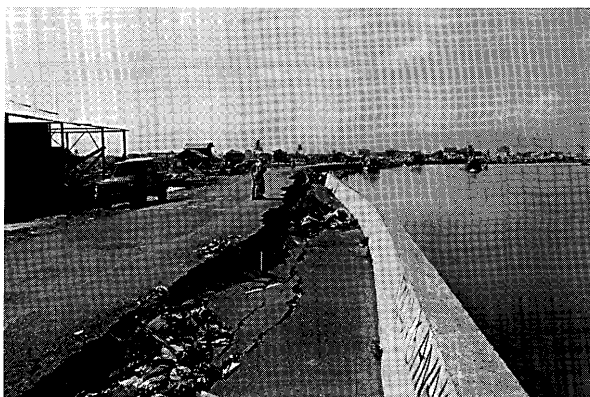
At this location, river protection walls were constructed by L-shaped concrete slabs, whose height was 2 m and the width at the bottom was 1.5 m (Fig. 9 and 10). The walls were displaced toward the river and in some parts totally collapsed. The material behind these river walls was mainly sandy clay and interbedded sands and gravels. Strong shaking and hydrodynamic force might have caused the damage to the river walls.

Fig. 9 Failure of river protection walls at Lampulo

- (3) Damage to the river protection walls at Lampulo where clayey soil was dominant might be due to the retraction force of the tsunami.
- (4) A major road between Banda Aceh and Meulaboh was destroyed. While a major road in the south of Meulaboh was undamaged except for the bridges. This is because the road in the north of Meulaboh was constructed closer to the ocean than that in the south of Meulaboh.

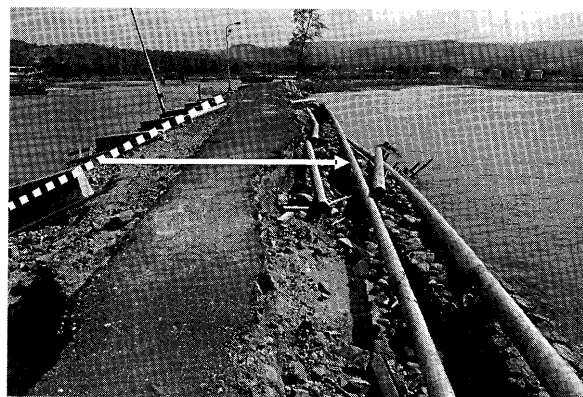
At Malahayati, east of Banda Aceh, an embankment to support oil pipelines suffered minor damage (Fig. 11). Its main body was not cut or submerged in the sea, only its shoulders were eroded; however, pipelines were cut and dislocated to the other side of the slope from their original position by tsunami induced force. The embankment was jutting into the sea about 1 km, and near the end the pipeline was supported by piled piers. The pier and machine cabin were undamaged.

Fig. 11 Minor damage to the embankment for pipelines at Malahayati. Pipelines were dislocated.

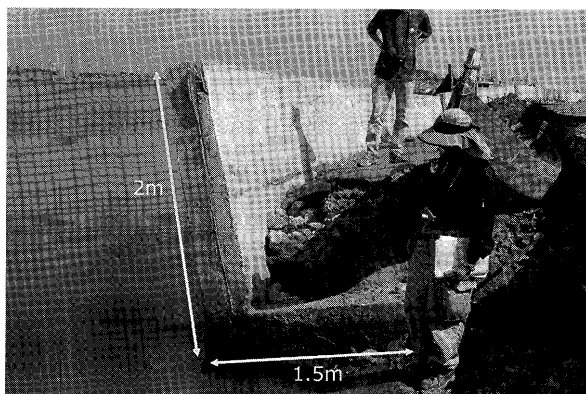
Fig. 10 Tilted and dislocated L-shaped river protection at Lampulo

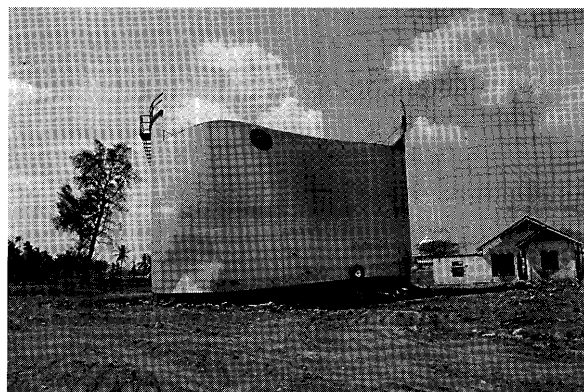
Other remarkable damage at the site was that three oil storage tanks out of nine were washed away by tsunamis due to the lack of anchor bolts (Goto, 2005; Saatcioglu *et al.*, 2006). One was relocated about 300 m west from its original position due to high tide of waves (Fig. 12). There were other relocated large objects, such as a power generating vessel and large tankers, which might have

Fig. 12 Relocated oil storage tank at Malahayati

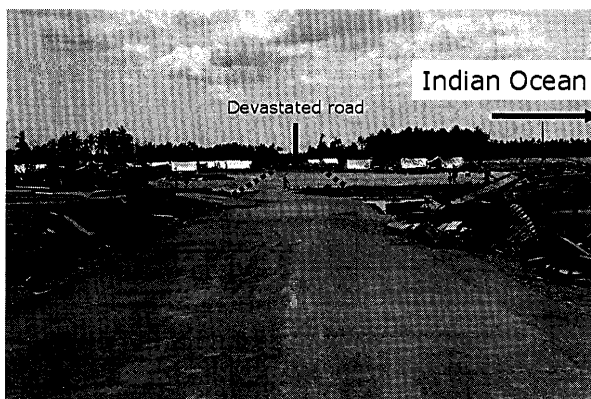
Fig. 17 Devastated road in Kuala Bubon. Photo was taken near the crossroads shown in Fig. 13, 14 and 16

A main road along the coastline of western Sumatra Island, which connected Banda Aceh and Meulaboh, were devastated. In the northern part of Meulaboh, because the road was constructed either on sand dunes near beaches or lowland just behind the sand dunes, parts of the roads, especially near river deltas, were completely lost (Fig. 16 and 17). While in the southern part of Meulaboh, the road was not damaged at all because it was constructed hundreds of meters inland from the coastline. After the earthquake, the main road was shifted to a narrow and unpaved road running inland in between Meulaboh and Kuala Bubon. The amount of traffic on the inland road, therefore, has been increased and protection works of road shoulders have been implemented using stones and mesh wires.

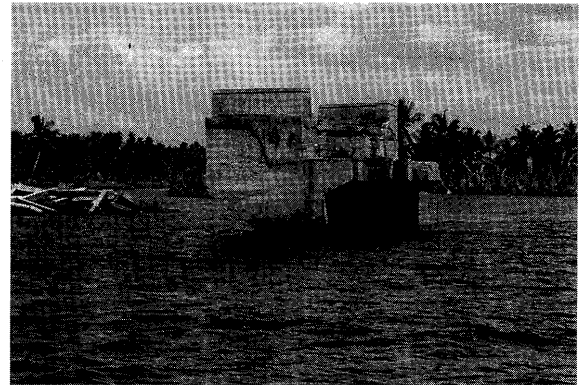
There was a 60 m steel truss bridge at the river estuary of Bubon River (Fig. 14). Its girders fell and only two bridge abutments are left (Fig. 18). Wave force is responsible for the bridge

Fig. 18 One of the bridge abutments of a collapsed steel truss bridge in Kuala Bubon

collapse. However, survivors said embankments to an access road to the bridge abutment settled before the arrival of the tsunami as a result of the strong shaking. People, therefore, could not escape by using bicycles or motorcycles. The settlement may be attributed to poorly compacted soil or liquefaction. This has often occurred after large earthquakes, e.g. vertical gaps at the edge of box culverts or near bridge abutments after the 2004 Mid Niigata Earthquake, Japan (Tobita *et al.*, 2005). In Kuala Tadu, where similar type of damage was observed (Fig. 19), the people tied up palm trees as a temporary bridge to fill the gap between the main bridge girder and the access road. It takes tens of minutes to temporarily repair. Considering the time until being struck by tsunamis, escape routes should be seismically stable.

- (5) Poor compaction and liquefaction might be responsible for the collapse of embankments adjacent to bridge abutments. If this occurs before the arrival of tsunamis, people are unable to use motorcycles and bicycles for quick evacuation. This indicates that it is important for escape routes to be seismically stable.

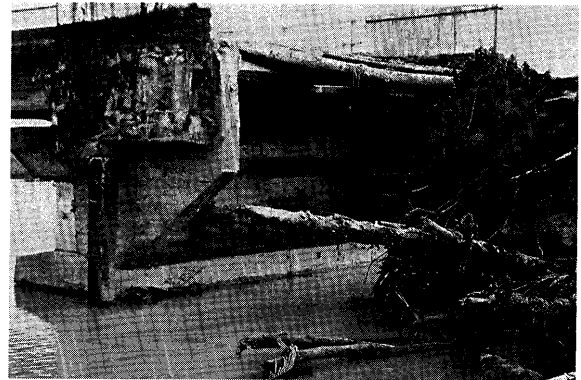
Fig. 19 Lost access road in Kuala Tadu
