A Case Study of Observational Method for a Failed Geotechnical Excavation in Singapore

Y. Iwasaki

ABSTRACT: Observational Method (OM) was studied based upon a case history of failed geotechnical excavation in Singapore. Several items including inclinometer provide vital information on the safety of the geotechnical construction sites. Engineer who is specialized in OM, adequate knowledge of geotechnical engineering as well as instrumentation, should be engaged during the design and construction phase. An ISO standardization is necessary to provide a basic process to implement OM.

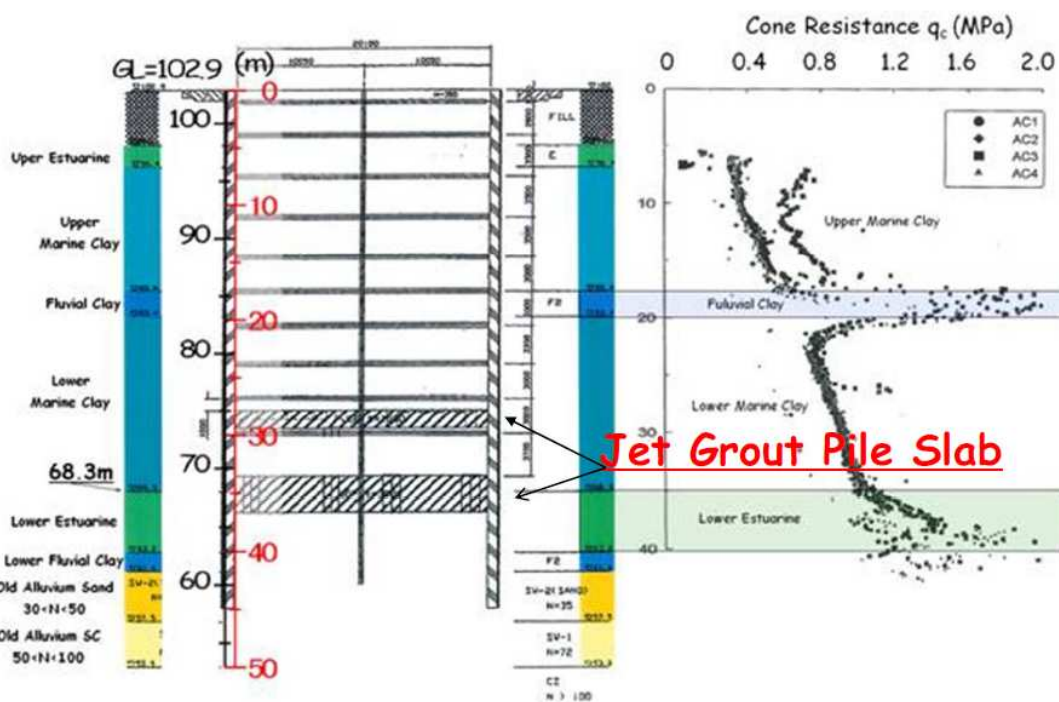
Fig.3 Design of Cut and Cover of Type M3

As shown in Fig.3, the special design was two sets of Grout slabs that had been installed before the

excavation started. The depth of the excavation was planned to GL-34.5 m above the lower grout slab. The cone penetration resistance shown in Fig.3 shows very soft soil down to 35m from the surface where stiff clayey soil continues.

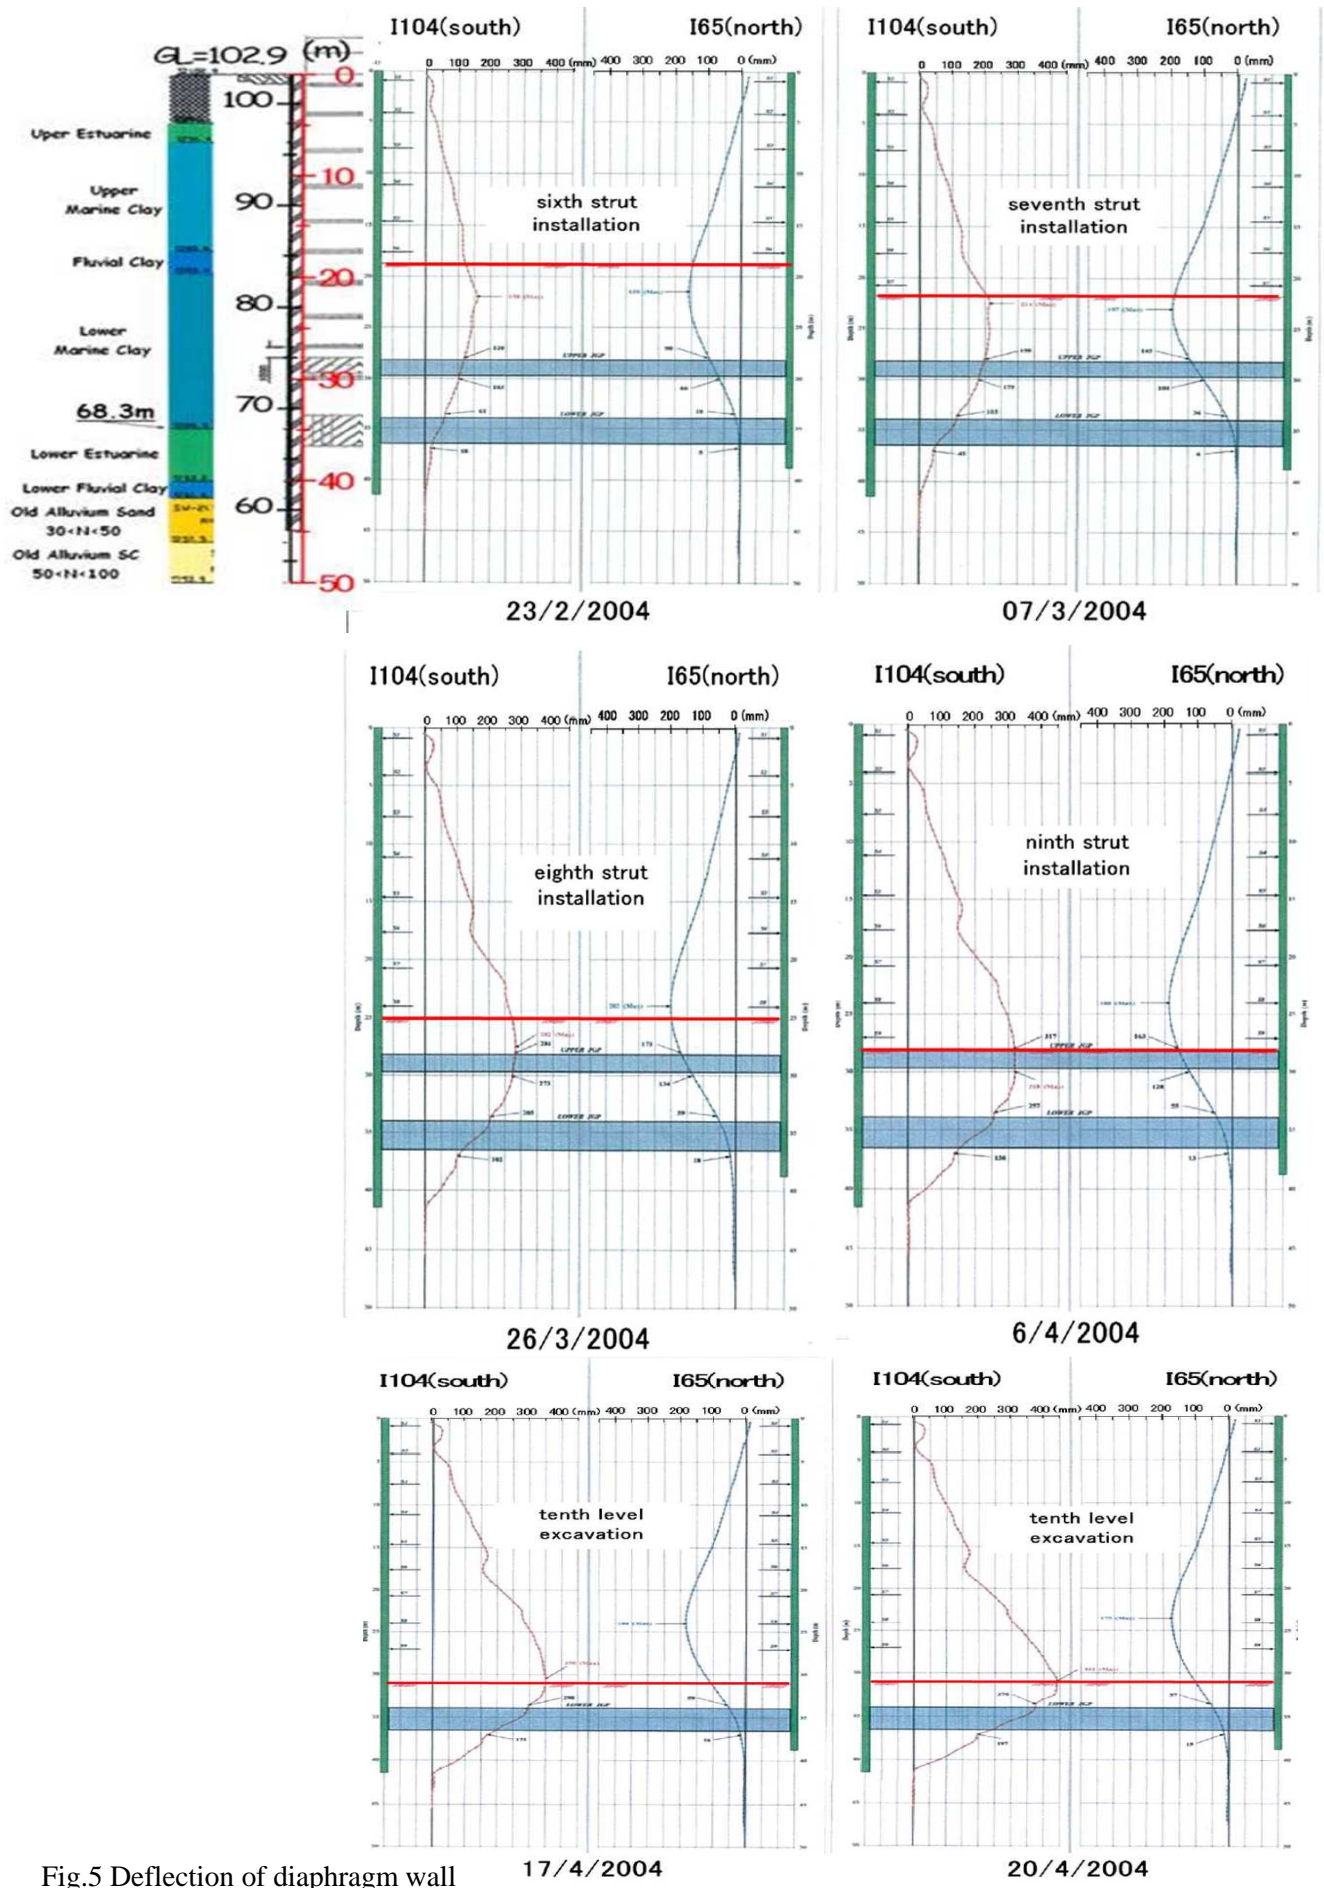
Fig.5 Deflection of diaphragm wall

Excavation started on 26 September, 2003, at the M3 Section. The monitored wall deflections from the six strut installation until before the failure took place are shown in Fig.5 as well as chronological time change of excavation with strut and the maximum deflection for I-65 and I-104 in Fig.6.

As shown in Fig.5 and Fig.6, the deflection after the sixth strut installation, the total deflection had reached 35cm, which resulted in about 1.7%.

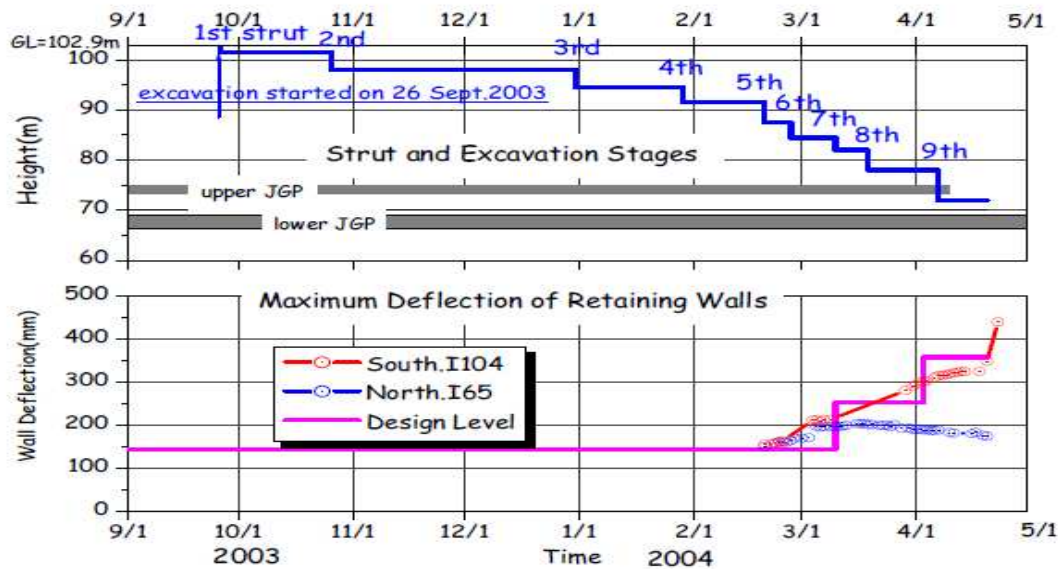
Fig.6 Change of Max. deflections with time

The max deflection at I-65 that is shown in Fig.6 shows its max deflection at the excavation stage after the sixth strut installation. After this point, the maximum deflection was decreased, which implies the diaphragm wall of the north side was moving backwards.

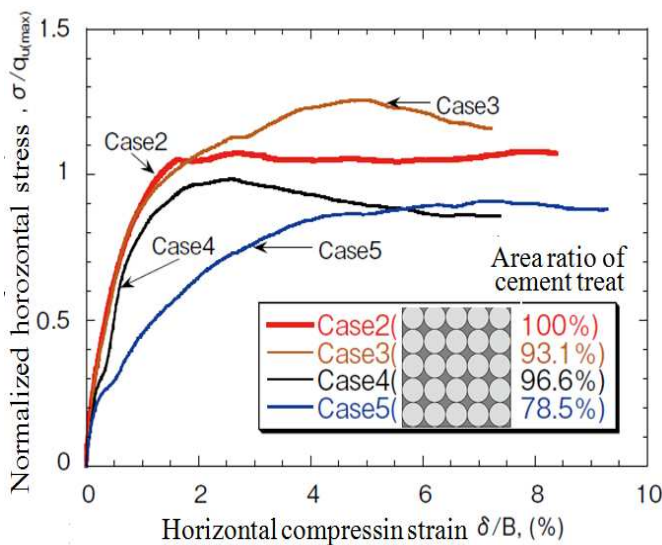
Fig.7 Stress-strain for JGP (Imamura et al.(2008))

Fig.7 shows basic stress and strain for horizontally loaded JGP obtained by laboratory tests (Imamura et al., 2008). The vertical stress was normalized by dividing horizontal stress by the unconfined compression strength of column of JGP (500kPa). Fig.7 shows the maximum allowable horizontal strain is estimated as 2%.

If safety margin is given as FS=2, the allowable deflection at the level of JGP is 1%, which is 20cm in total, or, 10cm for each side.

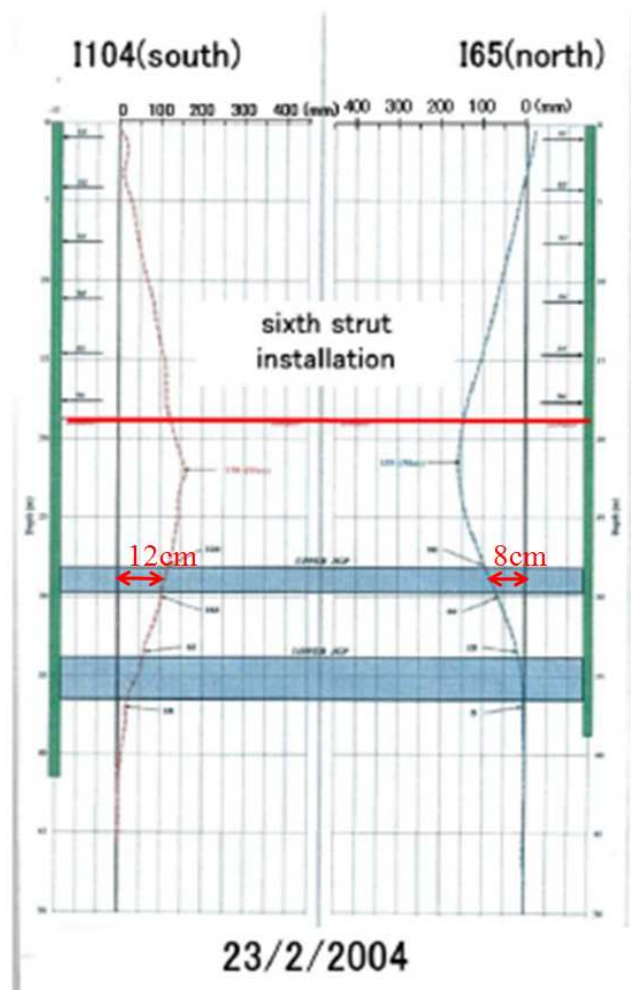
Fig.8 Wall deflection monitored after the sixth strut

As shown in Fig.8, the deflection at the level the upper JGP slab had reached 12cm for southern and 8cm for the northern side wall.

If OM should be applied, this could be the one of the critical phase when some countermeasures should be considered. The possible countermeasures include additional soil improvement in the zone above the upper JGP slab and/or additional strut installation to strengthen the temporary retaining structure. At this stage, different response of the wall deflections for north and south sides should have been noticed. The lower JGP was observed to have moved into center with about 5cm for southern side but no displacement for northern side. When the strut 8 was completed, the displacement for southern wall had increased to 35cm (25cm for southern and 10cm for the northern wall) at the upper JGP slab, which was 1.8% almost in failure. The asymmetry of the wall deflection for north and south sides was increased with the excavation steps. When the excavation reached at the upper JGP, the asymmetry became clear and the reason to have caused the phenomena might well be studied. The reason could be any difference of water pressure or earth pressure against for north and south walls. Many settlement points were installed along the retaining wall adjacent to Nicoll Highway.

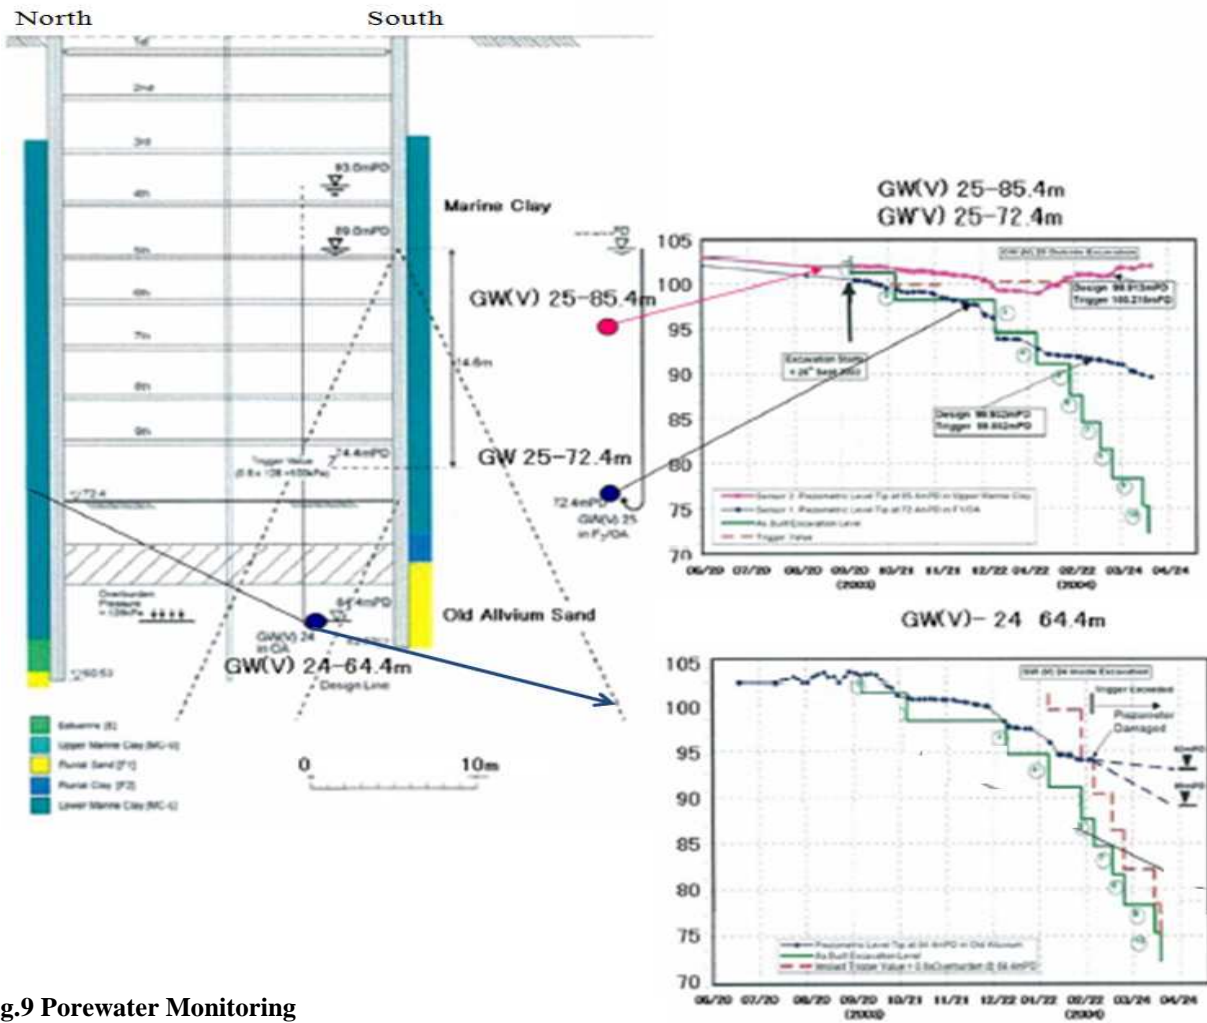
Fig.9 Porewater Monitoring

The Nicoll Highway is the nearby structure that should not be affected. monitoring had been installed for the evaluation. Pore water measurements had been also installed near the retaining wall as shown in Fig.9. One of the typical settlement installed at L111 was shown in Fig.10. The level of the ground surface was $GL=+102.9m$ RL. Fig.11 shows a comparison between the max deflection at I-65 and settlement at L-111 with the same time scale. The pore water pressure was monitored at two depths at $GL-17.5m$ and $-30.5m$ of behind the diaphragm wall. The ground water was observed $GL-2m$ in general in the area. The ground settlement at L111 was gradually had taken place and reached about 10cm in January 2004. After this point, the settlement had increased rather rapidly with time. The porepressure at $GL-17.5m$ had gradually decreased with excavation stage.

The decrease of the pore water pressure might be caused by inwards movement of the diaphragm wall that had resulted in volume expansion of the soil behind the wall.

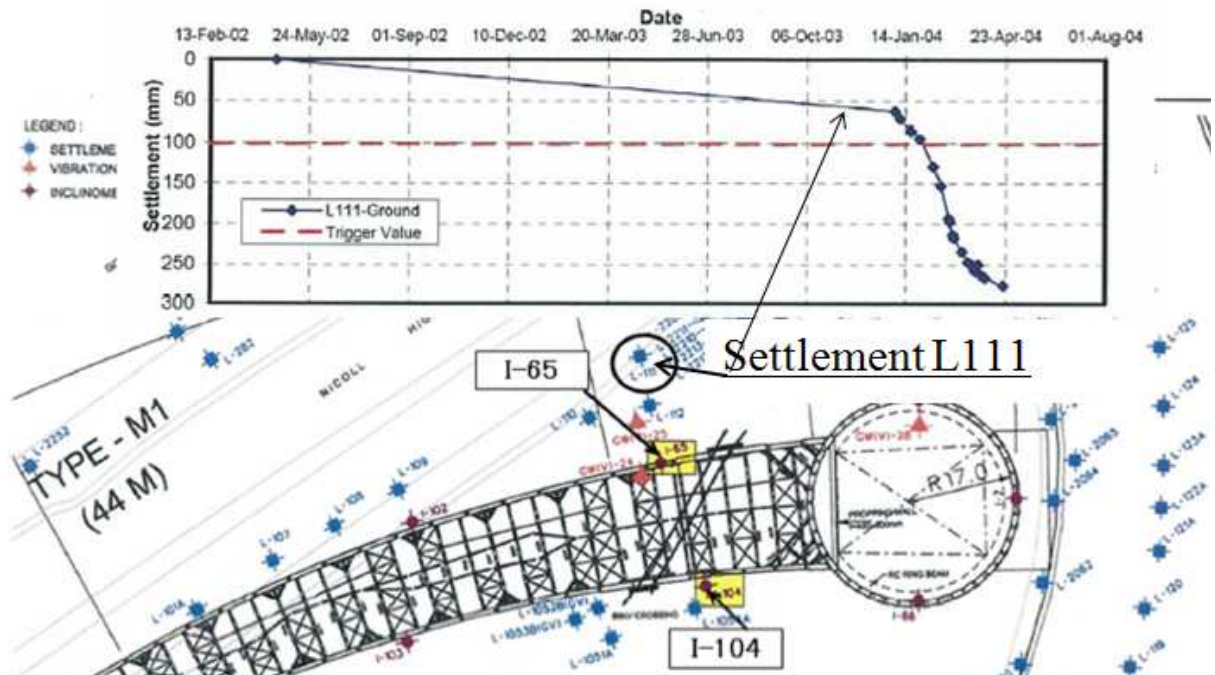
Fig.10 Settlement Gage at L111 and monitored result

The settlement at L111 was caused either by consolidation or displacement of diaphragm wall.

Since the settlement was increased so fast, the settlement was very likely considered by the movement of diaphragm movement.

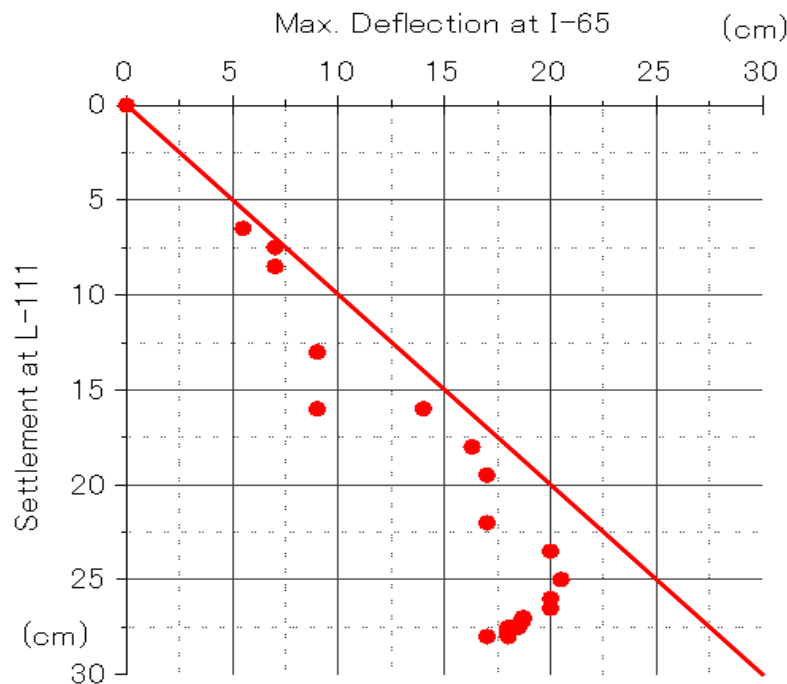
Fig.12 Max. Deflection at I-65 vs. Settlement at L-111

Fig.12 shows the relationship between the settlement and the maximum deflection. Until March 1, 2004, the settlement at L-111 is almost the same amount of the max. deflection at I-65. The direct relation of the settlement of the surface ground with the max. deflection means that the settlement is not caused by consolidation but the compensation of the soil volume caused by the retaining wall. After March 1, the settlement was continued to increase. On the other hand, the deflection had stopped and even gone backwards movement.

The backwards movement of the diaphragm wall is not easy to understand. This might be caused by the displacement assumption for the inclination calculation. It is a common practice to assume the bottom point of the inclinometer guide pipe that is embedded within rather dense sand or hard clayey layer is assumed as a fixed point. It is rather realistic to consider the bottom of the inclination guide pipe had moved. Fig.11 shows the estimated increase of the deflection assuming the linear relationship between the settlements at L-111 and the max deflection at I-65 as in Fig.12, which resulted in about 28cm..

To avoid any misguided result, the displacement of the top of the guide pipe should always be monitored when the inclinometers are measured.
