Forensic analysis of failure of shoring piles

N. Santosh Rao

Nagadi Consultants Private Limited, India

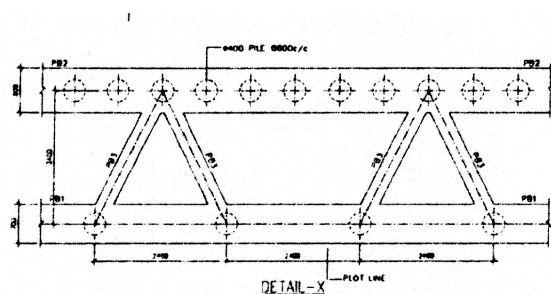
Fig. 1 Pattern of shoring piles

The shoring piles had been provided in a pattern as shown in fig.1. As per discussions held with the structural designers for the project, the front / facing row of shoring piles were provided for retaining the soil while the rear row of piles, lesser in number (i.e. one rear row pile for every 3 front row piles) were provided as anchors for the front row of piles with the anchoring ties provided at the top end of the piles in a triangular pattern as seen in the above figure. Capping beams had also been provided along the top of both the front and rear row of piles

Notably, the centre point of the collapsed portion of the shoring piles more or less lies at the break/shift in the continuous line of shoring pile system as indicated by the circle marked in fig. 1. This break/shift in the continuous line of the shoring pile system is critical in that any defect in the construction at this location can prevent the proper functioning of the shoring pile system as a two-dimensional system and instead make the shoring piles at this location act as free standing piles and consequently, cause a reduction in factor of safety against structural failure eventually leading to the structural failure of the piles at this location.

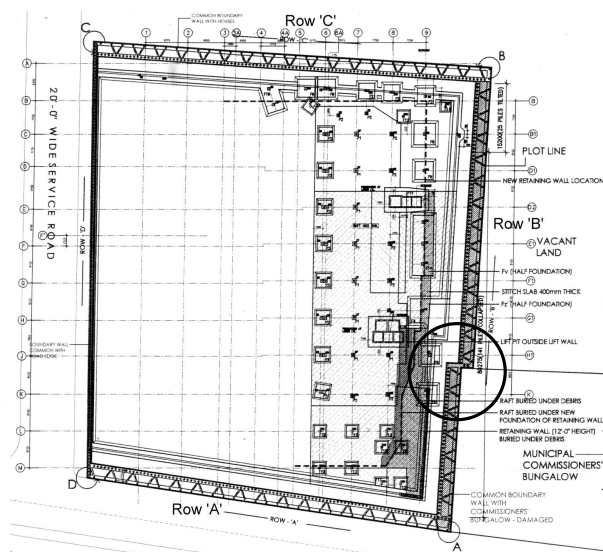
Fig. 2 Schematic site layout

The shoring piles along the site boundary in which the collapse occurred (i.e. row B; marked by shading in fig. 2) had been constructed by drilling the pile bores using the traditional DMC (i.e. drilling mud circulation) method and temporary liner/casing of about 6 to 8m length had been used during the drilling.

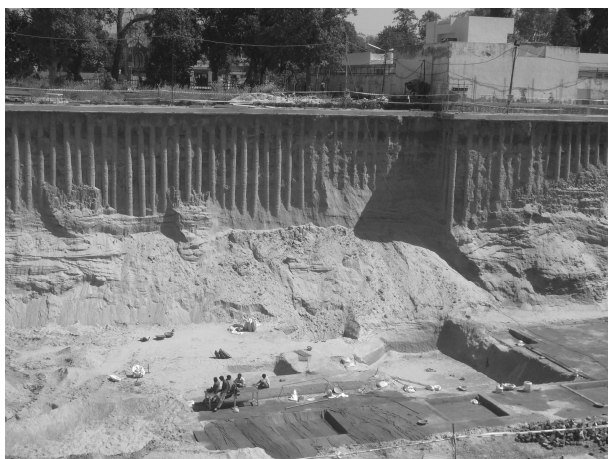
Fig. 3 Shoring piles prior to failure

Photograph showing the shoring piles prior to the failure is given in fig. 3, This photograph had apparently been taken prior to the gunting of the face of the shoring pile system. The photograph also shows clearly the sloping soil surface between the shoring piles and basement line.

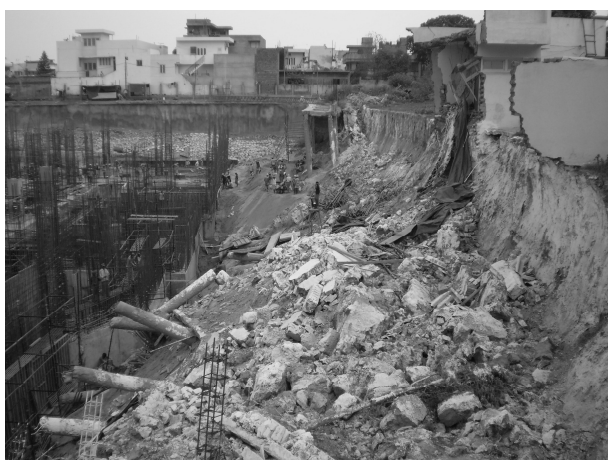
Fig. 4 Post failure conditions

- a. The piles are observed to have bent forward as seen from the photograph in fig. 4.

- b. The failure surface in the soil behind the line of shoring piles is only a few metres distance from the line of shoring piles and is almost vertical in the upper portion as seen from the photograph in fig. 4.
- c. Other views of the collapsed area very clearly show the bent and broken piles in photographs in figs. 5 & 6. The orientation of the bent piles indicates that the bent portion of the piles is only a few metres in length.
- d. The guniting adopted in the upper part and the sand bags provided in the lower part for preventing the soil behind the shoring piles from flowing out can be seen in the background in the photograph in fig. 4.

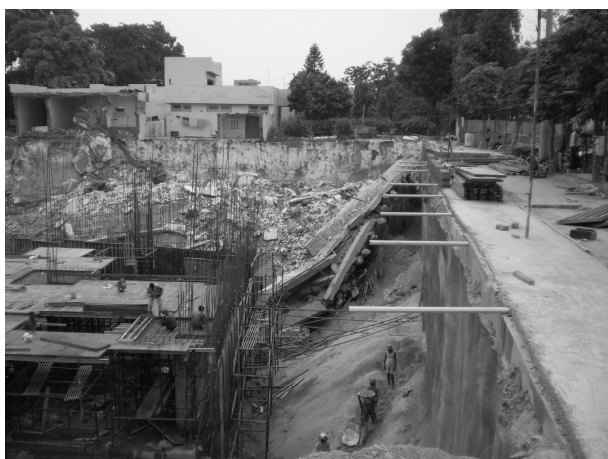
Fig. 5 Front view of shoring piles post failure

Although photographs had apparently been taken immediately after the failure event, these were not made available. However, some photographs taken a few weeks after the event, were made available and are shown in figs. 4 to 6. These photographs show different views of the area of the collapsed shoring piles thus giving an overview of the status of the site post failure.

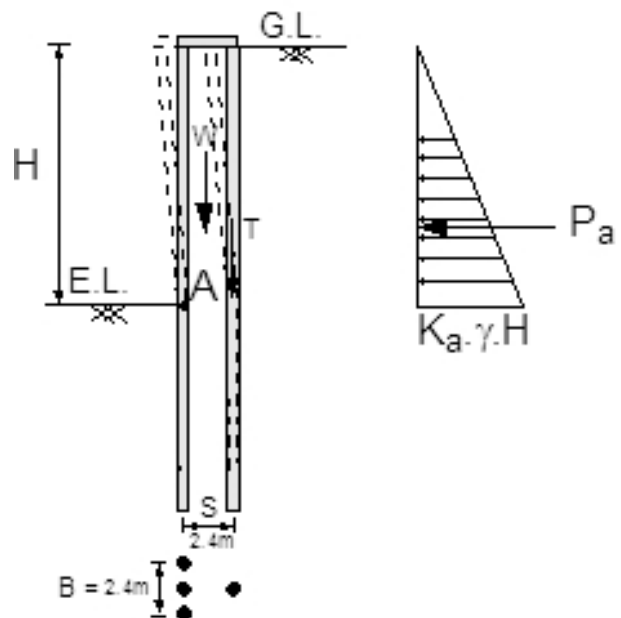
Fig. 7 Analysis of shoring pile system

point of intersection between the formation level and the front row of shoring piles, marked as point A in fig.7, which then leads to the equation given below:

By carrying out this analysis for the configuration of the shoring pile system adopted in the present case and taking into account the reinforced concrete section provided in the shoring piles, the factor of safety against failure even under the maximum depth of excavation of about 9m, works out to be about 1.45.

Hence, the possibility of the failure having occurred due to structural inadequacy of the shoring pile system can be more or less ruled out.
