Failure of a Cut Slope and Deterioration of Shear Strength due to Weathering

Akitoshi Mochizuki, Professor Emeritus*¹, Dr. of Eng., Graduate School, Tokushima Univ., Japan
Xianfeng Ma, Associate Professor *², Dr. of Eng., Dep. of Geotechnical Eng., Tongji University, China
Sreng Sokkheang, Researcher*³, Dr. of Eng., R&D Center, Nippon Koei Co., Ltd., Japan

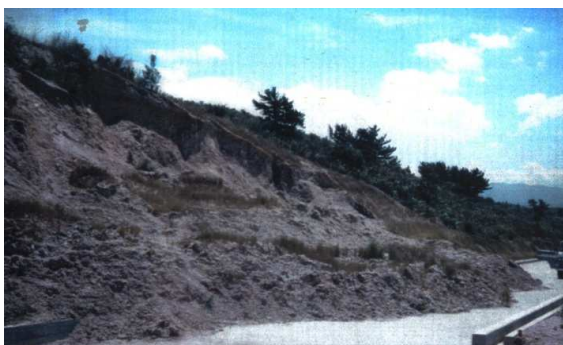
Fig.1 Picture of the slope failure

In this paper, a failure of a cut slope, which was constructed as part of a new local road through hills constituted of stiff clay of the Osaka Marine Clay group in the southern part of Osaka, Japan is investigated. The slope's gradient was 1:1 and had a berm at a height of 10m measuring 50m length for a new local road. Four months after cutting of the slope, in early spring, a 25m wide portion of

the slope collapsed. Fig.1 shows a photo at the site of the slope failure. Site investigations using sounding method and laboratory tests were carried out in order to study the cause of this failure.

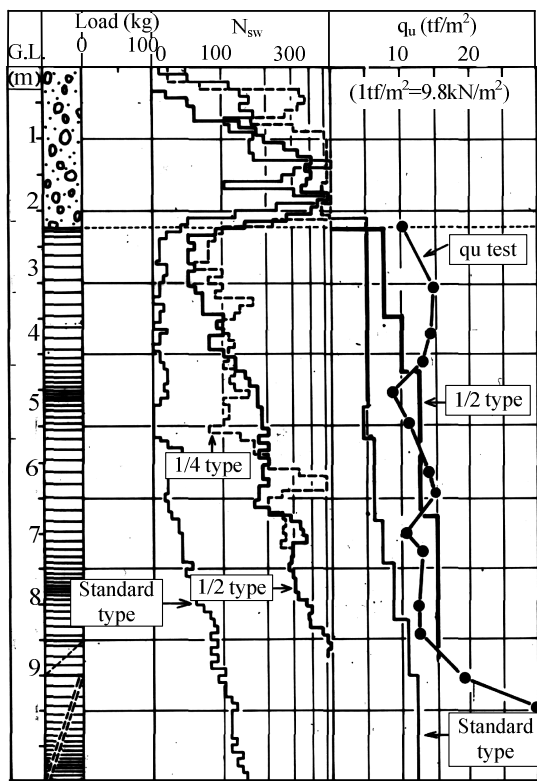
Fig.4 Drilling log at point No.9

The profile of borehole No.9, whose location is shown in Fig.3, is presented in Fig.4 as a representative soil profile of the hill. A layer, measuring almost 2m thick, of dense white-brown gravel with maximum particle size of less than 50mm covers the *Ma-8 stiff clay layer*, which is approximately 6m thick. This clay is grey-blue when fresh but changes to a white-brown color shortly after drying and also develops cracks and flakes propagating at the surface of the slope. Alternately there are thin silty-clay layers with a small amount of fine sand, and thin sandy-silt layers underlie the stiff clay. Although vegetation was planted, grass growth was poor due to the presence of sulfur in the clay.

The slip surface observed was to pass through *P-1* crossing the lower boundary of the Ma-8 Clay layer, coming up towards the top of the slope as shown by a dotted line in Fig.4.

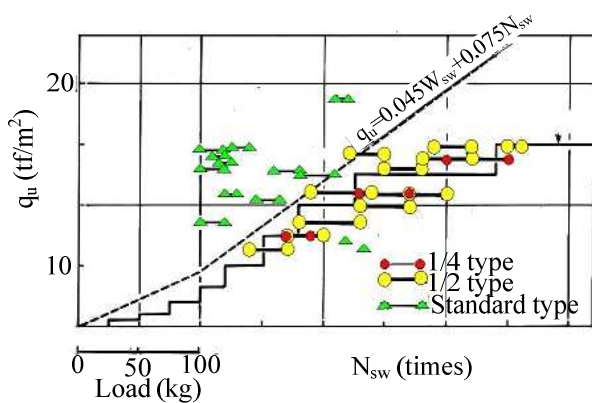
Fig. 5 Relationships of N_{sw} to q_u : Swedish sounding test

Fig.5 shows a correlation between strength of unconfined compression tests (q_u) and the half-rotation number obtained from the sounding test (N_{sw}) at borehole No.9. The value of N_{sw} is plotted by a pair of symbol marks against q_u -value since N_{sw} was observed at every 10 cm, whereas q_u was measured every 50cm to 100cm.

A step-like relationship between N_{sw} and q_u for the sounding test with 1/2 of the standard weight, as shown in Fig.5, is adopted. The dotted line in the figure was presented by Inada (1954) for the standard tester, however, this equation gives comparatively higher q_u -values than results obtained from an unconfined compression test carried out on the clay.

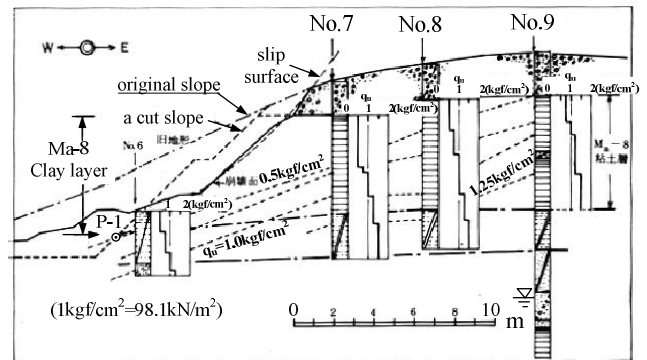
Fig. 6 Cross section of the slope and strength distribution

Fig.6 shows a cross-section through the central part of the landslide and the strength distribution of the sounding tests. Broken lines with dots separate zones with an increment of 0.25 kgf/cm^2 ($\doteq 25kN/m^2$) of q_u . These show values observed by the sounding tests. It is found that strength contours in the clay layers are almost parallel to the original topography, though the Ma-8 clay layer is located almost horizontally, namely, the parallel distribution of strength to the original topography is expected to be. It is supposed that some degree of weathering must have taken place as the decrease of the strength which should occur perpendicularly to the original hill surface.

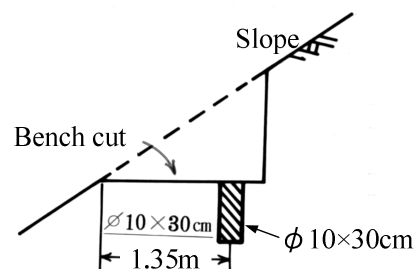
Fig.8 Bench cut and sampling tube

Un-weathered and undisturbed samples for a series of direct shear tests were taken from borehole No.9 and others were taken from the horizontal surface of a bench cut near the failure zone by driving thin walled tubes measuring 100mm in diameter and 3000mm in length (see Fig. 8). Samples from the bench cut shown had a light-brown color suggest

ing that it weathered more than those sampled from the borehole.

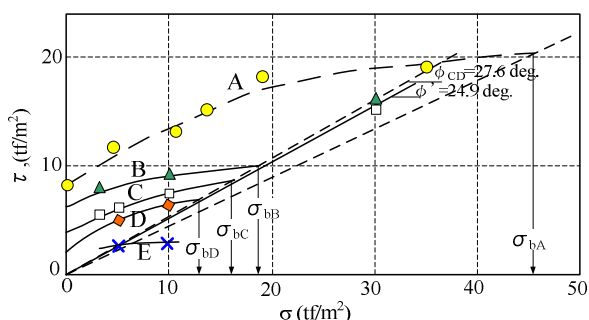
Fig.11 Strength curves obtained from *Test-A to E*

Fig.10 shows stress-strain curves for Test-B to Test-D. Fig. 11 shows shear strength, τ_f , plotted against consolidation stress, σ_0 , and the strength envelopes from all of the tests. Results of unconfined compression tests, c_u ($=qu/2$) are also plotted. These envelopes show a decrease in strength from Test-A to Test-E. At stresses higher than σ'_b , the ϕ_d defined by Test-B, -C and -D ($\phi_d=27.6^\circ$) almost coincide with ϕ' of Test-A ($\phi'=24.9^\circ$), whereas ϕ' is slightly smaller. It is found that curves in a stress level less than σ'_b are almost parallel corresponding in Strength-B to D. Strength-B shows almost half shear strength of Strength-A, and Strength-D is almost a quarter of Strength-A.

Residual strength is found to be smaller than Strength-D, and shows much smaller inclination of the strength curves. It is apparent that the residual strength does not belong to the scheme of strength curves in other tests.
