Case Study on Causes and Countermeasures of a Largely Deformed Reinforced Earth Wall with Geotextile in Hyogo, Japan

ABSTRACT: This study examines causes and countermeasures of large deformation that took place on the reinforced earth wall, a part of the Tottori expressway planned to pass Hyogo, Japan. Since this reinforced earth wall had experienced unexpected deformation of the wall during construction, the wall was re-constructed twice. However, the wall deformation showed no sign to cease even at the final stage of the construction. In this paper, case study was carried out on the interpretation of the mechanical behavior of the severely damaged reinforced earth wall comprising geotextile with the concrete panel facing. At First, the outline of the damaged reinforced earth wall is in detail described. The background and cause of the damage are discussed based on the results of site investigation. The engineering properties of the fill were examined by performing various in-situ and laboratory tests, including the surface wave survey (SWS), PS-logging, RI-logging, soaking test, the direct shear box (DSB) test, bender element (BE) test, etc. Consequently, the background as well

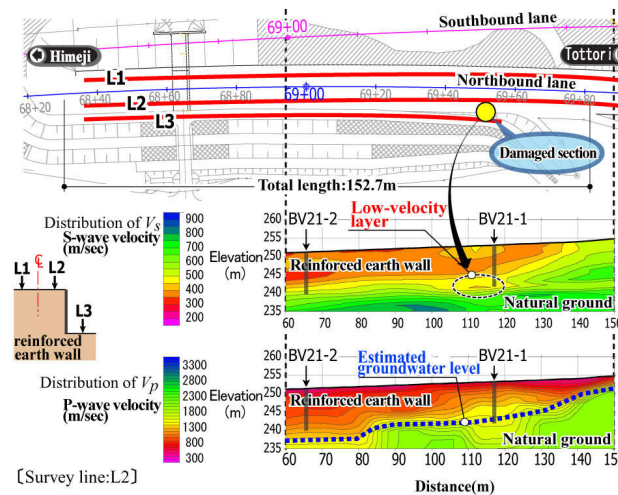
Fig. 5 Results of HR-SW survey.

The HR-SW survey was carried out to figure out the 2D profile of the elastic wave velocities, i.e., S-wave and P-wave velocities (V_s and V_p) of the fill, together with the foundation. Fig. 5 shows the profiles of V_s and V_p with depth for the 160m long survey line L1. In general, the V_s increases with depth involved with increase in in-situ stresses.

However, a low-velocity layer was observed for V_s near the severely damaged section at BV21-1 (n.b., elevation: approximately 240m, distance: 110~115m). The decrease in V_s strongly suggests some reduction of the magnitude of stresses at the deformed section.

On the other hand, the dashed curve in the profile of V_p represents the boundary associated with $V_p = 1500\text{m/s}$, noting that the specific condition of $V_p = 1500\text{m/s}$ is applicable to saturated condition. Accordingly, it may be surmised that the state of soil behind the damaged panels is close to saturation.

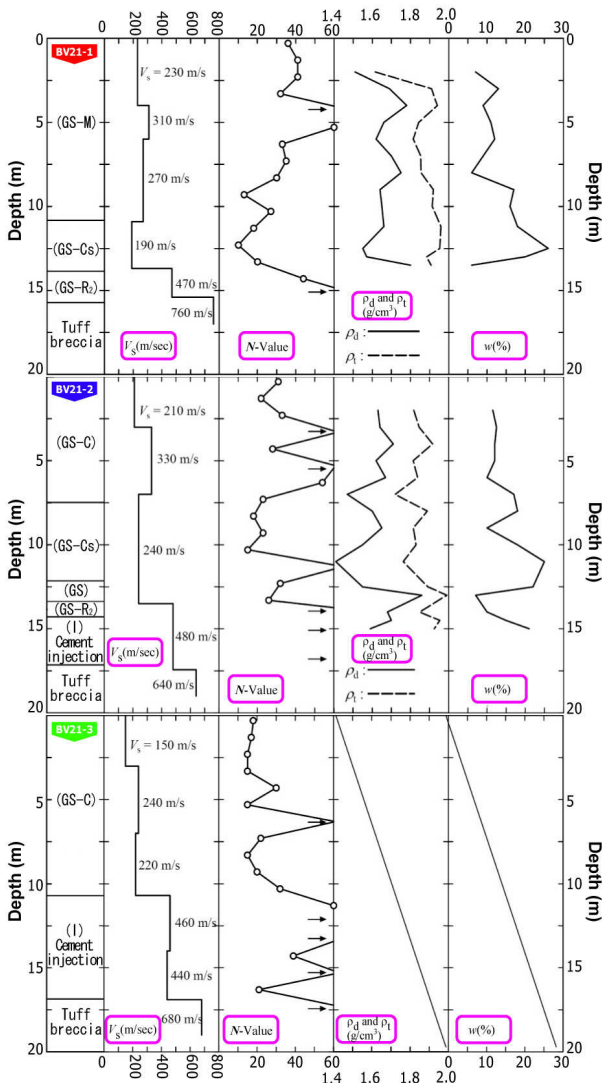
Fig. 6 Profile of physical properties of the fill.

Fig. 6 shows the profiles of V_s , N-value, ρ_p , ρ_d and w_n at three locations of BV21-1, BV21-2 and BV21-3, respectively (see Fig.3). As seen in Fig. 3-18, the horizontal layer over the depths roughly from 10m to 13m for the length between BV21-1 and BV21-2 is seemingly soft by showing higher

water content with the relatively low values of V_s , N -value, and ρ_d . The supposed soft soil layer corresponds to the portion characterized by the low-velocity from surface wave survey.

Meanwhile, both of V_s and N -value appear relatively large for the soil layer improved by cement-mixing (i.e., the portions for the first and second remedies, see Fig. 3).

In addition, the controlled value for the density was set to $0.9\rho_{d \max}$ based on the compaction curve similar to that of the sample at point A. It is now almost certain that the soft soil layer with larger amount of fines, and having lower values of V_s , N -

value and ρ_d is responsible for the damage of the wall as shown in Fig. 6. The profile of $V_{s,f}$ with depth is shown in Fig. 9, in which the result of the BE test is also shown for comparison.

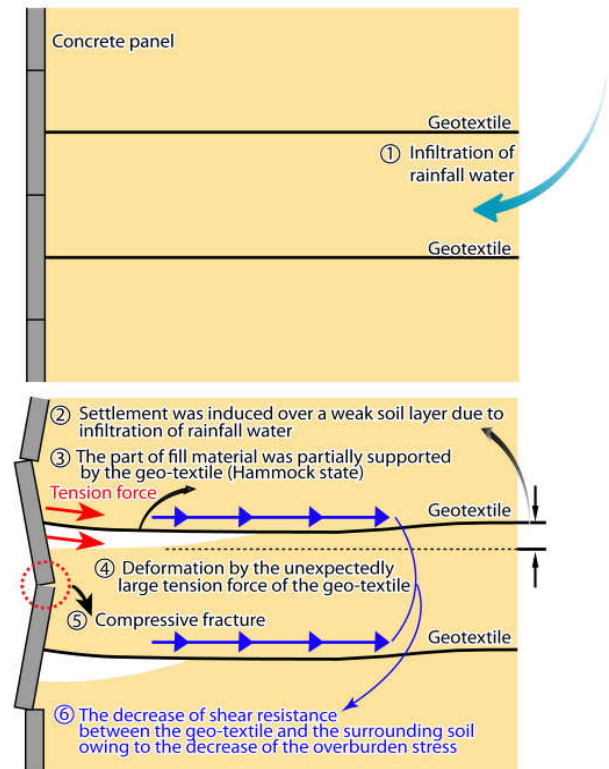
Fig. 13 Mechanical behaviour of a largely-deformed reinforced earth wall with geo-textile.

Based on this observation, the background as well as the mechanical interpretation for the damage of the wall can be postulated as an image shown in Fig.13, it may be described such that;

- i) a considerable amount of subsidence took place over the weak soil layer in the lower part of the reinforced earth due to seepage of rainfall water,
- ii) the weight of the upper fill was partially supported by the geo-textile hooked on the concrete panels, and
- iii) the concrete panels associated with the hammock state were severely damaged by the unexpectedly large downwards compression force triggered by the tension force of the geo-textile.

Once the “hammock state” was reached inside the wall, the overburden stress corresponding to the hammock state in the fill will be dramatically reduced, which in turn would bring about decrease of the shear resistance between the geo-textile and the surrounding soil.

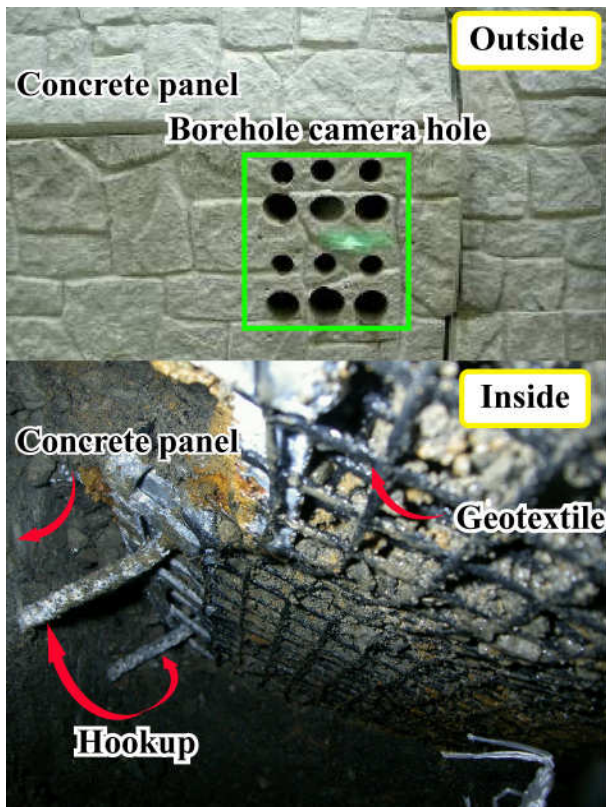
Fig. 12 Pictures inside reinforced earth wall.

The results of site investigation have revealed the fact that a 3m-thick weak soil layer extends behind the damaged section of the wall. The weak soil layer may be characterized with unexpectedly low values of V_s , ρ_d and the SPT N-value. In addition, the soil properties can be characterized by the occurrence of a considerable amount of settlement on soaking. Fig.12 shows the pictures inside the wall at the deformed section.

A space was found underneath the geotextile, suggesting that the weight of the fill above the geotextile was partially supported by the geotextile. In this paper, the new wording of “hammock state” is conveniently used for describing it.

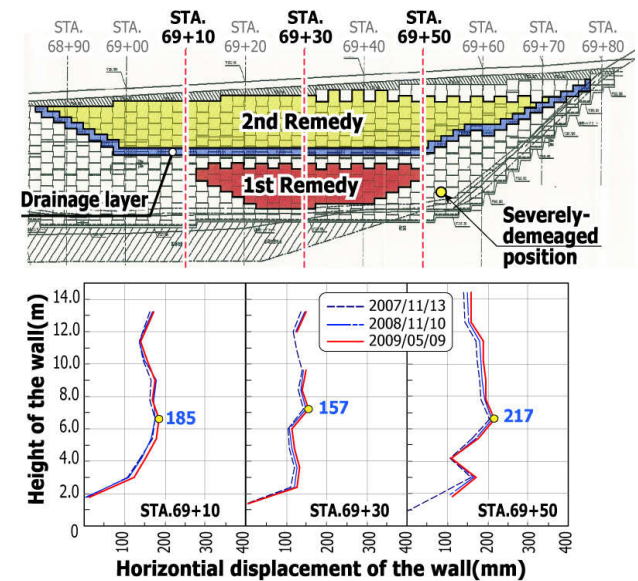
Fig. 14 Observed deformations of the wall facing.

As seen in Fig.14, the range for the maximum value of horizontal deformation was 150 to 200mm. This corresponds to deformation rates of 1.0 to 1.5% against the height of the wall.

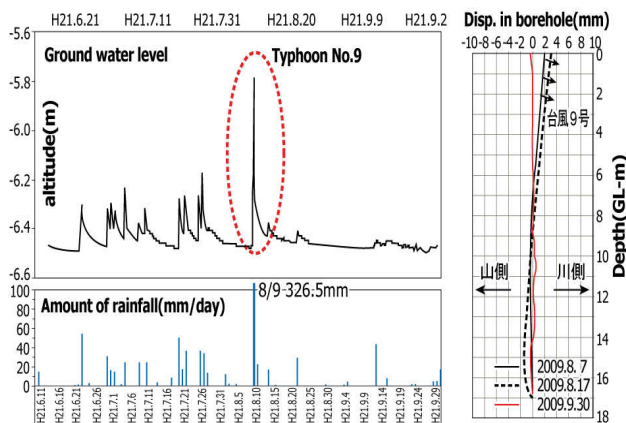
Fig. 16 Record of rainfalls at the site

Fig. 16 shows the record of rainfall at the site. It shows that the measured displacement increased after raining. This result may be interpreted due to the effects of infiltration water caused by heavy rains, which remained inside the embankment, despite that the drainage layer was made at the time of the second remedy construction.

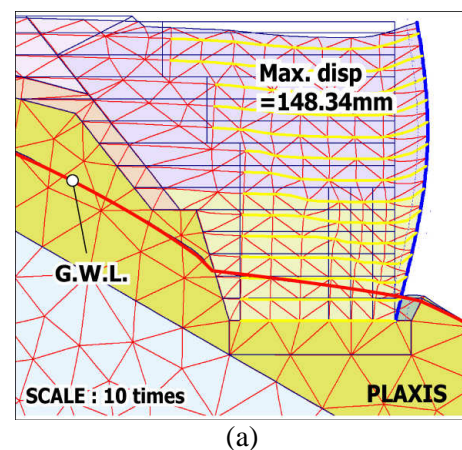
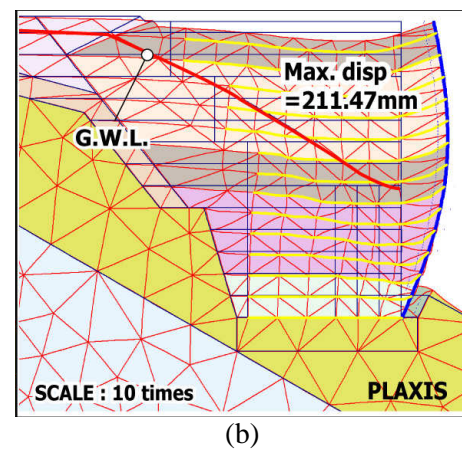
Fig. 18 Deformed meshes due to increase in water level.

Fig. 18 shows how the reinforced earth wall deforms according to the increase in the ground water level. The maximum amount of displacement with and without raining is 211.5mm and 148.3mm, respectively. This simulation demonstrates that the infiltration water permeating the reinforced earth wall has a strong influence on the movement of the wall.
