## Damages to Metro Tunnels due to Adjacent Excavations

**ABSTRACT:** Metro tunnels are vulnerable to ground movements, therefore precautionary measures must be taken to prevent potential damages to existing tunnels if excavations are to be carried out in close proximity to tunnels. Presented herein are the regulations adopted to protect the Taipei Metro and three case histories on damages occurring to metro tunnels to illustrate how tunnels respond to activities associated with excavations. It has been found that localized ground treatment would not serve the purpose of reducing wall movements and neither would a single buried cross panel in excavations with considerable lengths.

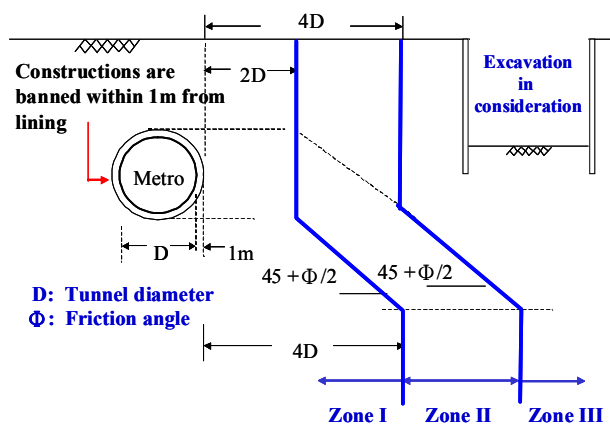
Fig. 1 Zoning for restricting excavations in the vicinity of metro tunnels

For shield tunnels, as shown in Fig. 1, construction activities are totally banned within 1m from

For shield tunnels, the changes in tunnel diameter are limited to 20mm in any direction. The lining should in no case ingress into the dynamic envelope of trains which is the outer limit of the space required for operation and safety.

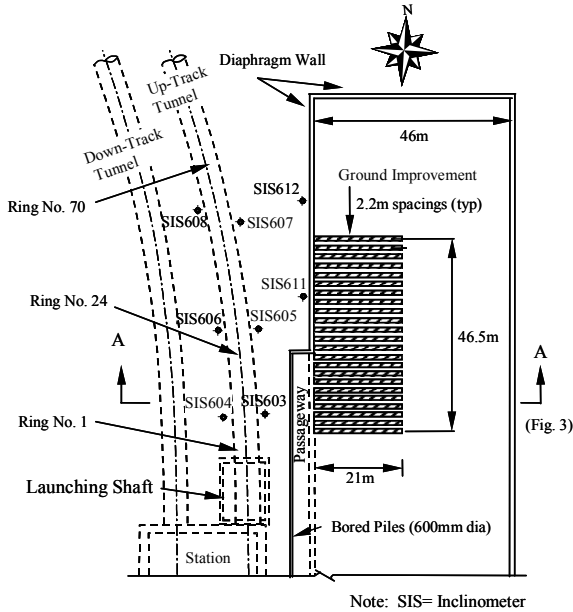
Fig. 2 Case 1 – Site plan and locations of instruments

Shown in Fig. 2 is a case in which excavation was carried out to a depth of 21.1m with a minimum distance of 12m to the nearest tunnel, i.e., the up-track (Chang, et al., 2001). The excavation was carried out in the period of 1996 to 1998 before the Regulations were amended. Specifications were not as stringent as they are nowadays, therefore, the excavation was conducted without prior approval from the metro authority and were not closely watched till cracks were observed on the linings when the excavation was about completed.

The soft deposits at surface are underlain by a thick gravelly layer at a depth of 50m. The retaining diaphragm walls were 1.2m in thickness and 36m in length. Despite the fact that, as shown in Figs. 2 and 3, jet grouting had been conducted to treat a block of soil in an attempt to reduce wall movements, lateral movements of the ground were

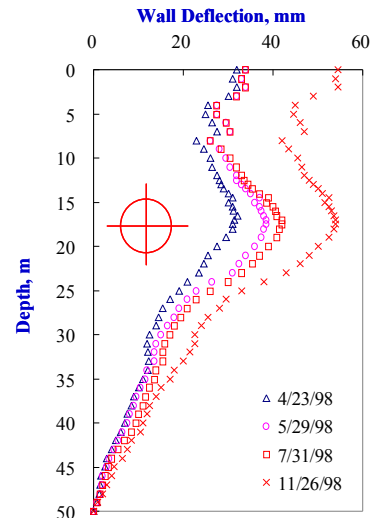
Fig. 4 Case 1 – Readings of Inclinometer SIS605

quite large. As depicted in Fig. 4, Inclinometer SIS605 showed a maximum wall movement of 54mm at the depth coinciding with the depth of the tunnels. Figure 5 indicates that the longitudinal axis of the up-track tunnel moved by as much as 27mm laterally and settled by 33mm maximum. As a result, the invert slab became detached from the lining segments and had to be replaced.

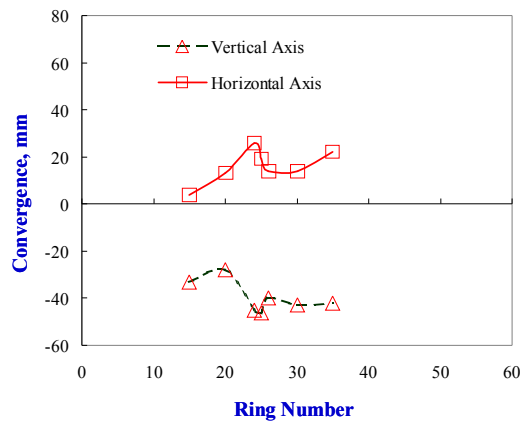
Fig. 6 Case 1 – Convergences of linings of the up-track tunnel

Shown in Fig. 6 are the convergences of linings in the tunnel obtained by configuration survey. The maximum changes in diameter were 46mm in the vertical direction and 28mm in the horizontal direction. Ring No. 24 (or, simply 24R), which appears to be the most affected, was shortened by 45mm in the vertical direction and elongated by 26mm in the horizontal direction. A total of 41 rings (10R to 50R) were severely damaged and had

to be reinforced by steel segments as a secondary lining.

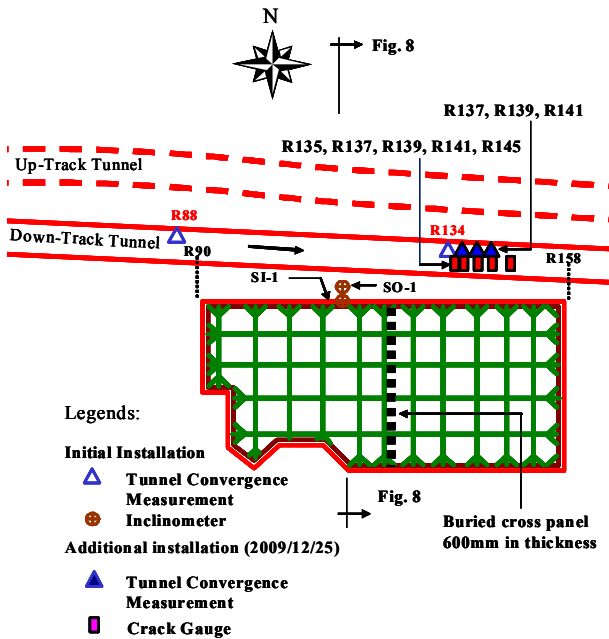
Fig. 7 Case 2 – Site plan and locations of instruments

Shown in Fig. 7 is a case in which excavation was carried out to a depth of 15.9m with a minimum distance of 7.3m to the nearest tunnel, i.e., the down-track (Hwang, et al., 2010). The soft

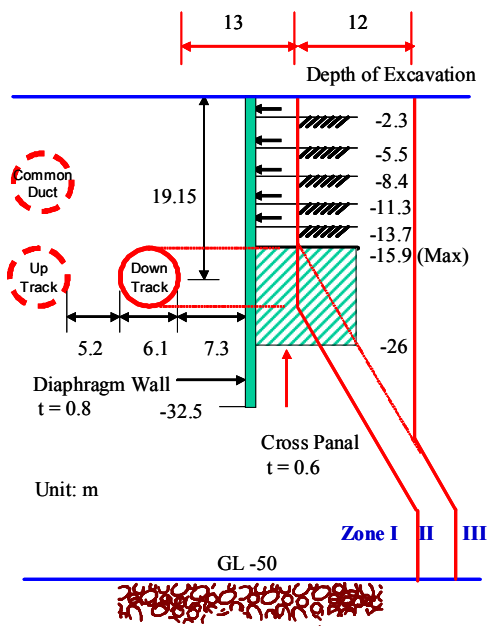
Fig. 8 Case 2- Excavation scheme

deposits at surface are underlain by a thick gravelly layer at a depth of 50m. The retaining diaphragm walls were 0.8m in thickness and 32.5m in length. As shown in Fig. 8, excavation was partly carried out in Zone 1 and measures were required for reducing ground movements. Accordingly, a cross panel, 0.6m in thickness and 10m in depth, was installed by using the diaphragm walling technique and was structurally connected to the diaphragm walls to form T-joints at its two ends.

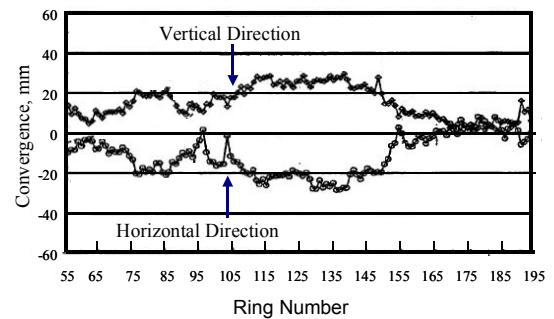
Fig. 9 Case 2- Convergence of the down-track tunnel (2010/1/18)

Ring No. 134 (or simply, 134R) was found to have lengthened by 19.9 mm in the horizontal

direction and shortened by 13.7mm in the vertical direction on 26 October 2009 when the excavation was approaching its final depth. The former already exceeded the Alert Level of 15mm. The squashing of the ring continued; and the lengthening of the diameter in the horizontal direction reached 27.5mm and the shortening of the diameter in the vertical direction increased to 21.4mm on 18 December. Since the former exceeded the Action Level of 25mm, an injunction was issued on 25 December by the metro authority and the excavation was halted. Crack gauges were mounted on 5 rings next to 134R as depicted in Figure 7 for long-term monitoring of the changes in widths of the cracks. In addition to 134R, the convergences of 137R, 139R and 141R were also monitored daily. The readings taken for 55R to 195R on 18 January 2010 are depicted in Fig. 9.

To avoid deterioration of the situation, temporary struts were installed at the B4 level in the excavation to limit wall movements and internal bracings were installed in the tunnel to limit the deformations of 99R to 155R. These measures

were completed on 25 January 2010 and were found effective as the deformations of the tunnel did not increase further subsequently.

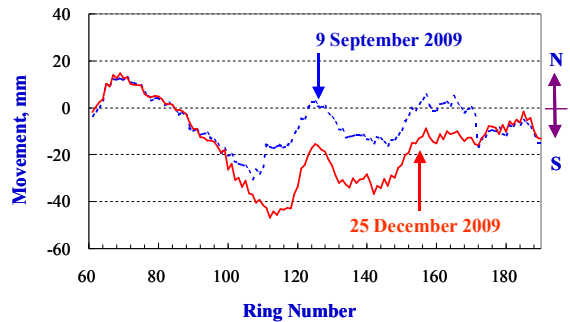
Fig. 10 Case 2- Horizontal movements of the down-track tunnel

Figure 10 shows that the longitudinal axis of the tunnel moved southward toward the excavation by, as much as, 30mm by 9 September. The section between 110R and 170R was found to have further moved by 20mm when the injunction was issued on 25 December 2009.

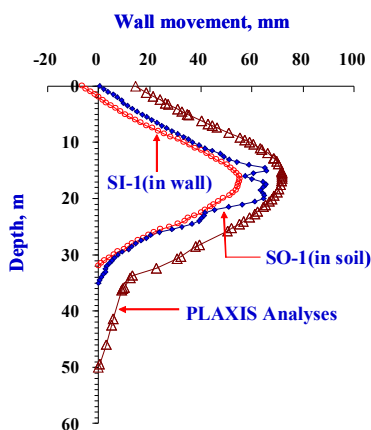
Fig. 11 Case 2- Inclinometer readings (2010//3/24)

Figure 11 compares the readings obtained by two side-by-side inclinometers on 24 March 2010 with the results of numerical analyses using the finite element program PLAXIS. It is estimated that the toes of these inclinometers moved by 10mm or so because they did not reach the bearing stratum.

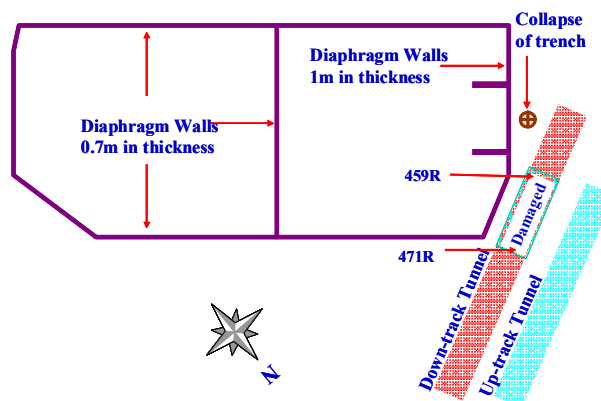
Fig. 12 Case 3- Site Plan

Shown in Figs. 12 and 13 is a case in which tunnel linings were damaged even before the commencement of excavation (Ju, et al., 2007). The diaphragm wall at a corner was only 3m to the nearest tunnel, i.e., the up-track, which was completed on 28 December 2004. The subsoil at the depth of tunnels mainly consists of silty clays (Soil Type CL). The bearing stratum was not encountered at the maximum drilling depth of 40m.

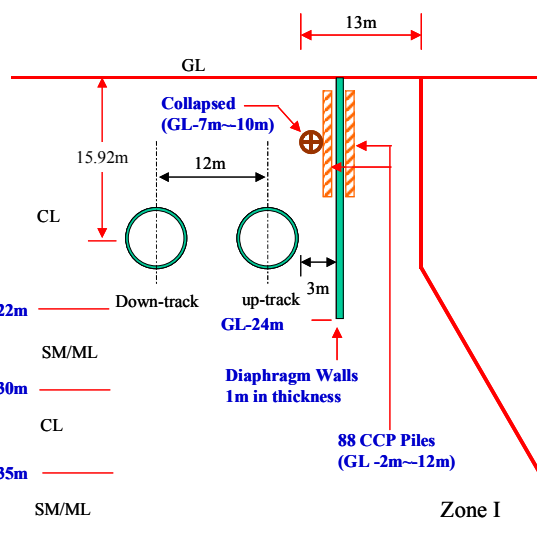
Fig. 13 Case 3 – Remedial measures

They were installed from a depth of 2m to a depth of 12m below ground surface as depicted in Fig. 13.

The cause of the event is rather difficult to ascertain. It has been attributed to grouting pressure during CCP installation (Ju, et al., 2007). The accusation, however, is not supported by data. Take 463R for example, configuration survey conducted on 17 March, 9 days after the completion of CCP piles, indicated that the tunnel was stable with nil changes in diameters as shown in Fig. 16. In fact, it is inconceivable for the tunnel to be damaged by grouting carried out at positions above the crown, refer to Fig. 13, because it is very unlikely for grout to run downward except in very rare situations.

As shown in Fig. 13, although the upper portion of the trench was protected by CCP piles, the lower portion was not. Therefore, localized collapse could have happened thereat. Even without collapse, large lateral ground movement could have been induced as a result of the relief of the horizontal geo-stresses. As shown in Fig. 14, Units #3M, #4F, #5M and #7M (M stands for male and F

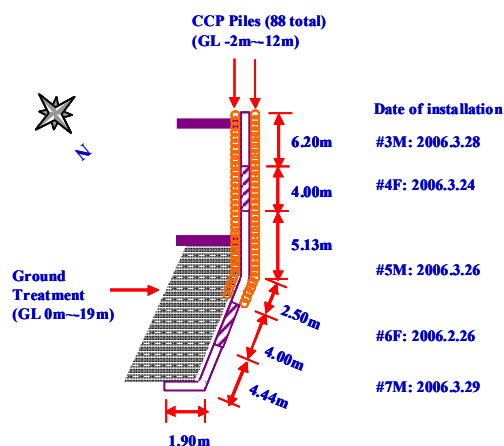
Fig. 14 Case 3- Protection measures

The diaphragm walls were 1m in thickness on the north side and 0.7m everywhere else. The trench collapsed during the installation of Panel #4 on 3 March 2006. As shown in Fig. 14, CCP piles, 400mm in diameter, were sunk on the both sides of the trench in the period between 5th and 8th March to ensure that this unit and two neighboring units could be successfully installed. They

stands for female units) were installed within a rather short 5-day period between 24 and 29 March. Ground movements could partly be attributed to the fact that trenching was carried for secondary panels before the primary panels became stable. Unfortunately, instrument readings were not taken till 20 April.

To reduce ground movements during excavation, ground treatment was carried out at the corner next to the excavation, as depicted in Fig. 14, to the same depth of the bottom of the tunnel, i.e., 19m. Two rows of cast-in-place piles were installed immediately next to the wall, followed by 6 rows of cement-soil-mixing piles giving a total of 192 piles. All these piles were of 600mm in diameter. Excavation was resumed and successfully carried out to the final depth of 11.9m.

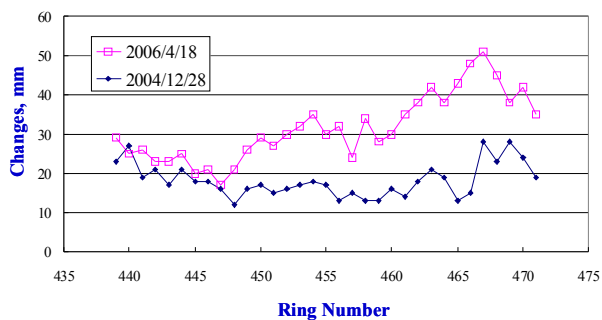
Fig. 15 Case 3- Convergences of linings

Cracks were observed on linings and configuration survey conducted on 18 April revealed that, as depicted in Fig. 15, the deviations from the theoretical diameters of the tunnels had increased from

the initial value of 28mm to 51mm for Ring No. 467 (i.e., 467R) which appeared to be damaged most seriously. Structural analyses indicated that 463R, 465R~468R and 470R had become deficient in structural capacity and had to be reinforced. It was finally decided to install steel segments in 459R to 471R as secondary lining. Because of the squash of the tunnel, the invert slab between 450R to 473R became detached from the tunnel and had to be replaced.
