Piping Failure of a Metro Tunnel Construction

Wei F. Lee

Kenji Ishihara

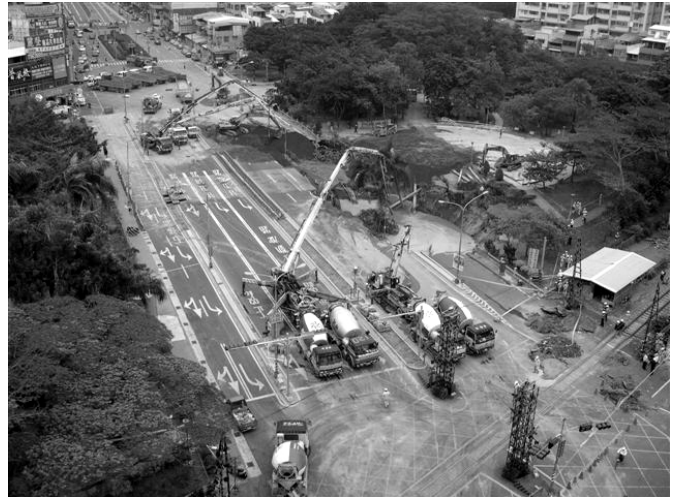
Figure 3. A bird-eye views over the cave-in in Kaohsiung

The location of the collapse is shown in Figure 1 and the feature of the cave-in on the ground surface is displayed in Figure 2. A bird-eye view over the cave-in is displayed in Figure 3. The plan and side view of the tunnel are shown in Figure 4. It is to be noted that there was an underground roadway called Chung Cheng underpath just above the subway tunnel. The dual tunnels were constructed by the tunnel boring machine (TBM) which can advance by rotating a large steel disk equipped with cutting blade, while the cutting face is balanced by the mud pressure.

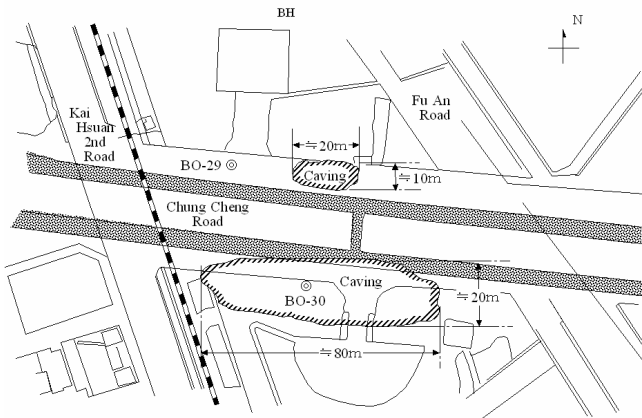
Figure 2. Features of the cave-in in plan view

portal and the adjacent segment. The length of the tunnel in which the debris packed in the entire cross section was as long as 130m on the west side and 80m on the east side in the up-line on the south, as shown in Figure 13(d). Thus, another cave-in occurred on the north side, as seen in Figure 2. The amount of soils and concrete dumped to fill the caves was 12,000m³ and the volume of water inflow from the 60cm diameter water main lasting about 18 hours until 11:50 p.m. next day was approximately 2,000m³. Thus the total amount of debris was as much as 14,000 m³.

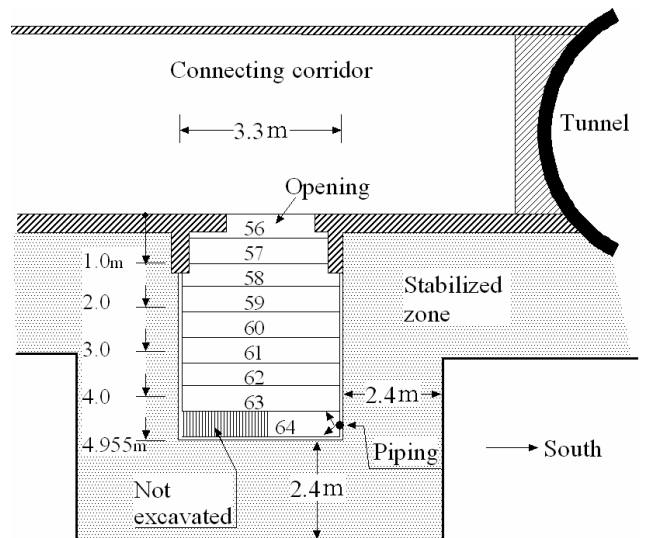
Figure 8. Details of the excavation for the sump and initiation of piping

On December 4, 2005, the piping occurred at 3:30p.m. at the very last stage of excavation of the sump. A block of silty sand was detached from the south wall at the bottom of the excavation which is located at a depth of 35m from the ground surface. The circumstance at this time at the bottom of the sump excavation is illustrated in details in Figure 8.

It is believed that the mud water flowed into the sump from the bottom through a single hole probably with a diameter of about 30cm. This assumption would hold true in the light of the fact that the zone stabilized by the jet grouting could not so easily broken down in the horizontal direction, and a weak zone might have existed in the form of vertical pipe.

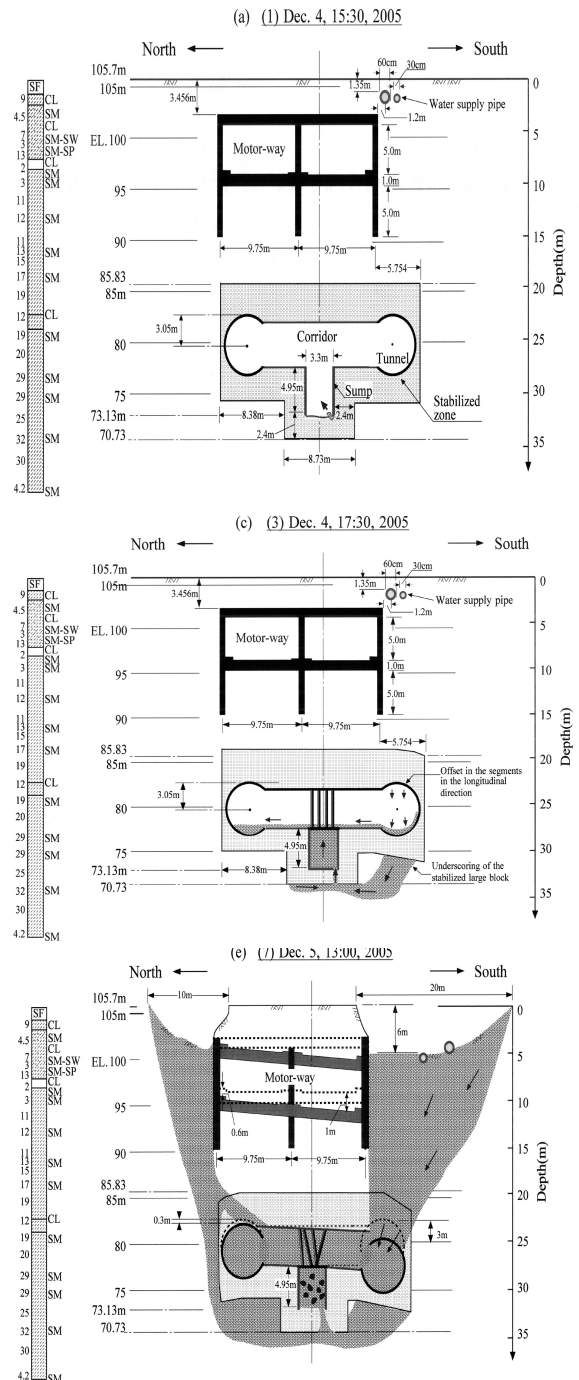
Figure 9. A sequence of likely scenario for progressing the piping failure.

A sequence of the events after triggering the piping which are likely to have occurred is illustrated in the cross sections in Figure 9. The blackish mud water continued to come out in the sump with increasing volume. Two men at work at the bottom strove in vein to clog the hole by dumping sand bags from the corridor. About one hour later, the sand bags were seen moving around in the sump as illustrated in Figure 9(b). At this stage, the workmen closed the entrance to the sump by placing a steel lid and several bars for its support as illustrated in Figure 9(c).

About two hours later, engineers at spot heard squeaking sounds of breaks at segment joints of the tunnel on the south, accompanied by mud water cascading from the ripped joints of segments at the ceiling. It appears likely that because of the under-scoring of the bottom portion, the stabilized zone subsided together with the tunnel body, resulting in the stepwise settlement in the longitudinal direction. The probable feature of the breakage at this stage is illustrated in Figure 9(c).

Around 10:20p.m., the fall-off of the soil above the ceiling had spread upwards and, assisted by the slipping along the vertical wall of the motorway structure, soil mass fell down into the tunnel. This resulted in creation of a large cave-in on the ground surface on the south side. At this time, two mains 60m and 30m in diameter for water supply were broken releasing a large amount of water for a prolonged time. This breakage of buried pipes appears to have transferred the collapsed soil deposits into more flowable debris.

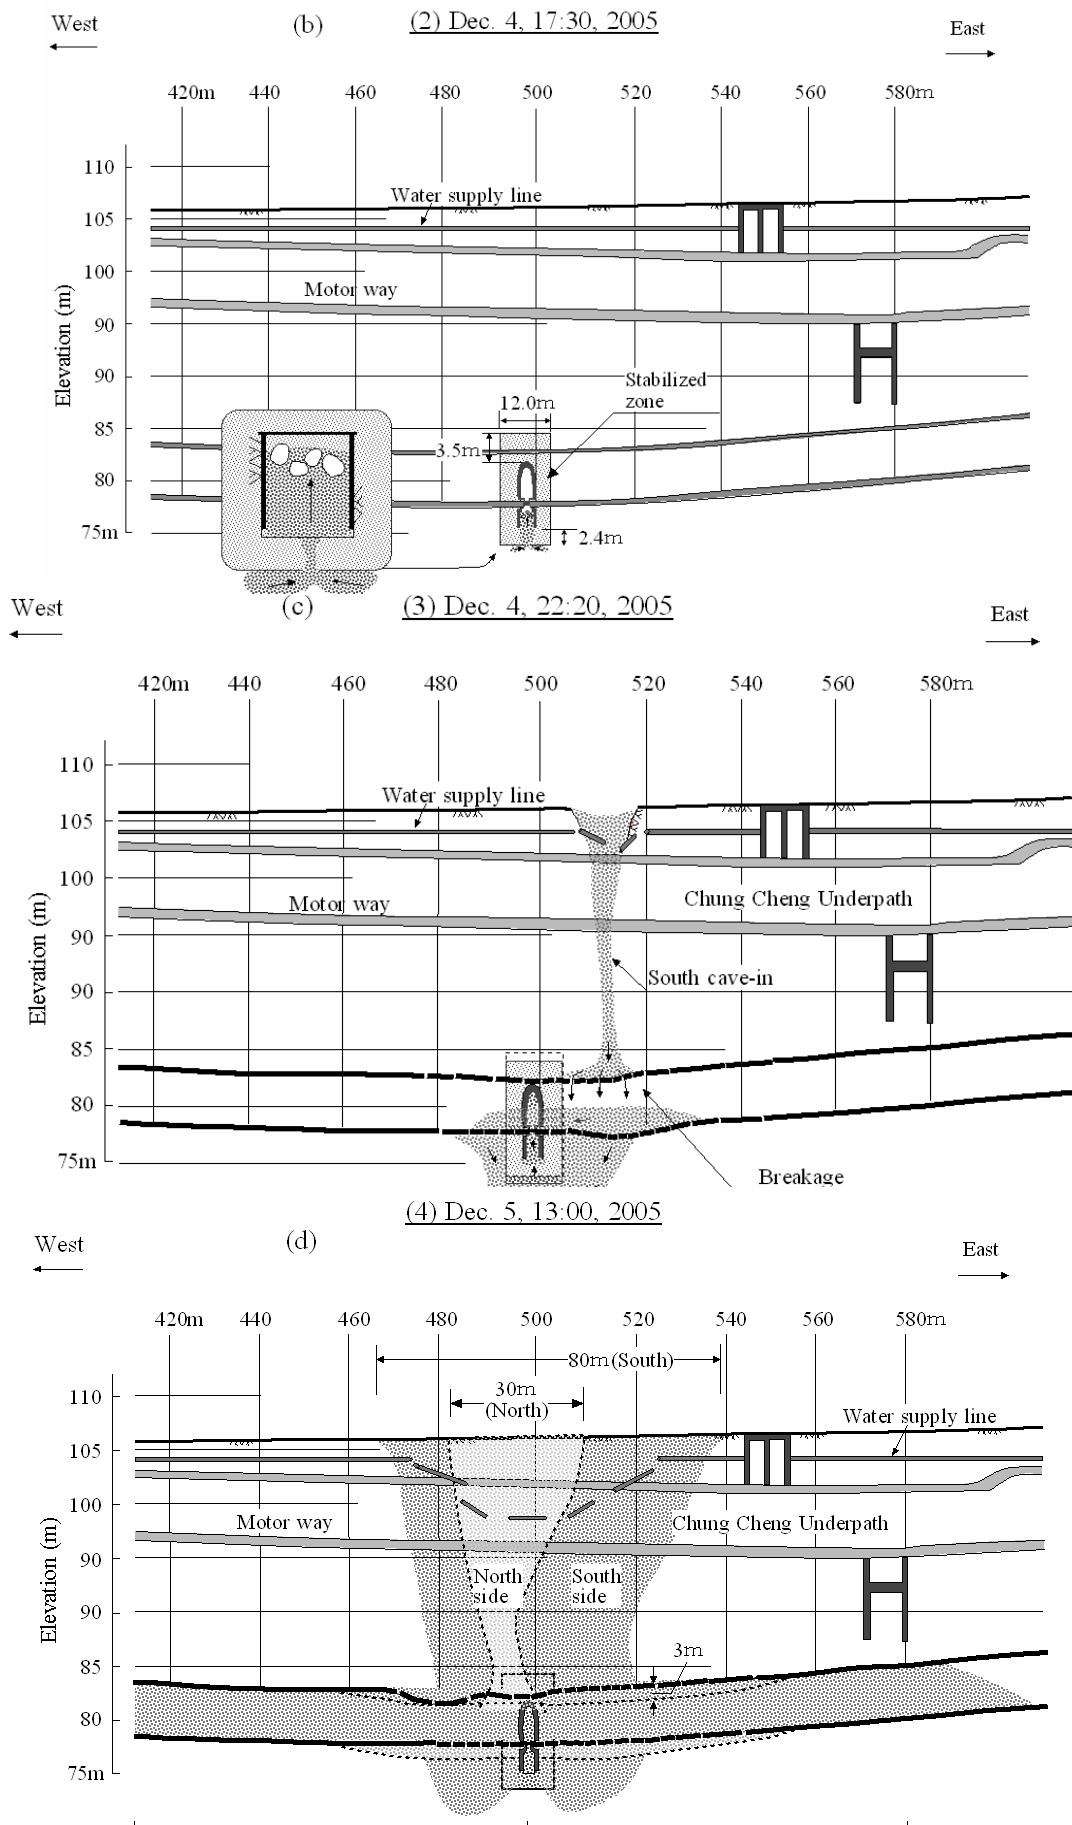
Figure 13. A sequence of likely scenario in the longitudinal direction

The feature of the collapse propagation as above would be understood more vividly by visualizing the sequence of events that might have occurred in the longitudinal direction. These features are described in Figure 13(a) through 10(d). Figure 13(c) and (b) shows the progress of the collapse from 3:30p.m. to 5:30p.m. on December 4, 2005. Figure 13(c) indicates the breakage of the tunnel, segment by segment, resulting in the fall-off the debris from the offsets of the segments in the ceiling on the east side. On the north side undermining of the tunnel body did occur as well as shown in Figure 9(d), resulting in the sinking of the tunnel together with the large block of the stabilized zone. This led to the breakage of the segment joints on the north side and allows the mud water cascading mainly through the opening at the junction between the

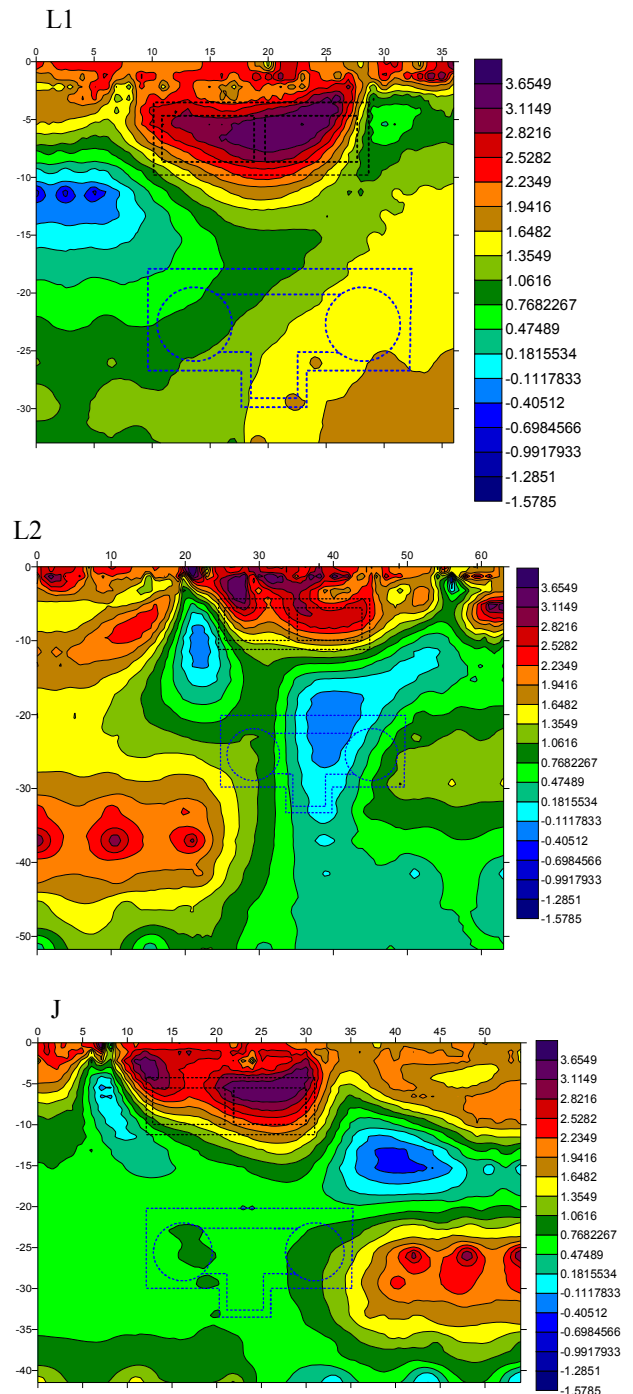
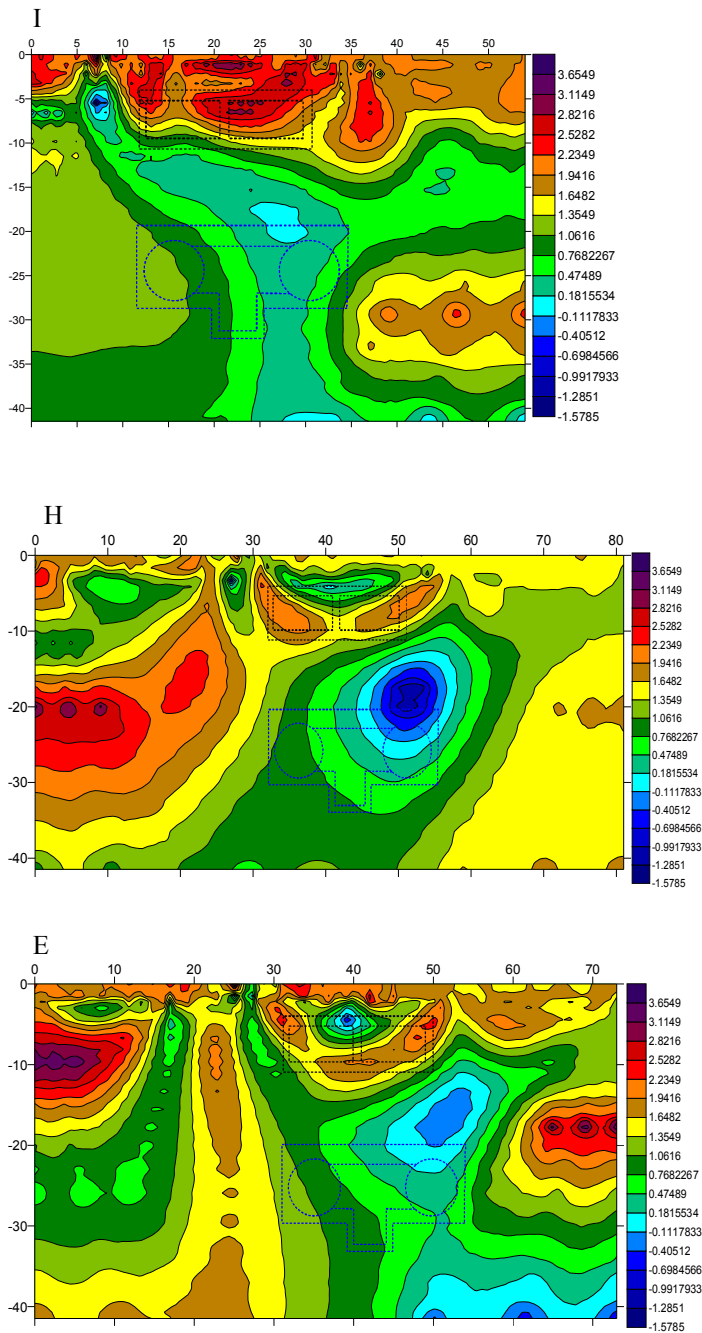
Figure 12. Results of RIP tests

Figure 12 shows the results of 2D RIP in cross sectional profiles. In the figures, cold colors, from green to deep blue, represent low resistivity materials as the disturbed ground with larger volume of ground water content. On the contrary, warm colors, from yellow to red and brown, represent high resistivity material such as grout materials or cemented backfill. Underground structures shown in imagines of 2D RIP tend to be distorted from rectangular shapes into upward shell shapes. As depicted in Figure 12, despite the imagine distortion, area in between the underground carpass and the subway corridor were identified as in seriously disturbed condition. At locations of Line L2 and Line E, which are the east and west boundaries of the soil improvement block of the damaged corridor, soil beneath the subway tunnels was also found to

be severely agitated by the piping failures. This observation implied that the subway tunnels outside the grouted area might subside and resulted in dislocations of tunnel ring segments. Imagines shown in Figure 12 also indicate that immediate remediation grout treatments have effectively reached both sides of the corridor as displayed in warm color. By interpreting the 2D RIP results, failure schemes shown in Figure 9 were possibly pictured to pursuit causes of the failure. Borehole probing was also conducted at the same time when 2D RIP survey was performed in an effort to validate the scale of the damaged tunnel portion.

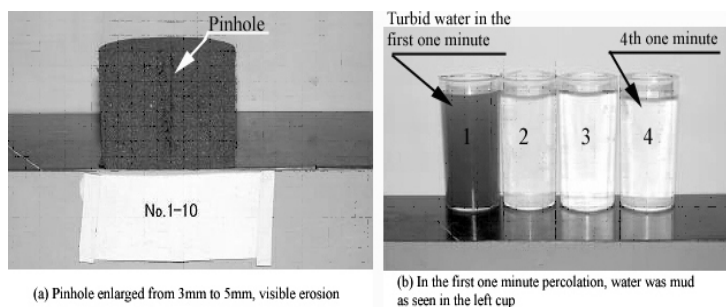
In the first series, the tests were conducted on disturbed samples, one from Kaohsiung and another from Japan. The result of the pinhole tests on a disturbed sample is presented in Figure 17. For the disturbed silt-containing sand sample from Kaohsiung, the pinhole is seen enlarging to a diameter of 5mm from 3mm as displayed in Figure 17(a). Correspondingly, the drained water from the bottom was muddy for the first one-minute period of water percolation as seen in the water colour in the left-side cup of Figure 17(b). The result of the pinhole test on the Japanese silty sand is shown in Figure 18. In contrast to the Kaohsiung soil, the circulation of water through the Japanese soil did not exhibit any appreciable change in colour in the first one minute of percolation as seen in Figure 18(b). There was no change in the pinhole diameter for the Japanese soil before and after water permeation except for a local collapse at the top. Thus, it may be conclusively mentioned that the silty sand from Kaohsiung is potentially susceptible to internal erosion as compared to the soil from Chiba, Japan, although they had almost the same grading. This is believed to stem from the highly non-plastic nature of the Kaohsiung silt contained in the sand.

Figure 17. Silt-contained sample from Kaohsiung

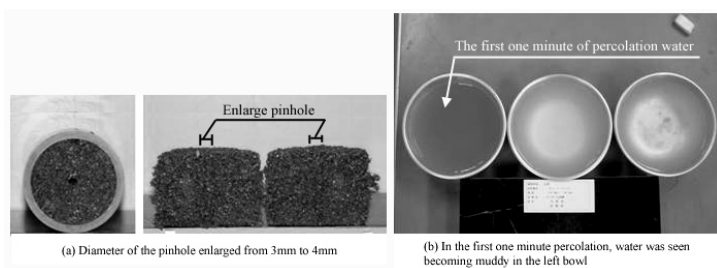
In the subsequent series, similar pinhole tests were conducted on undisturbed samples. The undisturbed sample from the depth of 14m in Kaohsiung also demonstrated dirty blown colour in the first one-minute of percolation accompanied by the enlargement of the pinhole from 3 to 4mm, as displayed in Figure 19.

Figure 19. Pinhole tests on undisturbed samples from Kaohsiung
