Collapse of Braced Excavation in Singapore

K. Ishihara

ABSTRACT: After the collapse of the subway excavation in the Nicoll Highway, extensive in-situ investigations were carried out to identify causes of the accident. The results of detailed studies disclosed that lack of toe-in depth of the diaphragm wall into the stiff competent strata could be one of the causes of the incident. This aspect of the studies is highlighted in this paper.

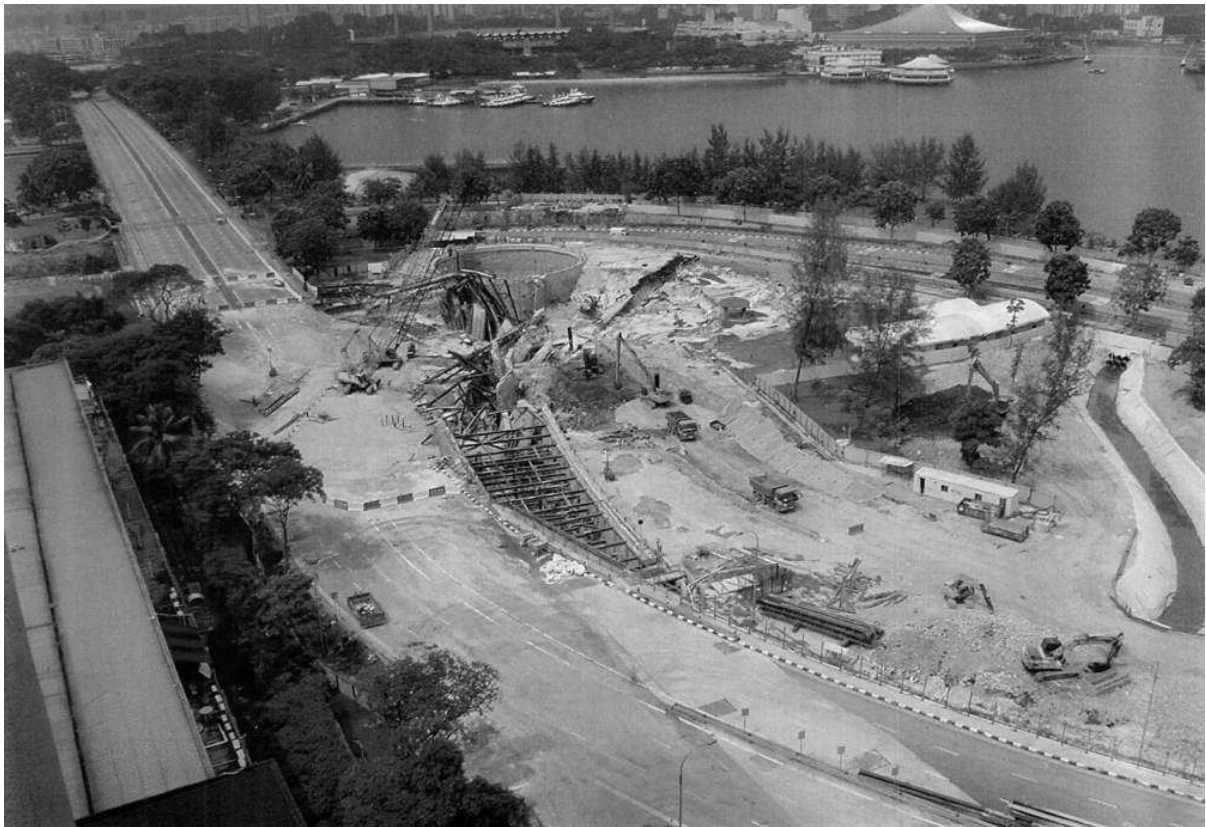
A section of temporary retaining wall structure adjacent to Nicoll Highway collapsed almost suddenly within a matter of a few minutes at 3:30 p.m. on April 20, 2004. An overview of the site of failure is shown in Fig. 3. This is located at the seaward side of the land reclaimed around 1970. The features of the braced excavation and collapse are roughly shown in the plane view of Fig. 4 where it is noted that a large tunnel access shaft (TSA) 17m in radius had been constructed to facilitate transport of structure elements and materials down to the floor of the excavation.

Fig. 3 Oblique view of the site to the east after the collapse.

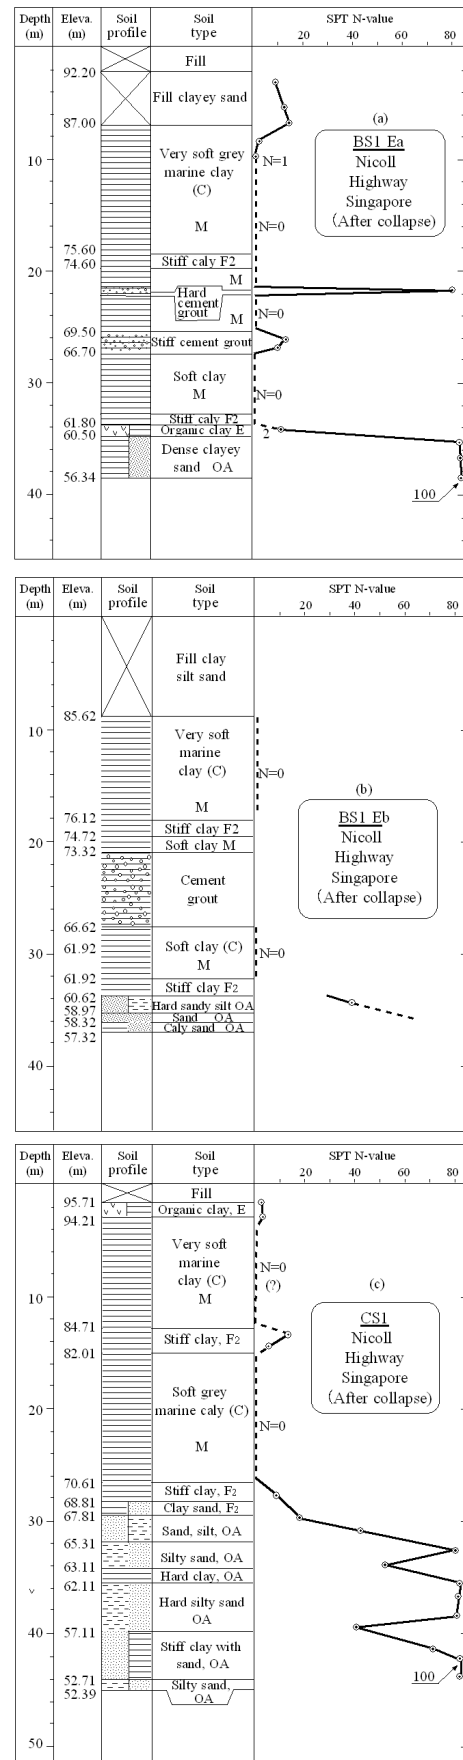
Some of the results of the borings conducted at points BS1Ea and BS1Eb about 7m south of the collapsed wall is displayed in Figs. 11(a) and (b) where it can be seen that remains of the grouted cement were encountered at an elevation of 73m and 67m RL. In another boring at CS1 shown in Fig. 11(c), the soil stratification was found to be about the same as that before the failure event.

Fig. 11 Soil profiles just south of the collapsed diaphragm wall panels.

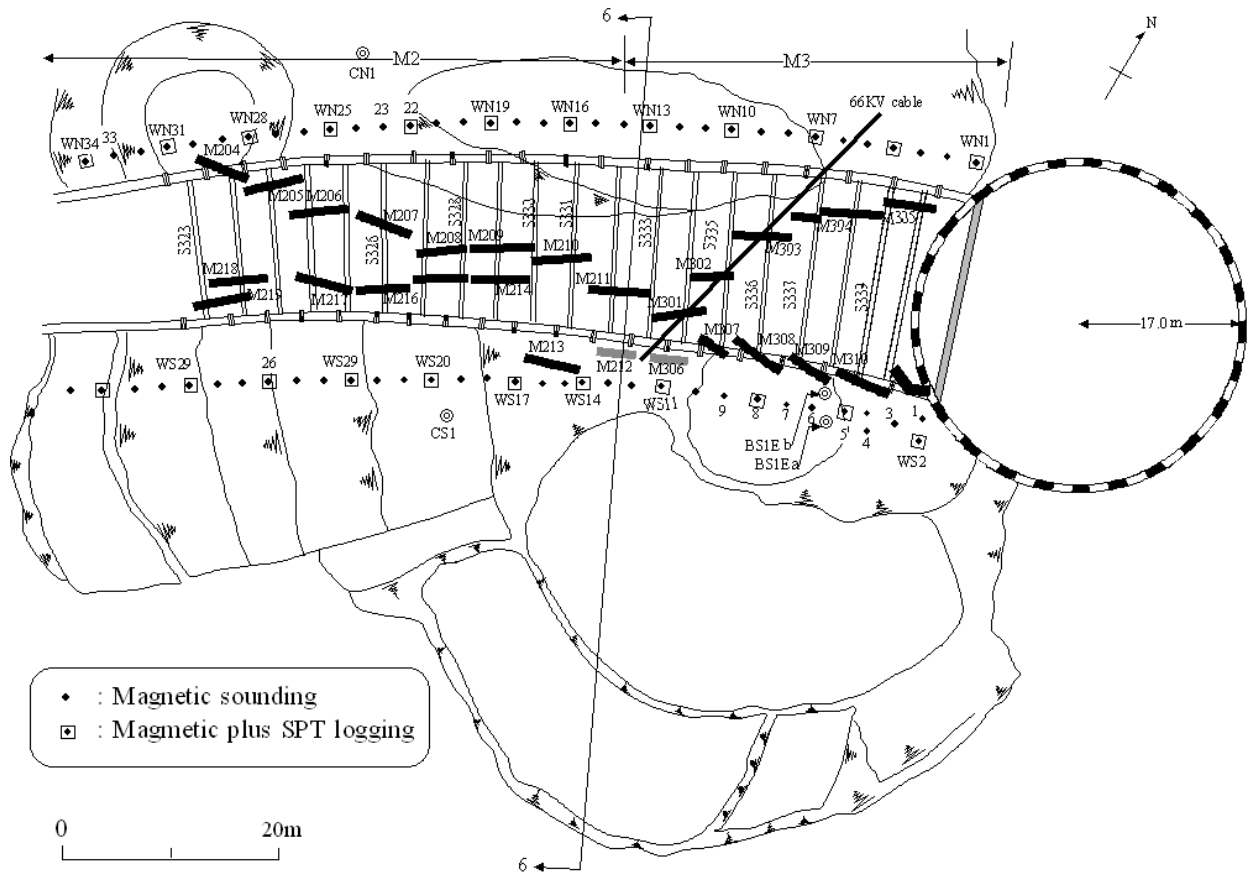
After investigating the location of the exposed top of the diaphragm wall panels, it became possible to approximately figure out the scenario of the failure. Exact locations of the panel top in plan view are shown in Fig. 12. Based on the features shown in this figure it may be mentioned that the collapse mechanism at panels M213, M212 and M306 were different from that elsewhere and almost certainly it involved the toe of the diaphragm wall panels kicking in, and flow of the soil underneath the diaphragm wall panels. This form of the failure will have allowed the maximum southward movement of the opposite north wall panels, namely M211 and M301.

huge amount of soil mass moved into the excavated space. In fact, a subsidence of the ground surface as much as 10m was observed on the south side in proximity to the wall and the settlement extended about 50m southward, as seen in Figs. 4 and 12. The area of the ground settlement extended also north towards the Nicoll Highway but to a lesser extent as can be seen in Fig. 4. Thus, it was considered certain that the failure was initially triggered by the breakage of the diaphragm walls on the southern side, thereby involving a landslide towards the excavated space. As a result of losing the horizontal support, the northern walls moved also towards the excavation, inducing sliding of soil mass towards the south but to a lesser extent.

Fig.12 Locations of the magnetic sounding and boring conducted after the collapse.

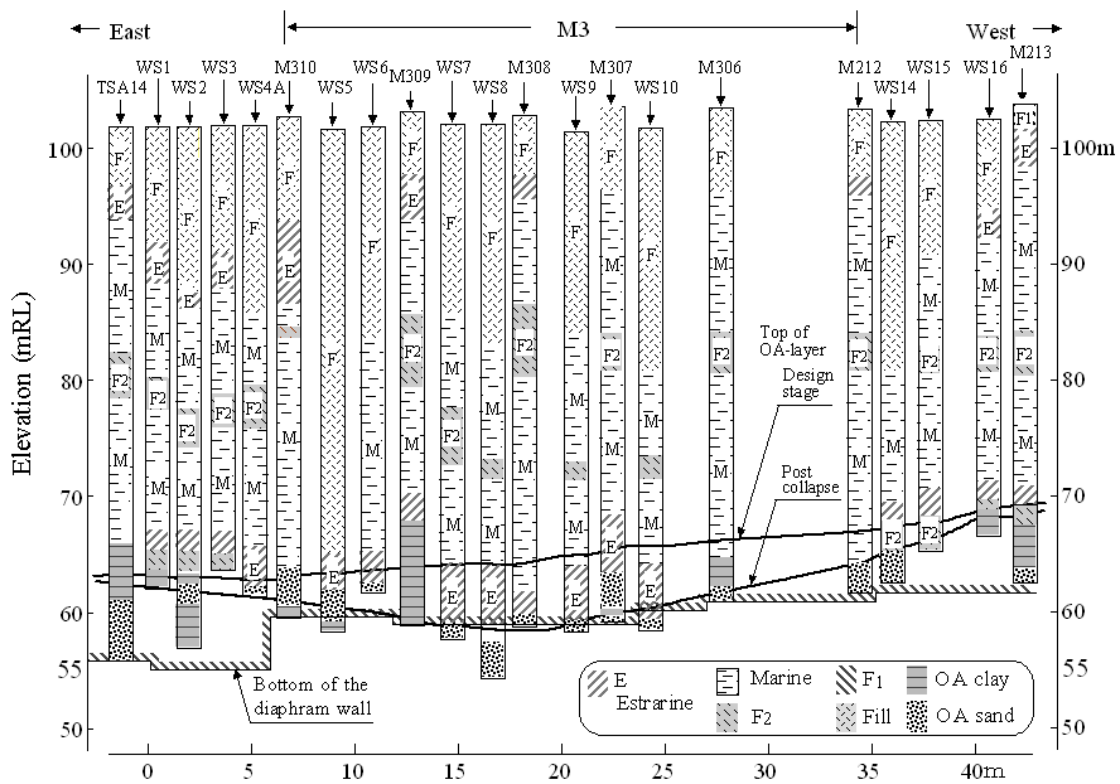
Fig. 17. Soil profile along the south wall and bottom of the diaphragm wall.

By comparing the elevations at the top of the OA layer before the collapse with those of the bottom of the diaphragm wall, it can be seen from Fig. 17 that in the eastern zone between WS1 and WS4A, the toe-in of the wall was more than 3m. In the zone of collapse between WS5 and WS16, the toe of the diaphragm wall seems not to be embedded sufficiently deep. However, the depth of embedment into the OA layer may be considered deeper than 3m in consistence with that considered in the design. It is to be pointed out, however, that the quality of the soils at the upper part of the OA layer was less competent in stiffness or strength as compared to that assumed at the time of the design. This point would have a more important bearing from the forensic point of view.

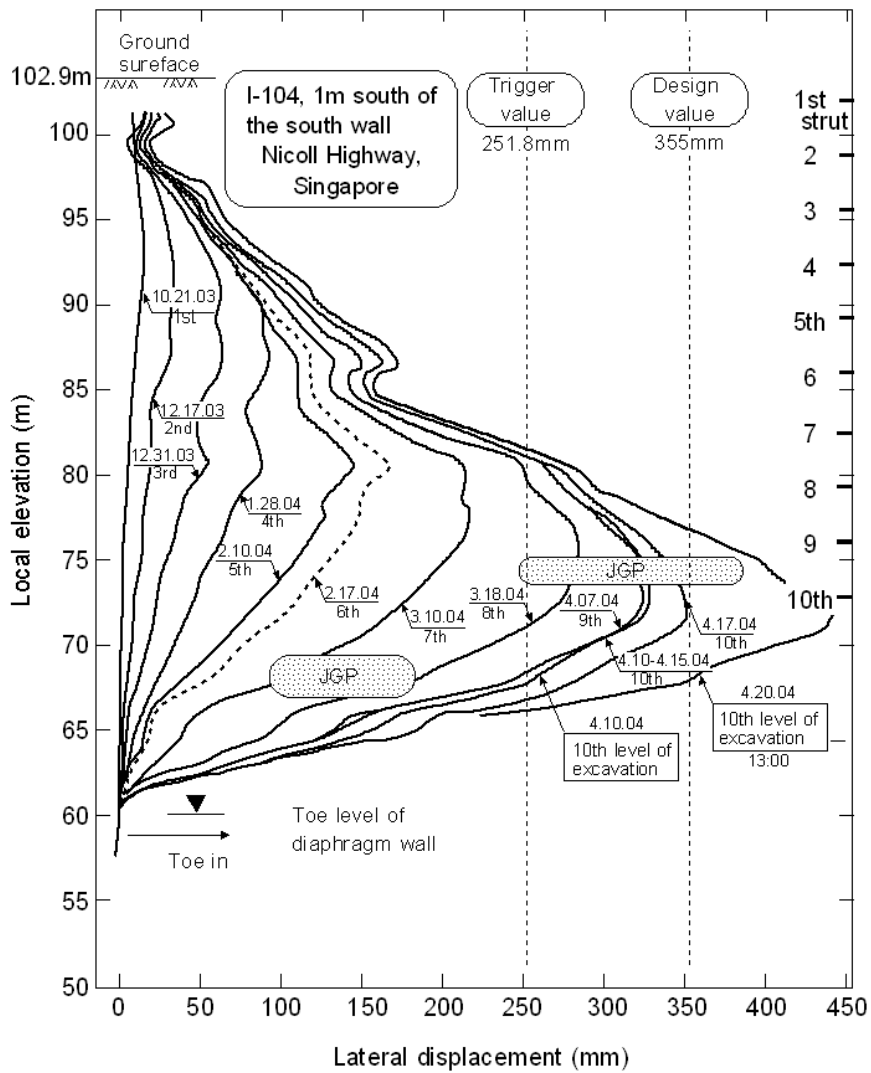
Fig. 19 Time change of depthwise distribution of the wall measured by the inclinometer in the soil deposit 1m apart from the south wall.

It is known that the wall deflection started to increase significantly from April 17, 2004 as indicated by a dash line in the figure.

The maximum displacement measured at 13:12 on April 20, 2004 is known to have amounted to 43.5cm at the elevation of 72m. It is to be noticed that actual collapse took place at 15:33. i.e. 2 hours 21 minutes (141 minutes) afterwards. Thus, it is likely that just at the time of collapse, the maximum value of the wall deflection might have been larger than 43.5cm. It should be cautioned that the waler-strut system had sustained the deflection of at least 43.5cm for the period of 141 minutes without causing collapse.

To be noticed, moreover, is the fact that the distribution of the wall deflection shown in Fig. 19 was obtained by integration of tilts at several depths measured by the inclinometer on the assumption that the tilt at the toe was equal to zero. This assumption may not be correct in the present case, because the toe of the diaphragm wall had not been firmly embedded in a stiff base stratum. Thus, the distribution of the wall deflection shown in Fig. 19 should be taken simply as indicating the relative displacement counted from the toe of the diaphragm wall.
