# Damage by the 2011 Great East Japan Earthquake

Masakatsu Miyajima  
Kanazawa University, Japan

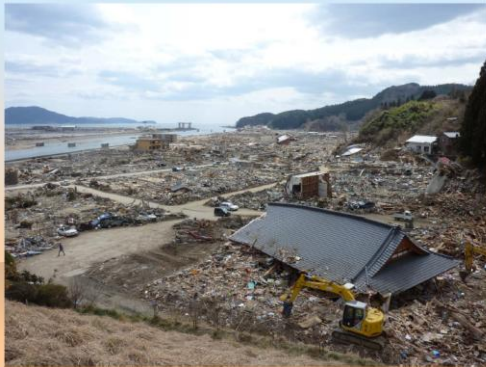
## Damage to houses

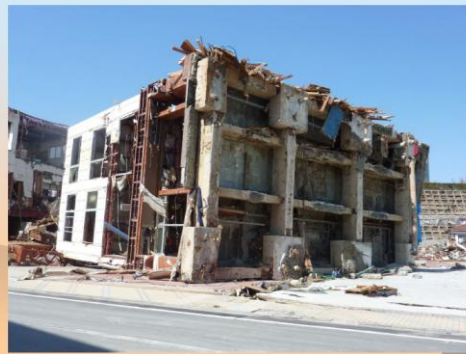
## Overturn of building

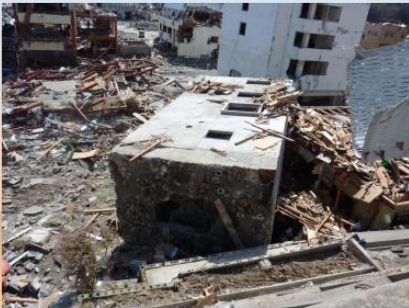
## Wash away and overturn of building

Most of RC buildings were not damaged severely even in coast area.

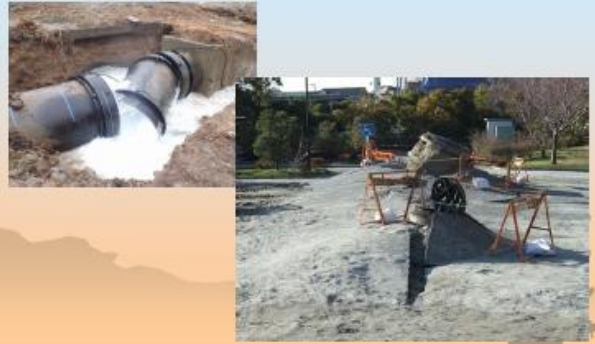
## Damage by ground shaking and liquefaction

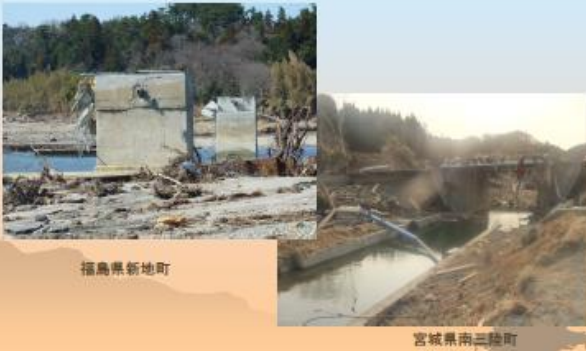
## Tsunami (Washing away)

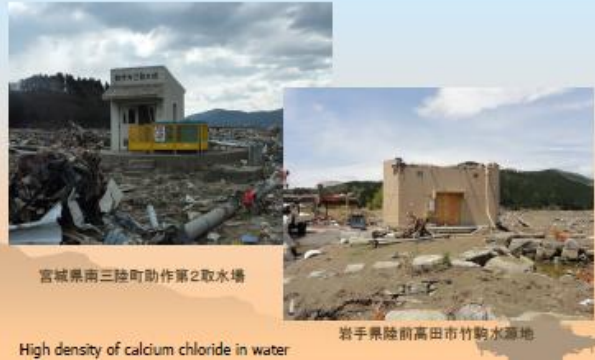
## Tsunami (Inundation)

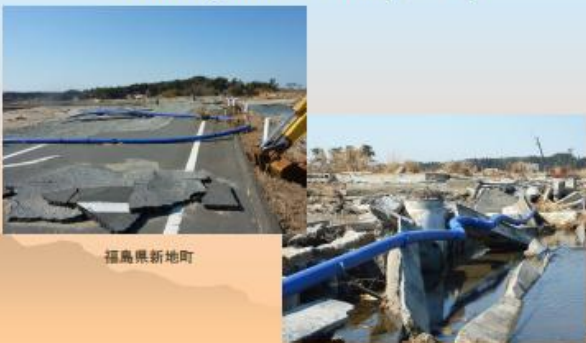
## Damage by tsunami (Scouring and washing away)

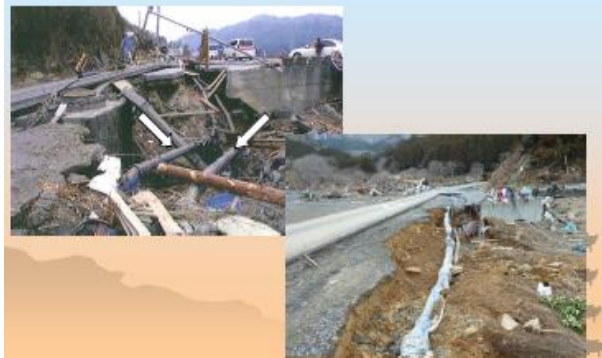
## No damage to earthquake-proofing pipe

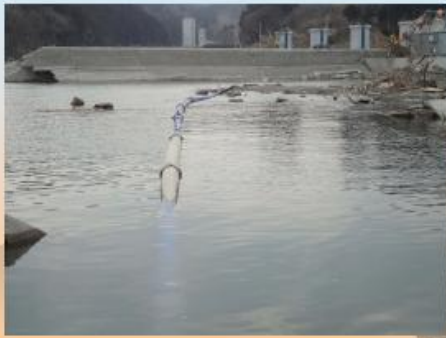
## No damage to earthquake-proofing pipe

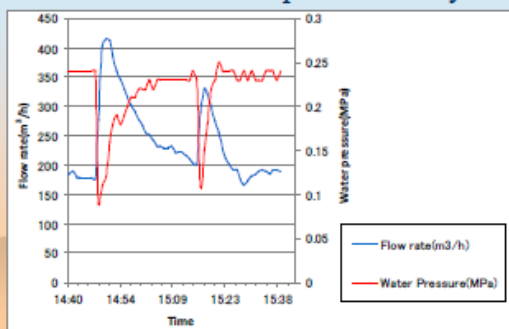
## Flow rate and water pressure at a water distribution plant of Tokyo

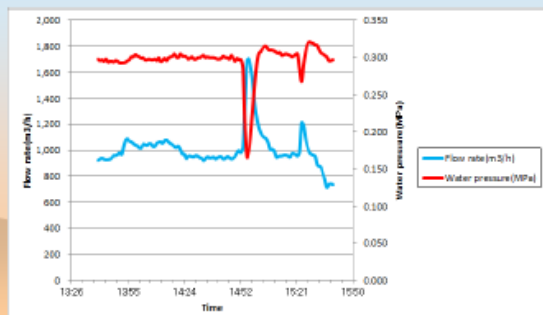
## Flow rate and water pressure at a water distribution plant of Osaka

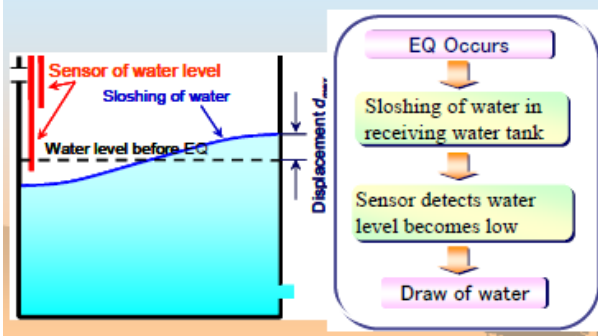
## Mechanism of draw of water

- If sloshing of water in receiving water tank is occurred by an earthquake, draw of water to receiving water tank from pipeline starts by error of sensor of water level in the receiving water tank. Sloshing of water in receiving water tank, therefore, seems to be one of the causes of unusual phenomena.
