**BUILDING DAMAGE IN 2010 CHILE OFFSHORE MAULE EARTHQUAKE
NO.4 FOURTEEN STORY RESIDENTIAL BUILDING IN VIÑA DEL MAR**

Chile Earthquake RC building Viña del Mar
Seismic assessment Lateral capacity Pushover analysis

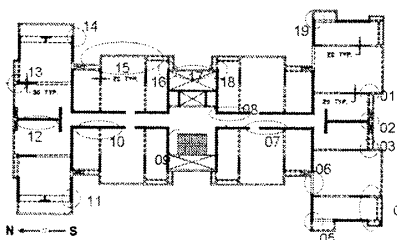
Fig.4 Damaged locations on 1st floor

Location	Damage description
1, 2, 3	Wall edge crushed in the vertical direction. Vertical reinforcement at edge buckled.
4	Cover spalling due to compression in the vertical direction. Minor damage.
5	Cover is about to spall due to compression in the vertical direction. Minor damage.
6	Shear cracks next to window opening
7, 8, 10	Walls failed in shear. Supplemental walls on two faces constructed after 1985 EQ came out due to insufficient anchorage
9	A plastic hinge formed at the north side of an external staircase at each floor
11	Wall edge crushed in the vertical direction. Too many vertical reinforcement was lap spliced to make congestion, and concrete may not have been consolidated. Windowpanes were broken.
12	Wall has horizontal cracks.
13, 14	Finishing mortar spalled
15	Windowpanes were completely taken out probably due to heavy damage
16	Finishing mortar spalled. Added column crushed in compression near the ground.

17	The wall behind the elevator has multiple diagonal shear cracks
18	Wall edge crushed in the vertical direction near the ground. Vertical reinforcement at edge buckled.
19	Finishing mortar closed to the ground spalled

Fig.4 shows the damaged location on 1st floor. The damage descriptions correspond to the damaged location numbers in Fig.4 are shown in Table 1

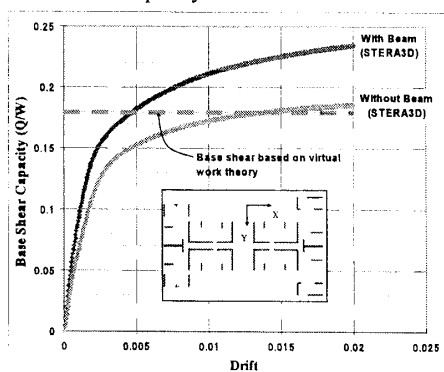
Fig. 6 Building capacity (North bound loading)

The capacity of building in X-direction by STERA3D is compared to the base shear based on the virtual work theory assuming the identical failure mechanism. The capacities are close to each other for models without beams. However, beams were connected shear walls to shear walls in reality, hence the model with beams is considered close to the real behavior. Fig.6 shows the base shear capacity of 0.24

As shown in Fig.6 the capacity based on flexure failure mode (Wall base) of building is 24% of the building weight while capacity based on shear failure mode (All walls) is at least 43% of building weight. Therefore, the flexure failure mode should be dominant but the shear failure of walls occurred in reality. The difference is considered due to dynamic effects.
