An Investigation of Traditional Javanese Wooden Houses ‘Joglo’ Damaged during the May 2006 Yogyakarta Earthquake, Indonesia.

Yulianto P Prihatmaji^{1,4*}, Akihisa Kitamori², Kohei Komatsu³

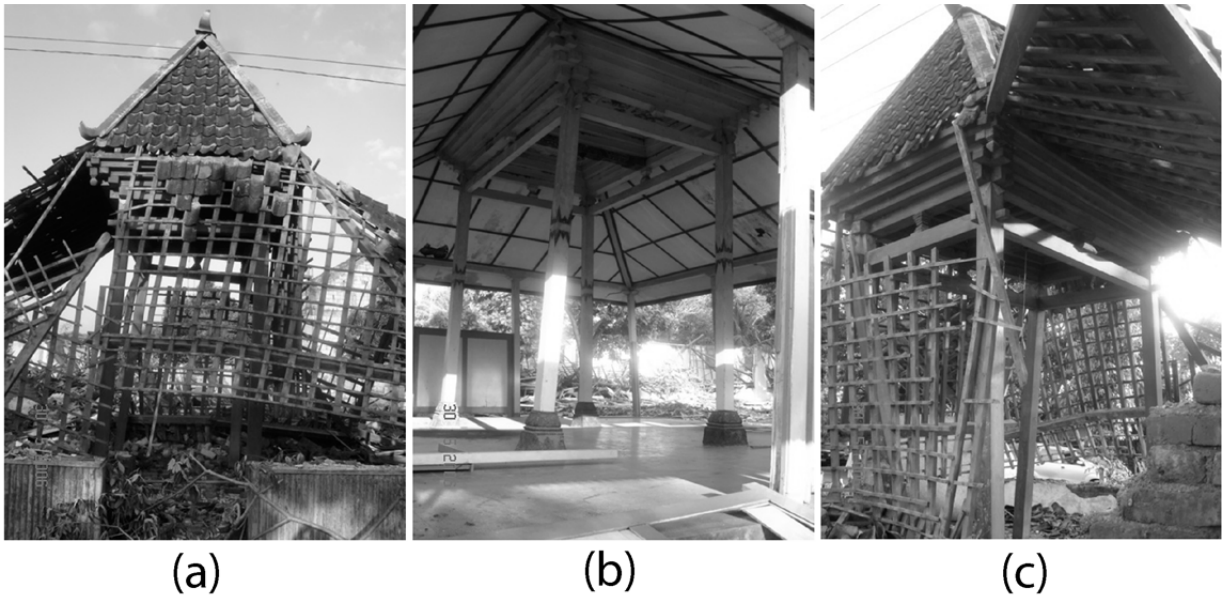
Figure 8a, b and c. State of Joglo's core structure after an earthquake.

Figure 8a-c, shows four columns that are severely inclined but still standing and securing human life. Hence, the role of joints is very important and significant. The most crucial damage between column and beam is observed at joints at the lower and upper beam. The joint of the long beam with the column gets damaged due to shear force and bending moment inside the mortise (Prihatmaji et al., 2011; Prihatmaji et al., 2010b). Furthermore, mortise of columns, into which a number of beams are inserted, may cause a fatal damage on the core structure.

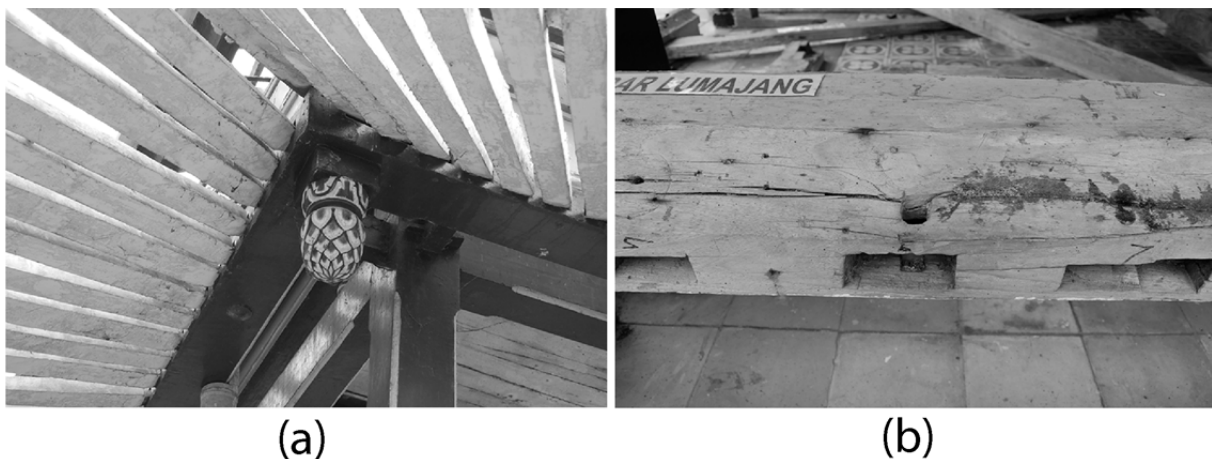
A clear indication of the roof construction’s failure begins with the column slipping from the stone base. Due to differences of in-plane stiffness between outer and core structure, only outer structure is largely shaken when earthquake force is applied. This is because both in-plane stiffness and vertical stiffness of core structure are higher than that of outer structure. The rafters of the roof of the core and the outer structure have mortise inserted at the outermost band of rectangular beams. Figures 10a-b show the outermost band of rectangular beams in detail. The shape of the mortise is highly complicated (Figure 4b); basically consisting on a parallelogram with different angles. The rectangular shaped mortises are only at the middle of the beam, this is common for rafters placed around the corner of the roof flanking the hip rafters. The slip of column or any large deformation of the outer structure causes the rafter to be pulled out from the main beam. Hence, the outer structure becomes unstable and collapses.

Figure 10. (a) The outermost band of rectangular beams, (b) mortises beam, where a series of rafter will be inserted.

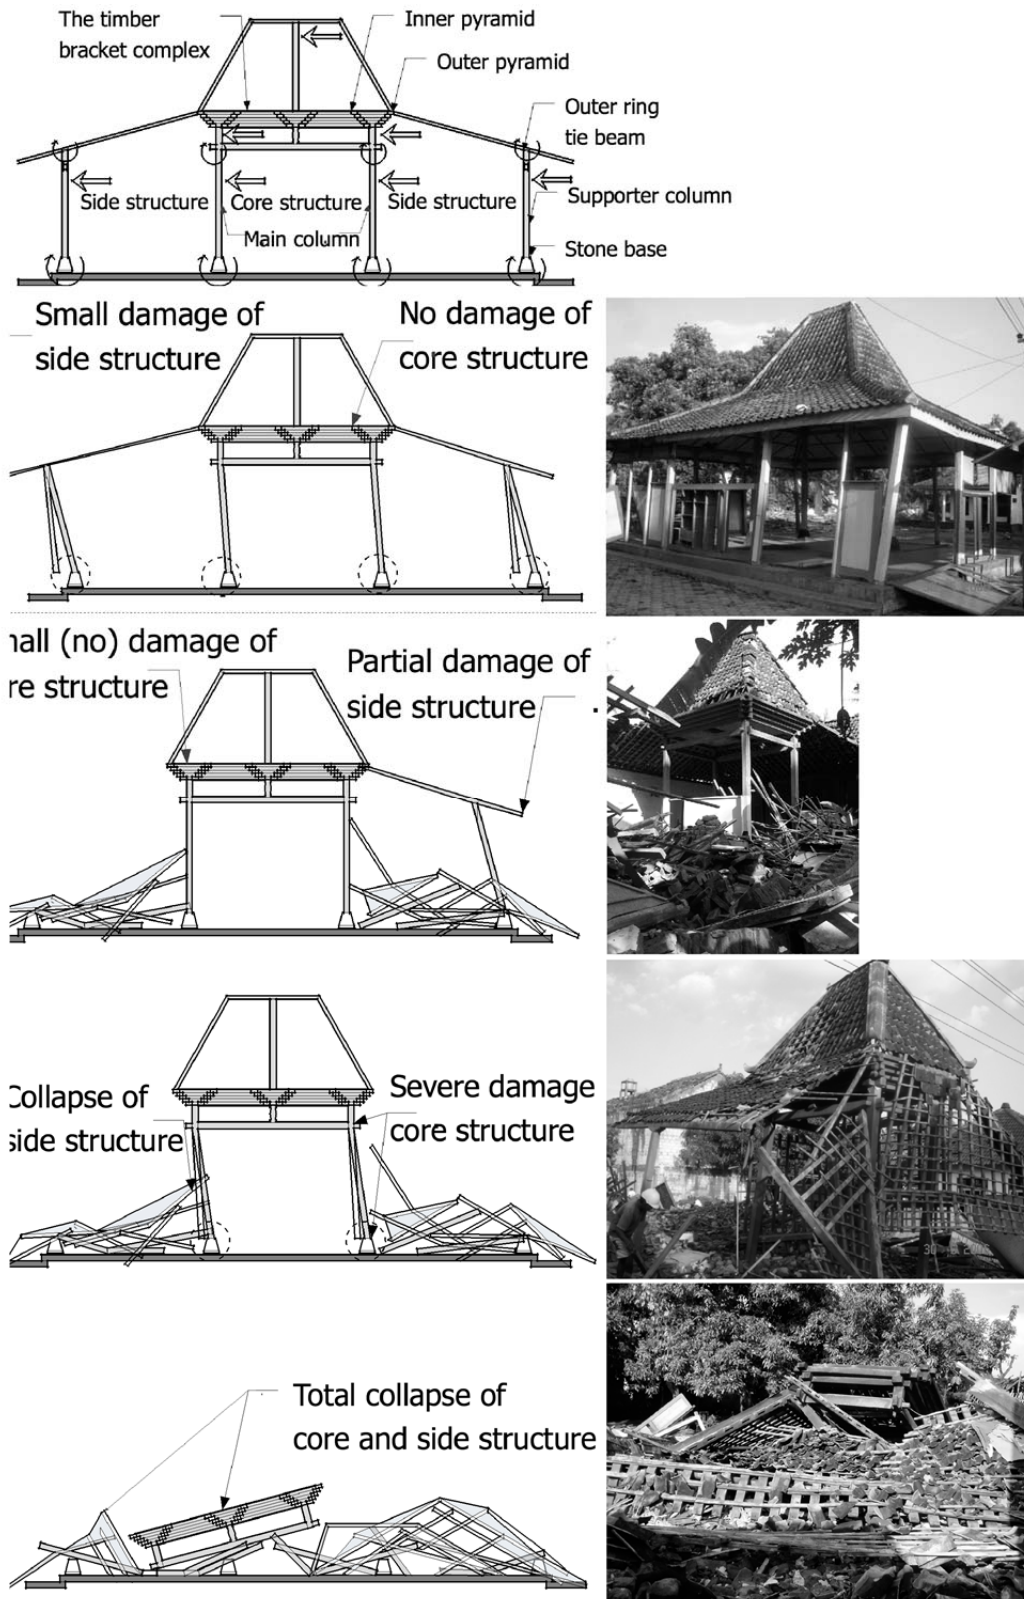
Figures 11a-d show different levels of damage in Joglo-type structures. We categorized them into 4 levels according to the gravity for the structural security and in order of appearance. Firstly, part of the side structure is selectively damaged while the core structure is still standing. This is due to the

difference of strength performance, as shown in Figure 11a. Secondly, the side structure is partially collapsed or damaged while the core structure is slightly or not damaged (Figure 11b).

Figure 11. Levels of damage of the Joglo building (a) First level of damage, (b) Second level of damage (Figure 10b in right courtesy by Wulandari, 2006), (c) Third level of damage, (d) Fourth level of damage (Figure Figure 10a, b and d in left modified from Prihatmaji, 2010b and Ikaputra, 2011. Figure 10d in right modified from JHS, 2007).

Figure 11c shows the third level of damage, which is identified by the collapse of the side structure, with the core structure remaining standing. At this stage, the core structure's columns are inclined but safe. This indicates the importance of the strength performance of the core structure for the security of the residents. At the fourth level of damage, the entire structure falls-down due to the collapse of core and side structure (Figure 11d).

The specific feature of the first level of damage involves broken mortise of columns, and slip between columns and stone foundations at the side structure, decline of column of side structure, and damage of outer ring joint. In the secondary level, joints between outer ring's beam and column are deformed or broken, and joints between inner ring beam at core structure and rafters broke, due to the rafter end connection being pulled out. In the third level, severe damages on the core structure are observed besides second level of damage. Severe damage on core structure is due to the main column's declining and breaking of the joint at lower beam of core structure. The main structures are totally collapsed including roof structures in the fourth level.
