## Study on Landslides in Weathered Granite Areas of Hai Van Mountain, Vietnam

Pham Van TIEN, Kaoru TAKARA and Kyoji SASSA<sup>(1)</sup>

### Synopsis

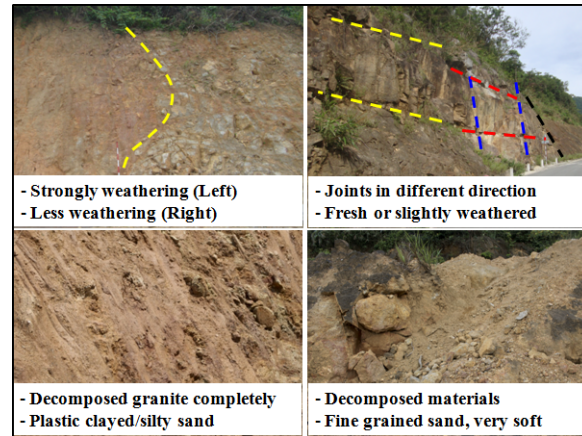
From a lithological point of view, the area is considered to be homogeneous as most of it is covered by various materials of weathered granitic rocks with diversified degrees of weathering process. Qualitatively, geological structure of slopes consists of three material layers on slope at least, namely loose sediments (alluvium/colluviums), strong and less weathered granitic rocks and bedrock of granite mass. The mass of weathered granitic rocks is covered by a thin sedimentary layer of 1 m to 3 m in depth and several single boulders. The granite masses with many cracks and joints in different direction were observed visually. Those features were found in the site survey clearly. Granitic rocks are fresh or very completely strong or less weathering or

partly weathering in different layers and different directions (Fig. 8). Thus, formed materials are very different from grain size distribution, mineral composition, colors and hardness grade. As for a completely weathering degree, granitic rocks were changed into soil-like materials with brown, yellow and white colors and are very soft and slightly soft. Other partly weathering degree, material of granitic rocks is a mix of soil and stones with different grain sizes. Such kind of materials is a bit hard with red and grey colors mixing with a speckled mineralogical composition in black color. The more weathering materials are softer and finer than others. Materials of weathered granitic rocks are very loose and

unconsolidated. They are very easily to be eroded by rainwater and become earth flows.

Fig. 8 Weathered granitic materials on slopes

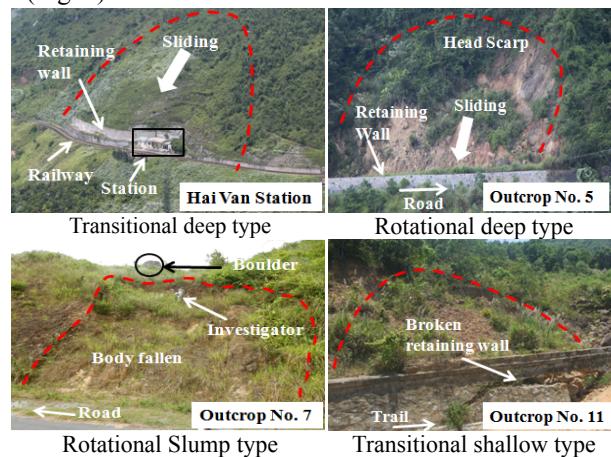
The most common types of landslide in Hai Van Mountain are earth slides, rock falls and debris flows. In which, sliding types are characterized by a

complex form of rotational and/or translational modes (Fig. 8).

Fig. 9 Type and description of investigated landslides

The movement of landslide material may vary from abrupt collapses (the outcrop No. 5) to slow gradual slides (landslides on the slope behind the Hai Van station). Landslides are at different scales in both shallow and deep types, which depend on the thick of residual soil on slopes, weathering degrees of granitic rocks and fracture zones. The shallow landslides have a volume of 50 m<sup>3</sup> to 500m<sup>3</sup> with a depth of sliding surface about 2 m to 5 m. Shallow landslides were frequently induced by rainfalls due to a loose and unconsolidated material of slopes. More specifically, landslides are mainly populated a long national highway while large-scale and deep-seated landslides are situated next to the railway or at the edge of steep mountains. In the region, at least five deep- seated landslides were found around Hai Van Station, which have a volume ranging from several hundred thousand 200,000 m<sup>3</sup> to several million m<sup>3</sup>. The estimated depth of potential sliding surfaces of those large-scale landslides in Hai Van Mountain often ranges largely about 5 m up to 50 m. Besides, site investigation revealed that most of failures were found with regards to artificially modified slopes (cutting/filling slopes for road constructions) and only several slides occurred on natural slopes.

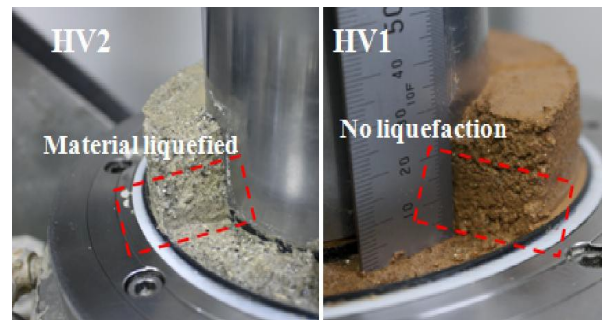
To examine how grain crushing of samples occurred at sliding surfaces, after the shear test was finished, both disturbed and undisturbed samples were collected from the shear zone and other than sliding zone of the shear box; then grain-size analysis was performed on these samples (Fig. 16). Grain-crushing, sliding plane and liquefied materials of two difference landslide tests are compared and denoted in Fig. 17 below.

Fig. 17 Photograph of the sample HV2 and HV1 after failure
