Experimental Evaluation of Seismic Residual Performance for Deteriorated Rubber Bearings in Highway Bridges

Kunihiro HAYASHI¹, Yukio ADACHI², Naota SAKAMOTO³, Akira IGARASHI⁴
and Ji DANG⁵

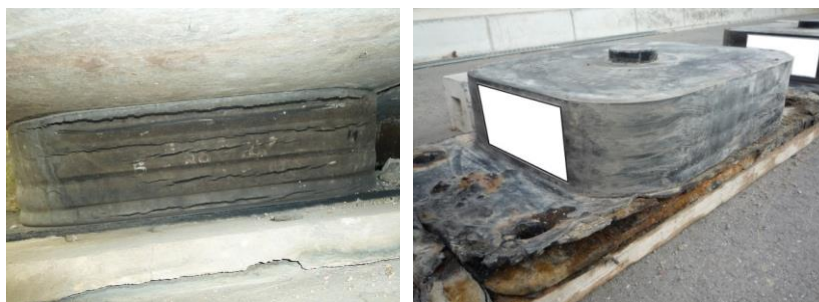
The bearings had been used in service for 27 years. As can be seen in Figure 2.2, surface cracks appear on the bearings because of aging deterioration of the rubber material over time. Moreover, the bottom plate suffered partial corrosion due to water leaked through the expansion joint.

Figure 2.2 Damage status and cracks of ring bearings

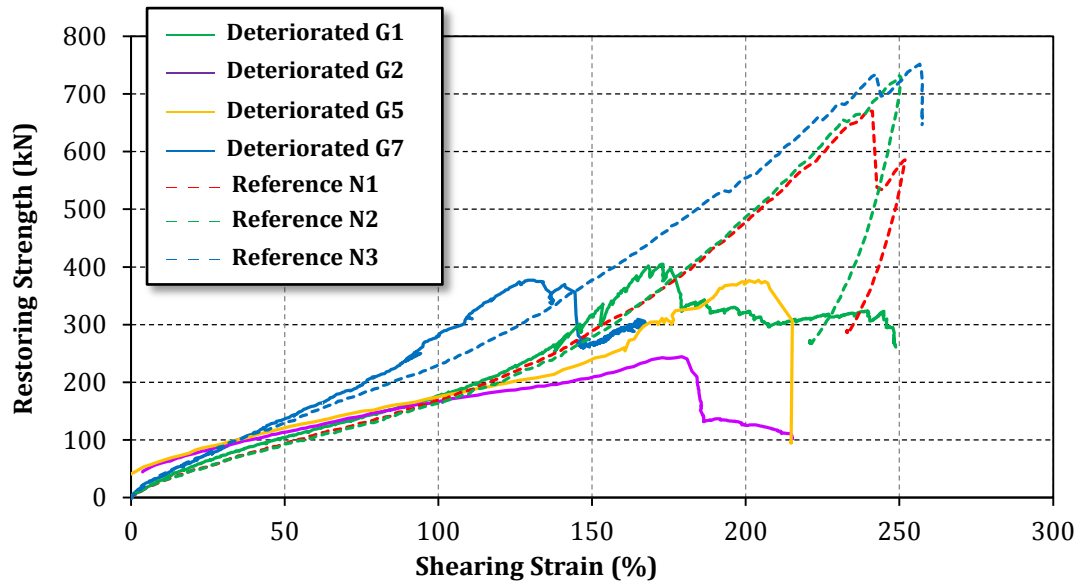
The restoring force curves obtained by the UD tests are shown in Figure 3.2. The reference sample bearings failed at 240% strain on average, satisfying the allowable shear strain requirement of 150%, although G7 failed at 131% strain. On the other hand, the failure of G1, G2 and G5 took place at shear strains exceeding 150%. Possible reasons for the variation in the failure strain among the samples include the difference in the progress of aging deterioration caused by environmental conditions in service period, manufacturing process or interaction between those factors.

Furthermore, the maximum restoring force of the four deteriorated bearings was 40% less than that of the reference bearing. Since the most influential factor to the load capacity degradation was inferred to be the aging deterioration, several supplemental tests had been conducted in order to evaluate the influence of the deterioration.

Figure 3.2 Result of UD tests

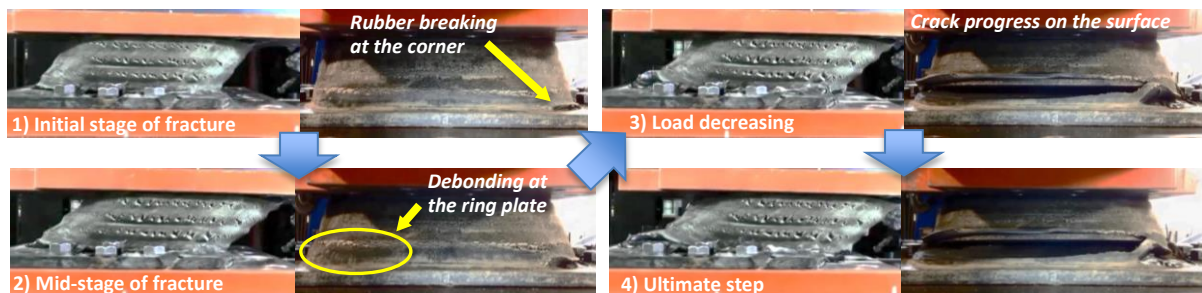
The onset of fracture and its progress were analyzed by the video image of the UD tests. The images of the G7 test are shown in Figure 3.3. Debonding began from the ring plate, followed by a gradual progress of cracking extended to the bearing surface, and then the ultimate state was reached. The fracture was induced along the boundary between the bottom plate and rubber. The process of fracture forming is identical for all the deteriorated bearing samples. On the other hand, the fracture forming in the reference bearings is different from this description. The fracture was induced within the rubber layer between lower ring plates as commonly assumed in the design of bearings.

Although many ozone cracks are generated in ring bearings during the regular service, any extension and growth of these cracks that cause fracture of rubber layers were not observed in the tests. Therefore, ozone cracks on the surface of the bearings are not considered to be a critical factor that affects the seismic performance or bearing fracture process.

Figure 3.3 Video capture of UD test in G7

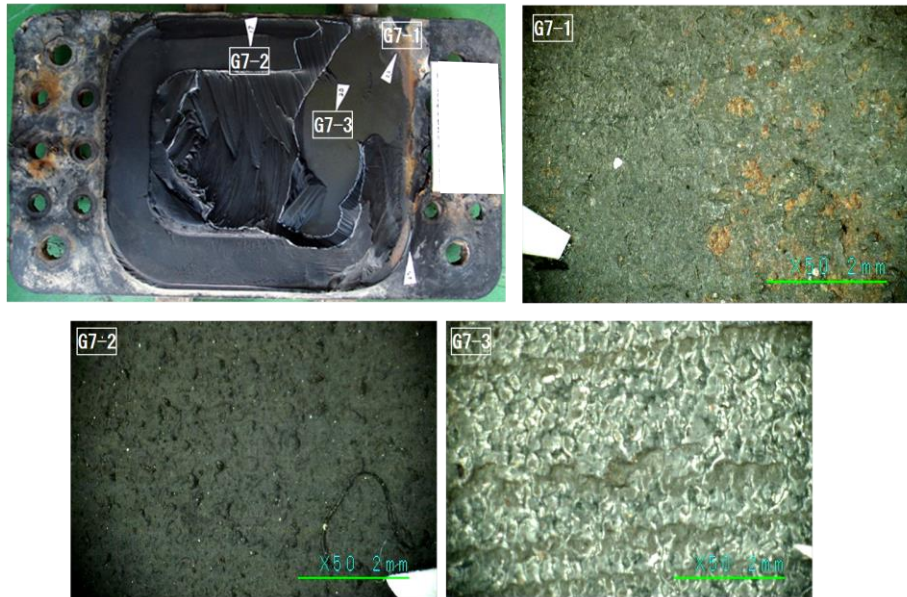
The fracture surfaces after the UD test were observed using microscope to explore the fracture mechanism. In general, several fracture patterns corresponding to the fracture mechanism of rubber are known, and the periodic striations associated with shear failure are typically observed. Figure 3.4 shows the fracture surface of the bearing sample G7 formed between the bottom plate and rubber layer. The image G7-1 was obtained on the outer edge of bearing involving rusted spots, image G7-2 was taken on the rubber side of the ring plate showing an almost flat fracture surface, and image G7-3 was observed on the surface of bottom plate having emerged due to the debonding between the bottom plate and rubber. The striation pattern is not found in those fracture surface images, including the other deteriorated bearing samples. This observation strongly suggests that the fracture in deteriorated bearings takes place on the area of adhesion between the steel plate and rubber.

Figure 3.4 Fracture surface of G7

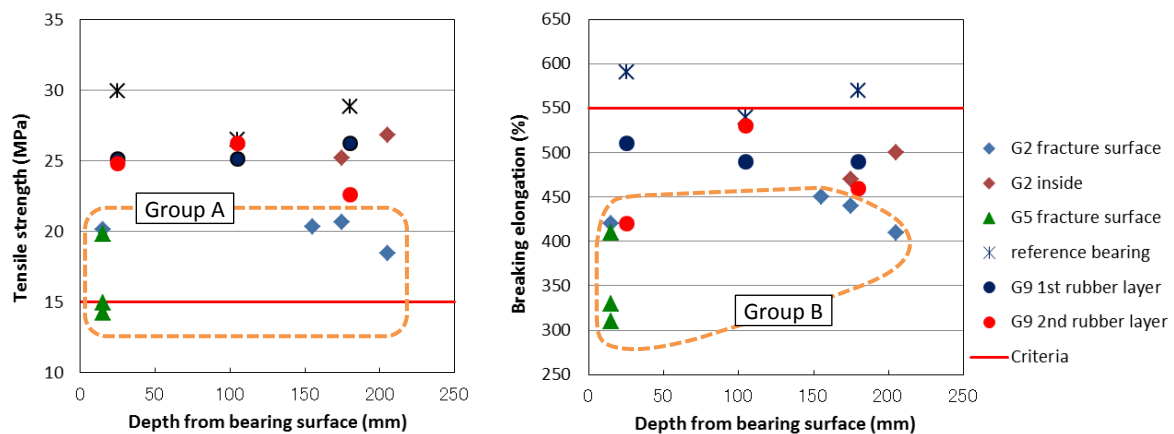
Figure 3.5 Results of tensile tests

The test result indicates that the strength and deformation capacity of the deteriorated bearings are lower than that of the reference bearings. It should be noted that the ultimate elongation capacity of the deteriorated bearings does not reach the criterion of 550%, implying that the degradation of the rubber is evident. Groups A and B in these plots correspond to the specimens taken from the fracture surfaces between the bottom plate and rubber, and the values of these groups consistently lower than the values of the other samples taken from different locations. In particular, since the samples of G5 were taken near the area where rust was seen, this result suggests that water or other external factors may contribute the deterioration process of rubber.

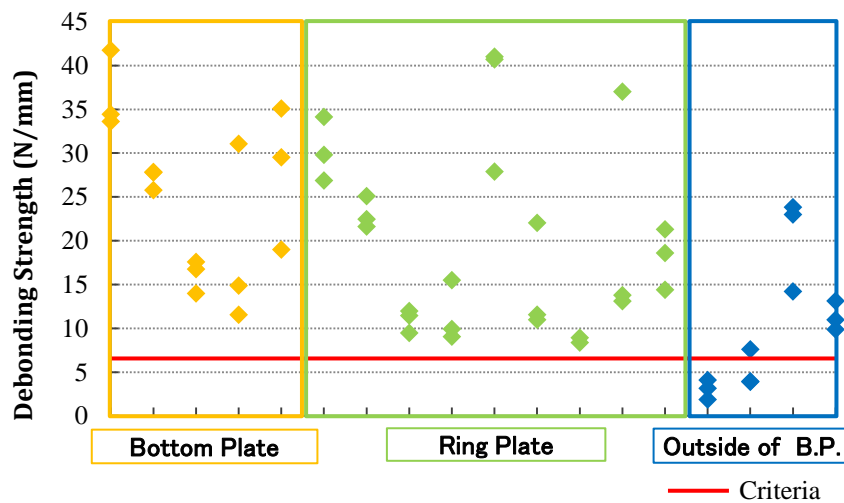
The adhesion debonding tests were conducted using the samples taken from the deteriorated and the reference bearings. All measurement results on the debonding strength are shown in Figure 3.6 indicating the difference of the debonding properties depending on the location. While the debonding strengths at the bottom plate and ring plate satisfy the requirement of 7N/mm specified in the manufacturing criteria, that at the outer bottom plate is not always sufficient. Figure 3.7 shows the photos of adhesion debonding tests at outside of the bottom plate of the deteriorated bearing G7 and reference bearing N0. In contrast to the smooth debonding surface of G7, a striation pattern is observed for the case of N0. These results suggest that the debonding strength of the bonding area in the deteriorated bearings is lowered by a loss of adhesive action.

Figure 3.6 Results of adhesion debonding tests

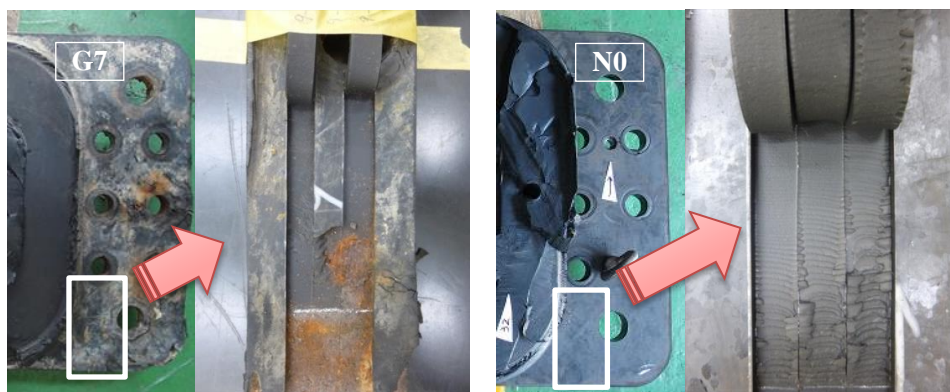
Figure 3.7 Appearance of outside of bottom plate in adhesion debonding test (Left: G7, Right: N0)

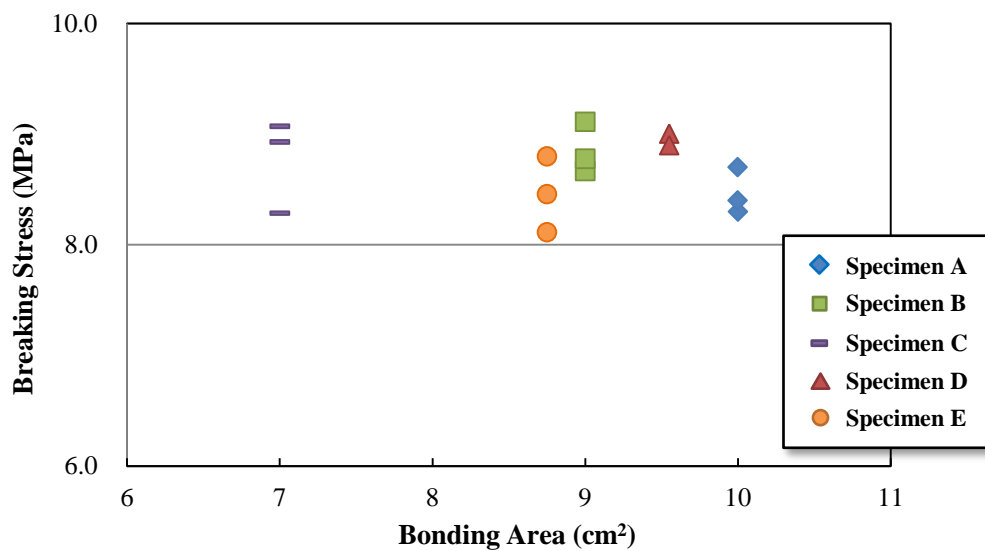
The difference of the failure stresses between the specimens is not significant. It is also noteworthy that the results of the specimen E are in the same range in spite of possible high stress concentration in the specimen E due to partly cutout. When a good bonding condition is ensured, the bonding between the steel plate and rubber is not regarded as a critical factor for the cause of rupture and failure of the bearing.

Figure 3.9 Results of lap shear tests

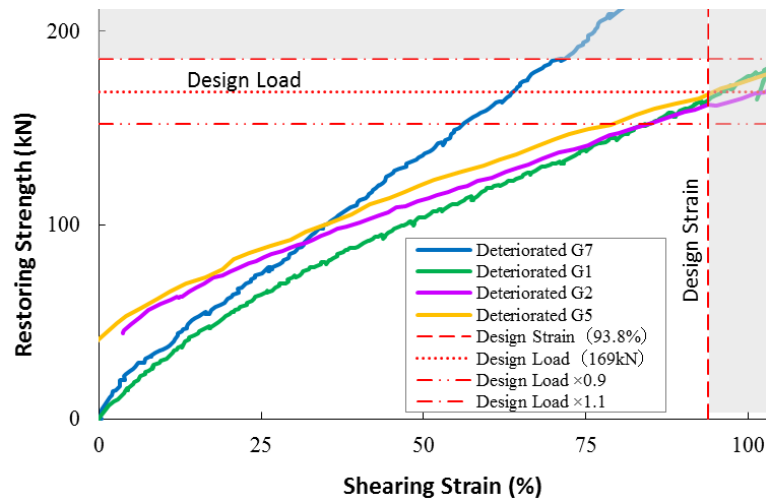
Figure 4.1 Design values and result of UD tests

Figure 4.1 shows the result of the UD tests in comparison with the design values. The strength of all deteriorated bearings exceeded the design load of 169kN, and the restoring forces at the design strain (93.8%) are found to be almost equivalent to the design load with a factor between 0.9 and 1.1, with the exception of G7. Therefore, the seismic residual performance of the deteriorated bearings is almost satisfactory with respect to the requirement for the Level 1 Earthquake. However, requirements for the Level 2 Earthquake (MCE) in the current seismic design specifications are yet to be investigated.
