Seismic Performance Evaluation of Nonstructural Components: Drywall Partitions

Tae-Hyung LEE, Mikiko KATO*, Tomohiro MATSUMIYA, Keiichiro SUITA,
and Masayoshi NAKASHIMA

Synopsis

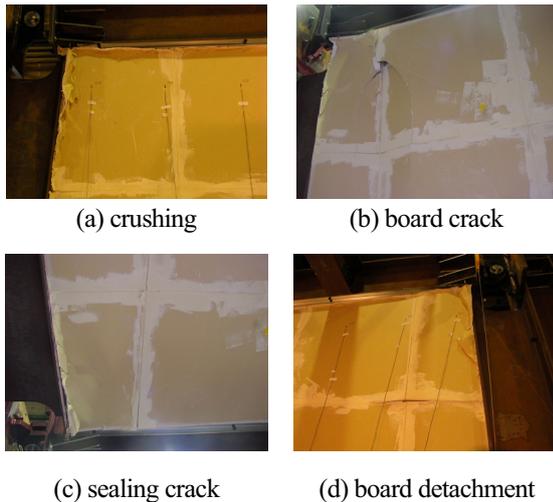
Fig. 5 Damage patterns.

This section describes the damage to the specimens observed by eyeball inspection, which is followed by the analysis of strain measurements. Observed damage patterns include crushing of boards, sealing cracks, board cracks, and out-of-plane deformation of boards whose parts around screws were crushed. Fig. 5 shows pictures of various damage patterns of the drywall partition.

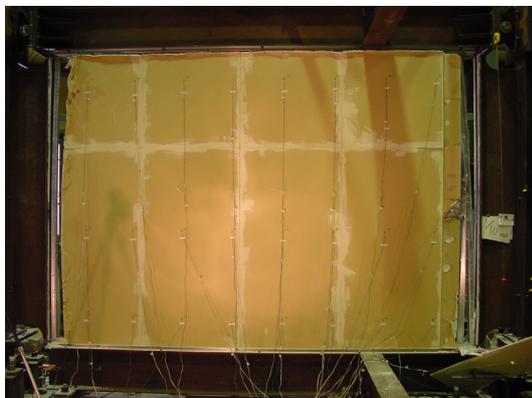
Fig. 6 Specimen No. 1 after the test.

No damage was observed in Specimen No. 1 as long as the story drift did not exceed 0.01 rad. The partition could slide without experiencing damage due to the connection detail of studs and runners and the initial gaps between the partition and the columns. The lateral rigid movement of the partition by 15mm (initial gap of one

side) in addition to the initial gap of 15mm on the other side prevented the partition from being damaged up to 30mm of the story drift that corresponds to 0.01 rad (30mm/2800mm). At 0.015 rad story drift, a room for the sliding was not available any more due to geometry and the column started to crush the neighboring gypsum board. Damage to the specimen is mainly due to compressions from the columns and beams, rather than the shear force. Fig. 6 shows a picture of Specimen No. 1 at the end of the last loading.

It is noted that the damage is concentrated at the boundaries of the partition, particularly the four corners, while the inside portion of the partition only suffers from relatively minor damage. To support this argument, the average strains of the inside portion, the boundary and the four corners of the partition are compared in Fig. 7(a),

Specimen No. 1 need not be repaired as long as the story drift is not greater than 0.01 rad because it only slid without being damaged. Therefore, at story drifts of 0.005 rad and 0.01 rad, which are considered the expected demands for Levels 1 and 2 earthquakes in Japan, respectively, no repair was needed. At the story drift of 0.02 rad, the cost ratio is already as high as 0.94. At the story drift of 0.04, the repair cost exceeds the initial cost. From the story drift of 0.015 to 0.04 rad, only

gypsum boards are to be replaced. At the 0.06 rad story drift, all parts except for the base steel frame are to be replaced. After the 0.08 rad story drift, the whole wall needs to be replaced and the cost ratio is 2.36.

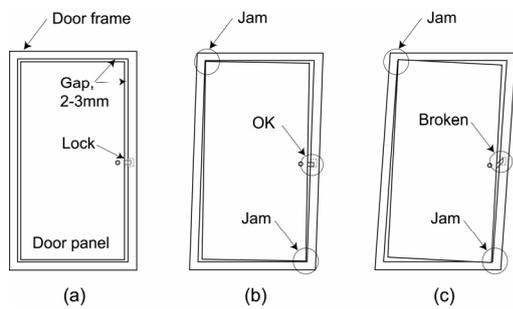
The feature of Specimen No. 2 is the door in the partition. The functionality of the door is of interest as well as damage to the partition for the safety issue. During the test, the door was jammed at story drift of 0.01 rad. As shown in Fig. 9(a), the gap exists between the door panel and the doorframe. At the story drift of 0.01 rad that causes 0.006 rad shear distortion of the doorframe itself, the gap was closed because of the rotation of the door panel to cause the door to jam, as shown in Fig. 9(b). However, when the load was removed to the zero story drift, the door panel and the doorframe recovered their original shapes and the door was working. At the story drift of 0.02 rad, the door lock was broken as well as the door jammed due to the door panel's rotation, as shown in Fig. 9(c). It was not recovered even at the zero story drift and the door was permanently jammed. It is noted that the shear distortion of the doorframe that caused this was 0.01 rad.

Fig. 9 Functionality of the door in the drywall partition; (a) initial configuration of the door; (b) deformation of the door under 0.01 rad story drift; (c) deformation of the door under 0.02 rad story drift.

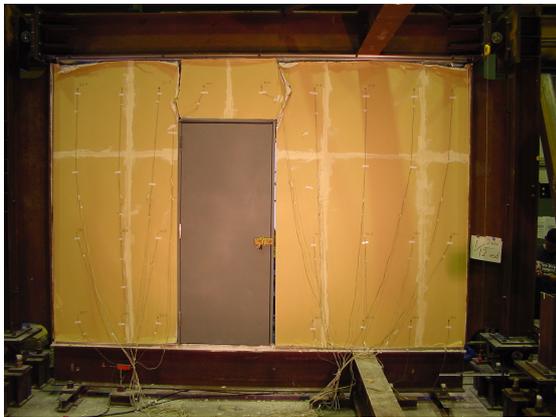
Fig. 10 Specimen No. 2 after the test.

Fig. 10 shows a picture of Specimen No. 2 after the test. It is clearly visible that the entire partition is completely divided into three panels by cracks: the left, above, and right side of the door. Fig. 11 shows the comparison of the average strains of the inside, boundary, and corners of the partition. Similar to Specimen No. 1, the corners suffer from higher strain than the other part of the partition up to the story drift of 0.02 where some of

Specimen No. 2 need not be repaired as long as the story drift is not greater than 0.005 rad. Some cracks were observed at the story drift of 0.005, but they were considered insignificant and not requiring repair. At the story drift of 0.01 rad, the cost ratio is 0.43. The cost ratio is 0.79 at the story drift of 0.02 rad, which includes the replacement of the doorknob. At the story drift of 0.04 rad, the repair cost exceeds the initial cost. After the 0.04 rad story drift, the door needs to be replaced, which causes an additional rise in the repair cost. It is noted that 50% of the initial cost of this specimen is the installation of the door. After the 0.06 rad story drift, the whole partition needs to be replaced and the cost ratio is 1.84.

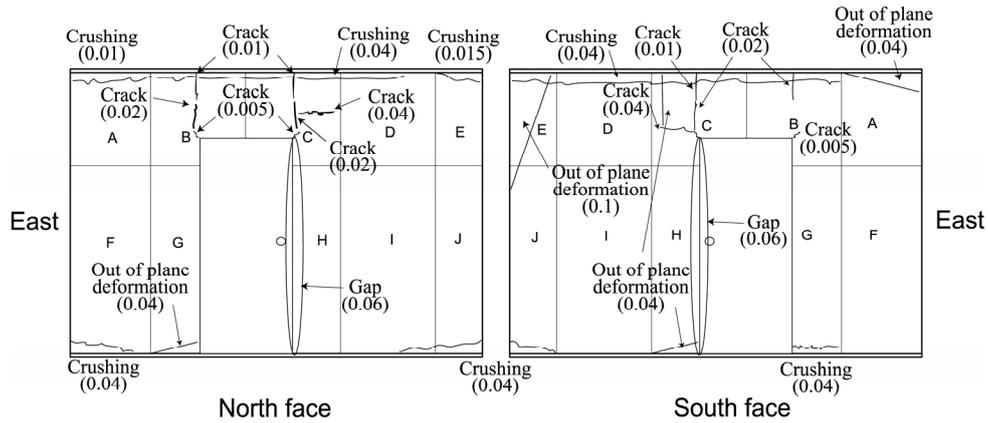
Fig. 12 Damage to Specimen No. 2.

the strain gauges at corners failed due to damage. Moreover, the boundary of the partition shows 150% higher strain than the inside. Damage to Specimen No. 2 is depicted in Fig. 12.

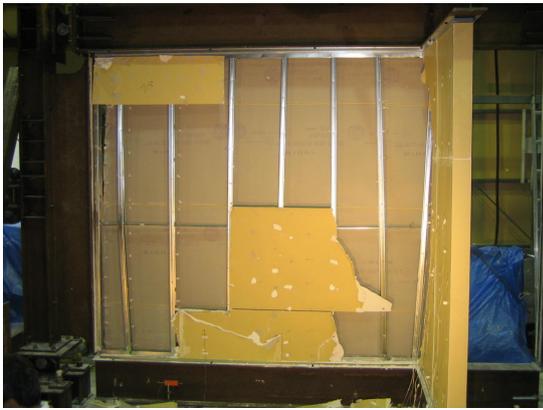
Fig. 13 Specimen No. 3 after the test.

The feature of Specimen No. 3 is an intersecting partition. The partition perpendicular to the loading direction is referred to as the orthogonal partition. The parallel (to the loading direction) partition did not show any significant damage up to story drift of 0.06 rad. At the next loading cycle (0.08 rad story drift) some of the gypsum boards were completely detached from studs and all the gypsum boards of the north face of the partition fell completely to the floor at the last loading cycle (0.1 rad). Fig. 13 shows the damage to Specimen No. 3. The damage to the orthogonal partition is relatively small. This is verified by the analysis of strain measurements.

Specimen No. 3 needs to be repaired as long as the story drift is greater than 0.0025, which is earlier than any other specimen. This is caused by the damage to gypsum boards and joint mixtures near the intersection of the parallel and orthogonal partitions. At the story drift ratios of 0.005 rad and 0.01 rad, the cost ratios are 0.08 and 0.24, respectively. At the story drift of 0.02 rad, the cost ratio is 0.85. From the 0.02 to 0.04 rad story drift, the orthogonal partition also needs to be repaired. From the 0.06 rad story drift where the repair cost exceeds the initial cost, almost all parallel partition needs to be repaired. However, this specimen does not require the whole replacement of the partition whose cost ratio is 2.02 because some parts of the orthogonal partition are intact.

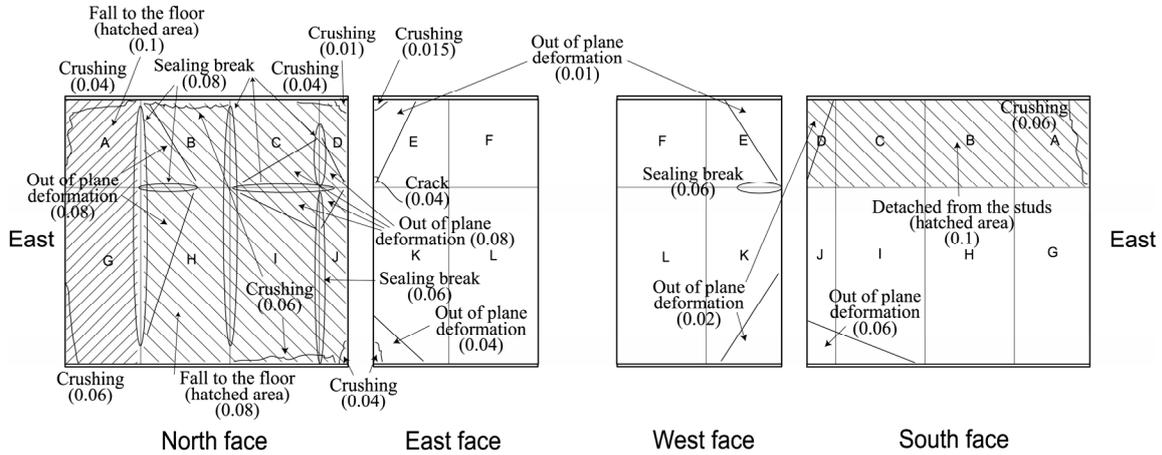
Fig. 15 Damage to Specimen No. 3.

Fig. 14 shows average strains of the parallel and orthogonal partitions. It should be noted that strain measurements near the intersection of the two partitions are excluded in the computation of the average strains. The average strain in the parallel partition is twice as high as that in the orthogonal partition. Damage to Specimen No. 3 is depicted in Fig. 15.

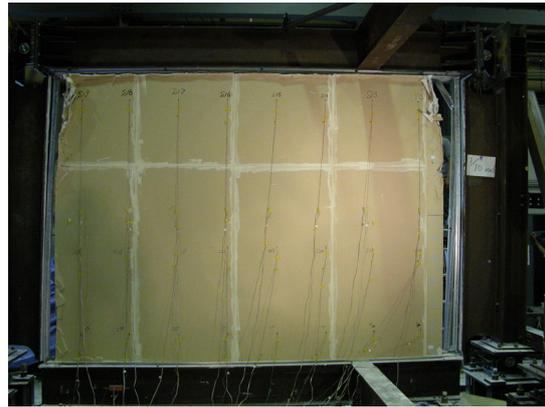
Fig. 17 Specimen No. 4 after the test.

amplitude of the story drift). The damage pattern is similar to that of Specimen No. 1 where the boundary of the partition is more damaged than the inside of the partition. Moreover, two gypsum boards were completely detached from the studs and fell to the floor. Fig. 16 shows average strains of the boundary, inside, and four corners of the partition. The trend of the plot is comparable to that of Specimen No. 1 in Fig. 7. A picture of Specimen No. 4 at the end of the test is shown in Fig. 17. Damage to Specimen No. 4 is depicted in Fig. 18.
