## Experimental Evaluation of Seismic Residual Performance for Deteriorated Rubber Bearings in Highway Bridges

**KEYWORDS:** Rubber bearing, Aging deterioration, Seismic residual performance

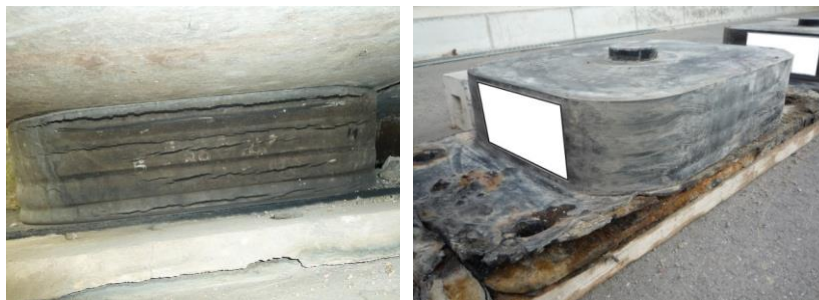
The bearings had been used in service for 27 years. As can be seen in Figure 2.2, surface cracks appear on the bearings because of aging deterioration of the rubber material over time. Moreover, the bottom plate suffered partial corrosion due to water leaked through the expansion joint.

Figure 2.2 Damage status and cracks of ring bearings

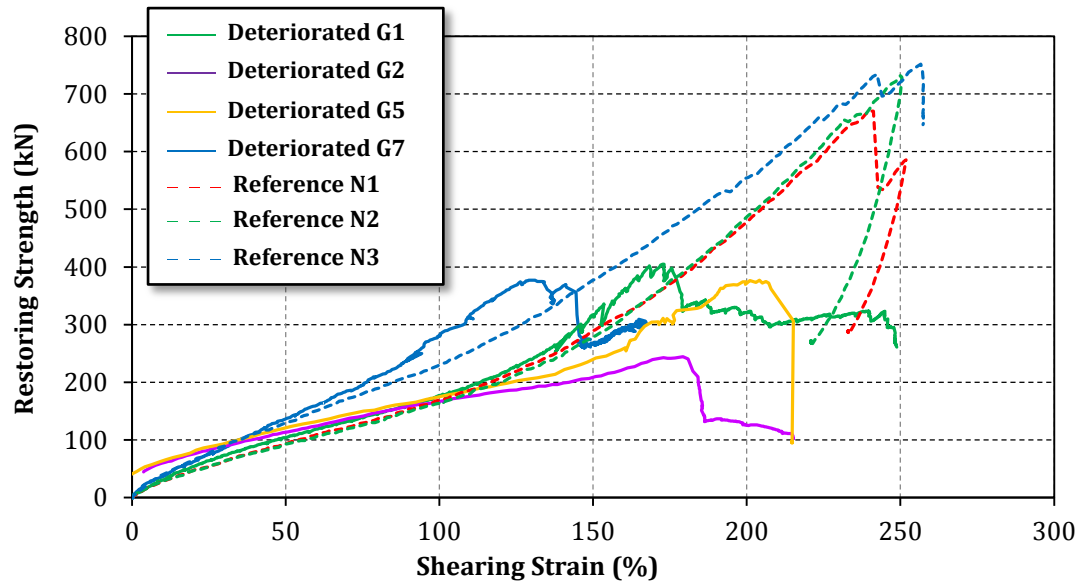
The restoring force curves obtained by the UD tests are shown in Figure 3.2. The reference sample bearings failed at 240% strain on average, satisfying the allowable shear strain requirement of 150%, although G7 failed at 131% strain. On the other hand, the failure of G1, G2 and G5 took place at shear strains exceeding 150%. Possible reasons for the variation in the failure strain among the samples include the difference in the progress of aging deterioration caused by environmental conditions in service period, manufacturing process or interaction between those factors.

Furthermore, the maximum restoring force of the four deteriorated bearings was 40% less than that of the reference bearing. Since the most influential factor to the load capacity degradation was inferred to be the aging deterioration, several supplemental tests had been conducted in order to evaluate the influence of the deterioration.

Figure 3.2 Result of UD tests

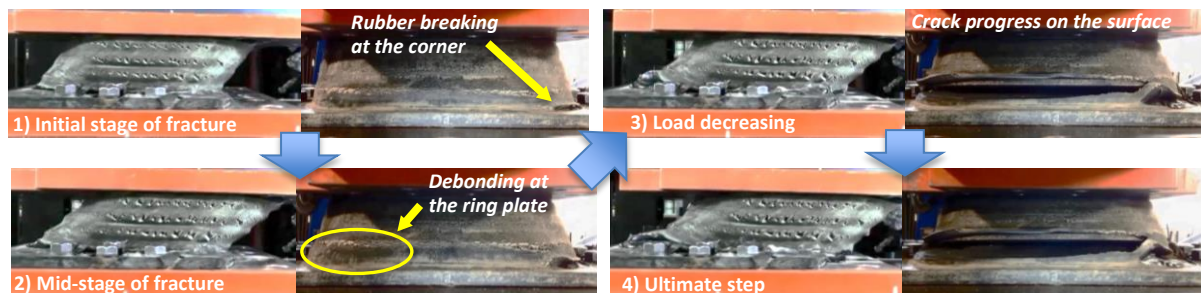
The onset of fracture and its progress were analyzed by the video image of the UD tests. The images of the G7 test are shown in Figure 3.3. Debonding began from the ring plate, followed by a gradual progress of cracking extended to the bearing surface, and then the ultimate state was reached. The fracture was induced along the boundary between the bottom plate and rubber. The process of fracture forming is identical for all the deteriorated bearing samples. On the other hand, the fracture forming in the reference bearings is different from this description. The fracture was induced within the rubber layer between lower ring plates as commonly assumed in the design of bearings.

Although many ozone cracks are generated in ring bearings during the regular service, any extension and growth of these cracks that cause fracture of rubber layers were not observed in the tests. Therefore, ozone cracks on the surface of the bearings are not considered to be a critical factor that affects the seismic performance or bearing fracture process.

Figure 3.3 Video capture of UD test in G7

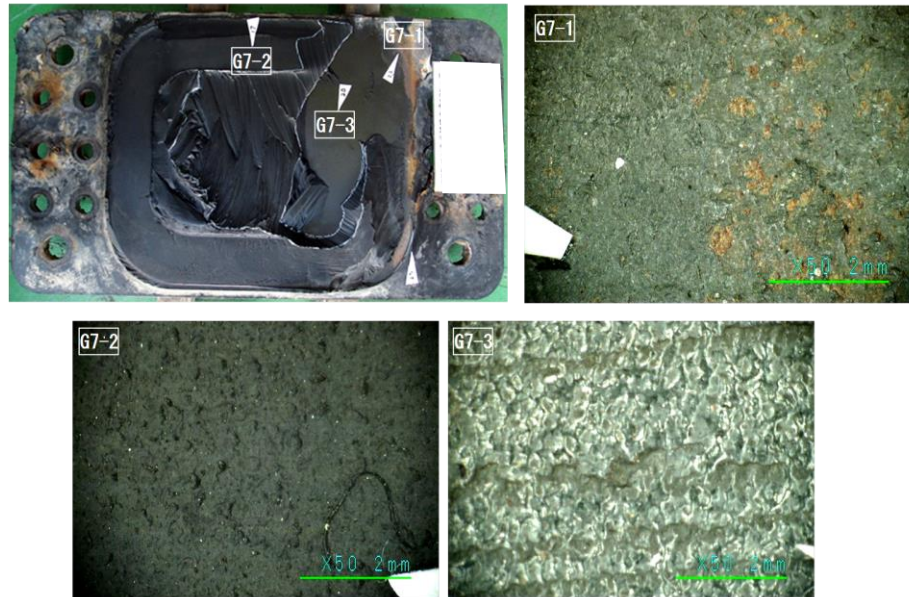
The fracture surfaces after the UD test were observed using microscope to explore the fracture mechanism. In general, several fracture patterns corresponding to the fracture mechanism of rubber are known, and the periodic striations associated with shear failure are typically observed. Figure 3.4 shows the fracture surface of the bearing sample G7 formed between the bottom plate and rubber layer. The image G7-1 was obtained on the outer edge of bearing involving rusted spots, image G7-2 was taken on the rubber side of the ring plate showing an almost flat fracture surface, and image G7-3 was observed on the surface of bottom plate having emerged due to the debonding between the bottom plate and rubber. The striation pattern is not found in those fracture surface images, including the other deteriorated bearing samples. This observation strongly suggests that the fracture in deteriorated bearings takes place on the area of adhesion between the steel plate and rubber.

Figure 3.4 Fracture surface of G7

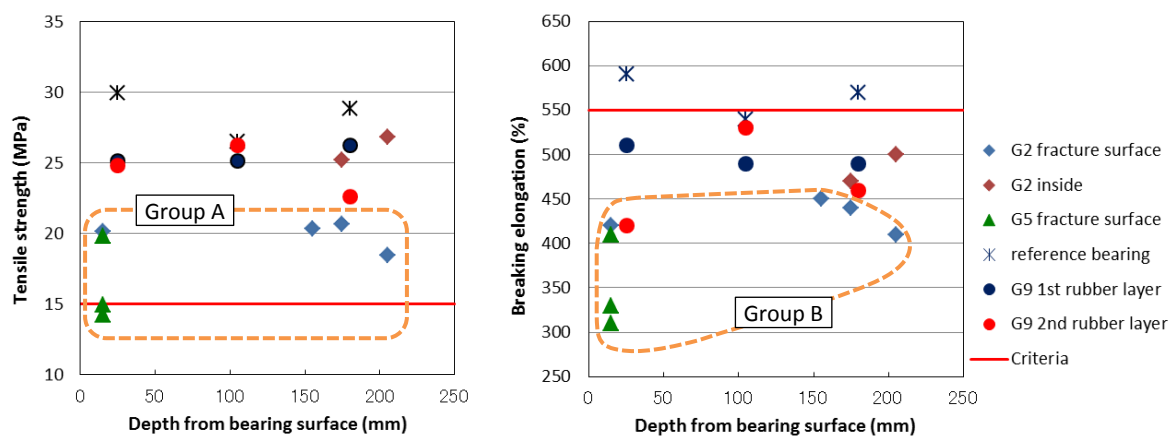
To evaluate the mechanical strength of the rubber, the tensile strength and the ultimate elongation capacity were measured by tensile tests. The tensile strength is defined as the maximum tensile force divided by the section area of the rubber specimen, and the ultimate elongation capacity is defined as the ratio of the ultimate deformation to the original length. Nine specimens were obtained from different layers of the deteriorated bearings and three specimens were sampled from the reference bearing. The obtained data of tensile strength and the ultimate elongation capacity are shown in Figure 3.5.

Figure 3.5 Results of tensile tests

Since the rubber samples taken from within the rubber layers of G9 are not subjected to significant aging deterioration, the load capacity degradation observed in the UD test cannot be elucidated by the hypothesis of aging deterioration of rubber material alone. On the other hand, the surface rubber of the bearing is more susceptible to aging deterioration due to exposure to water or air. It implies that cracks are easily induced in the surface rubber and the intrusion of water through the cracks may introduce corrosive action on the boundary between the bottom steel plate surface and neighboring rubber layer.

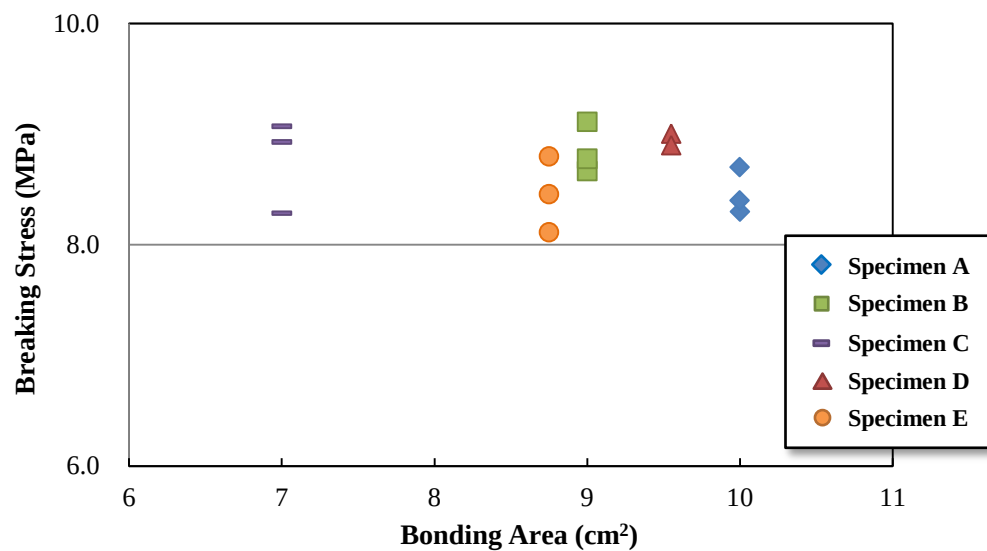
The lap shear tests were carried out to evaluate the influence of rubber surface cracks and debonding between the steel plate and rubber on the seismic performance of the bearing. As shown in Figure 3.8, five types of specimen (A~E) taken from differed distances from the bonding area and shape were prepared, and the failure strength in shearing direction were measured. The test results are shown in Figure 3.9.

The difference of the failure stresses between the specimens is not significant. It is also noteworthy that the results of the specimen E are in the same range in spite of possible high stress concentration in the specimen E due to partly cutout. When a good bonding condition is ensured, the bonding between the steel plate and rubber is not regarded as a critical factor for the cause of rupture and failure of the bearing.

Figure 3.9 Results of lap shear tests

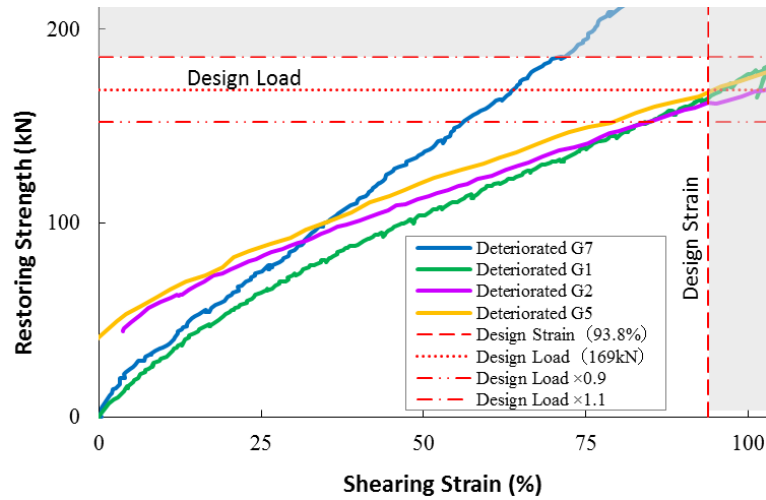
Figure 4.1 Design values and result of UD tests

Figure 4.1 shows the result of the UD tests in comparison with the design values. The strength of all deteriorated bearings exceeded the design load of 169kN, and the restoring forces at the design strain (93.8%) are found to be almost equivalent to the design load with a factor between 0.9 and 1.1, with the exception of G7. Therefore, the seismic residual performance of the deteriorated bearings is almost satisfactory with respect to the requirement for the Level 1 Earthquake. However, requirements for the Level 2 Earthquake (MCE) in the current seismic design specifications are yet to be investigated.
