- Outline of the earthquake and damage
- Damage to water supply facilities
- Unusual phenomena; an abrupt increase in flow rate and a decrease in water pressure of water distribution system in spite of no damage to pipelines
- Conclusions

## Characteristics of damage to water supply facilities

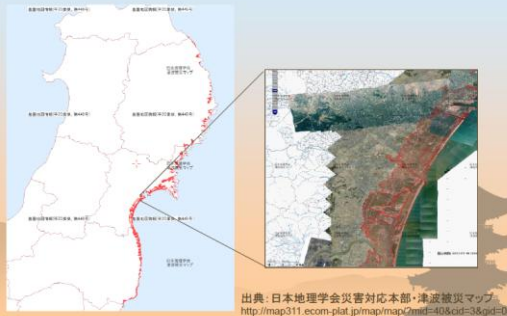
## Damaged area by tsunami

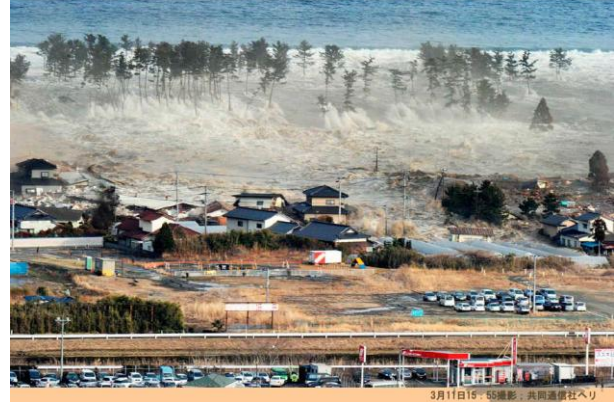
## Great tsunami hit residential area.

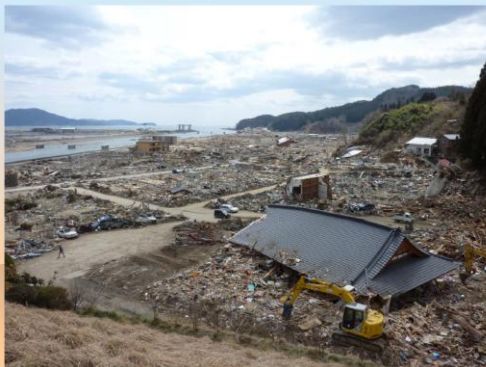
## Damage to houses

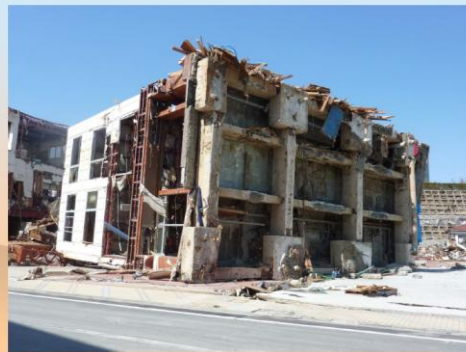
## Overturn of building

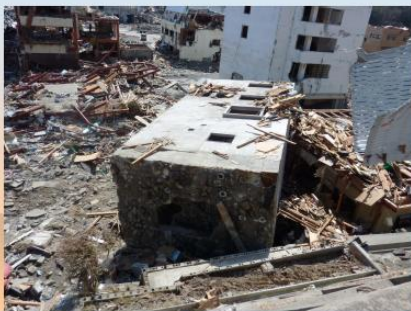
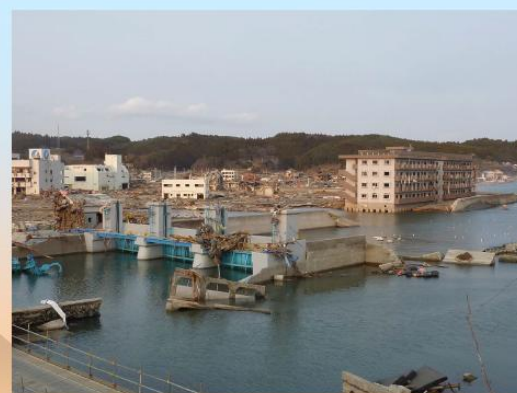
## Wash away and overturn of building

Most of RC buildings were not damaged severely even in coast area.

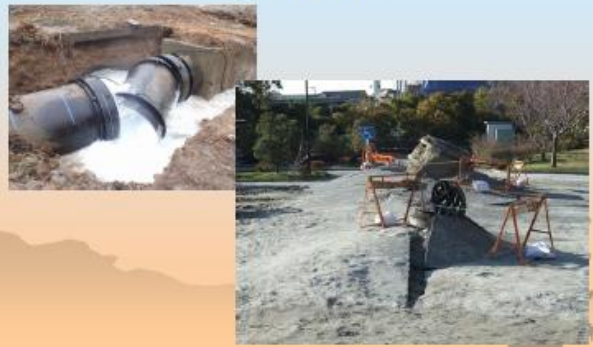
## Damage by ground shaking and liquefaction

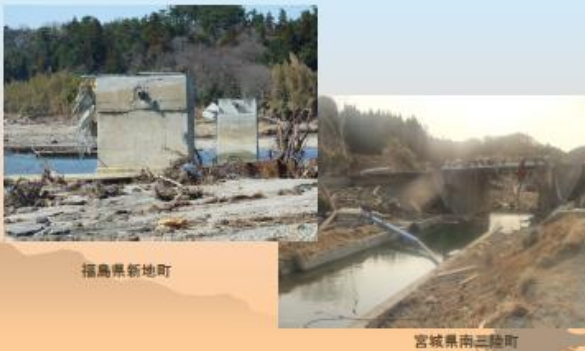
## Tsunami (Washing away)

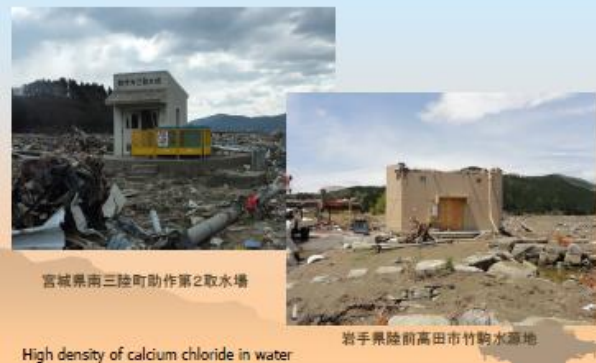
## Tsunami (Inundation)

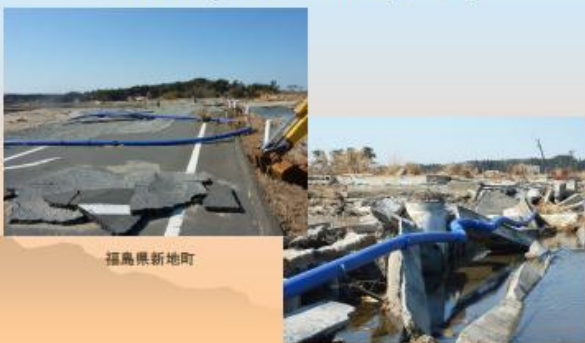
## Damage by tsunami (Scouring and washing away)

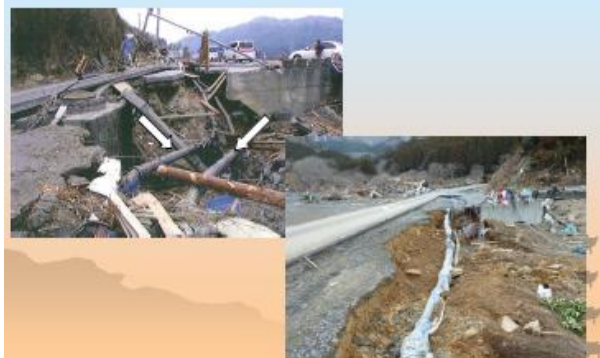
## No damage to earthquake-proofing pipe

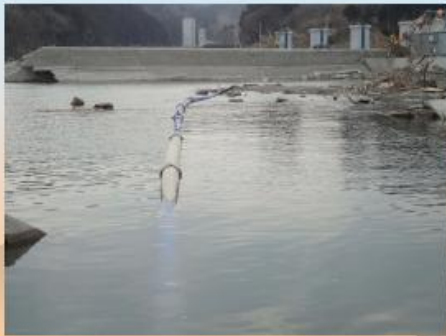
## No damage to earthquake-proofing pipe

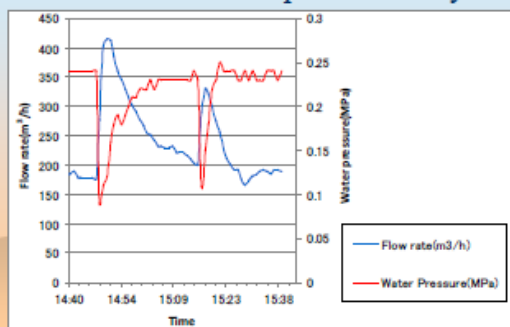
## Flow rate and water pressure at a water distribution plant of Tokyo

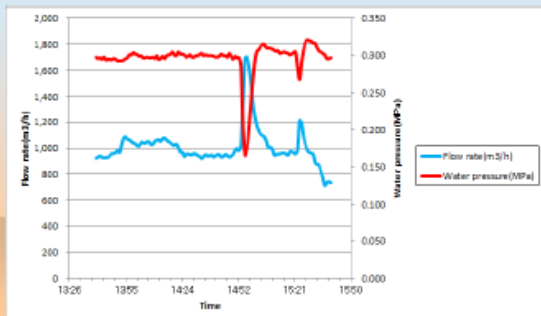
## Flow rate and water pressure at a water distribution plant of Osaka

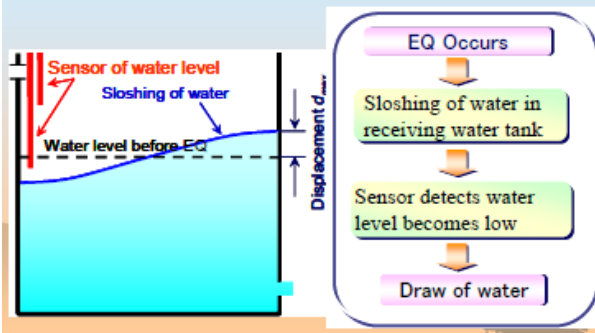
## Mechanism of draw of water

- If sloshing of water in receiving water tank is occurred by an earthquake, draw of water to receiving water tank from pipeline starts by error of sensor of water level in the receiving water tank. Sloshing of water in receiving water tank, therefore, seems to be one of the causes of unusual phenomena.
