# Failure of a Cut Slope and Deterioration of Shear Strength due to Weathering

*Akitoshi Mochizuki, Professor Emeritus\*<sup>1</sup>, Dr. of Eng., Graduate School, Tokushima Univ., Japan*  
*Xianfeng Ma, Associate Professor \*<sup>2</sup>, Dr. of Eng., Dep. of Geotechnical Eng., Tongji University, China*  
*Sreng Sokkheang, Researcher\*<sup>3</sup>, Dr. of Eng., R&D Center, Nippon Koei Co., Ltd., Japan*

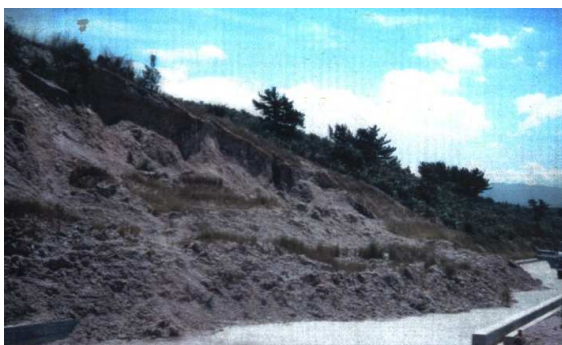
Fig.1 Picture of the slope failure

In this paper, a failure of a cut slope, which was constructed as part of a new local road through hills constituted of stiff clay of the Osaka Marine Clay group in the southern part of Osaka, Japan is investigated. The slope's gradient was 1:1 and had a berm at a height of 10m measuring 50m length for a new local road. Four months after cutting of the slope, in early spring, a 25m wide portion of

the slope collapsed. Fig.1 shows a photo at the site of the slope failure. Site investigations using sounding method and laboratory tests were carried out in order to study the cause of this failure.

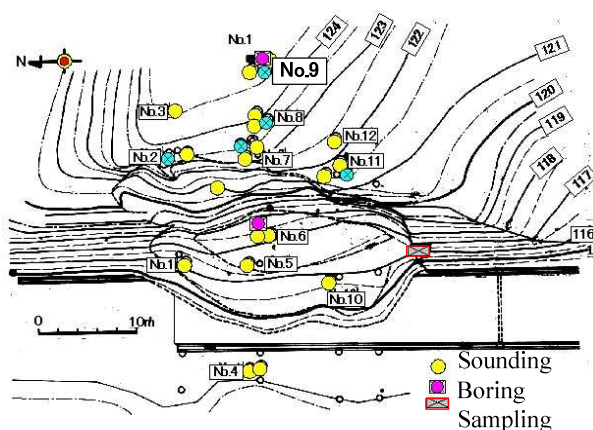
Fig. 3 Topographic map of failure site

Fig.3 shows a plan of the area around the landslide and the location of *in-situ* sounding tests.

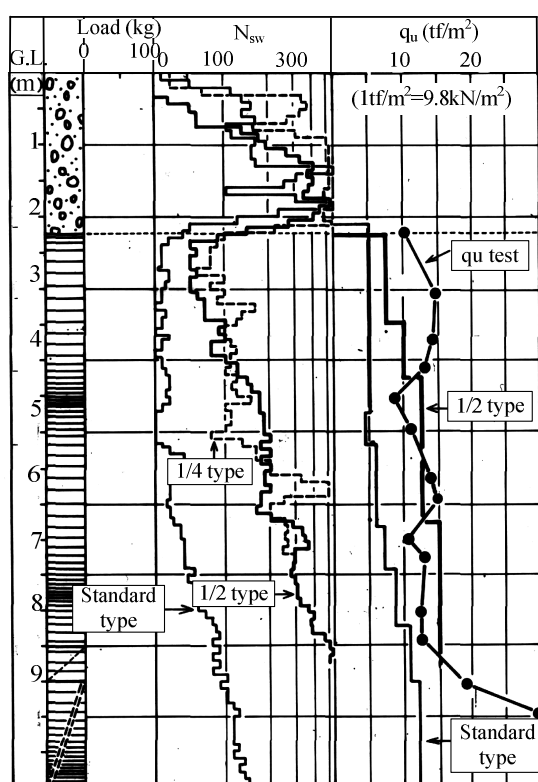
Fig. 4 Drilling log at point No.9

The profile of borehole No.9, whose location is shown in Fig.3, is presented in Fig.4 as a representative soil profile of the hill. A layer, measuring almost 2m thick, of dense white-brown gravel with maximum particle size of less than 50mm covers the *Ma-8 stiff clay layer*, which is approximately 6m thick. This clay is grey-blue when fresh but changes to a white-brown color shortly after drying and also develops cracks and flakes propagating at the surface of the slope. Alternately there are thin silty-clay layers with a small amount of fine sand, and thin sandy-silt layers underlie the stiff clay. Although vegetation was planted, grass growth was poor due to the presence of sulfur in the clay.

The slip surface observed was to pass through P-1 crossing the lower boundary of the Ma-8 Clay layer, coming up towards the top of the slope as shown by a dotted line in Fig.4.

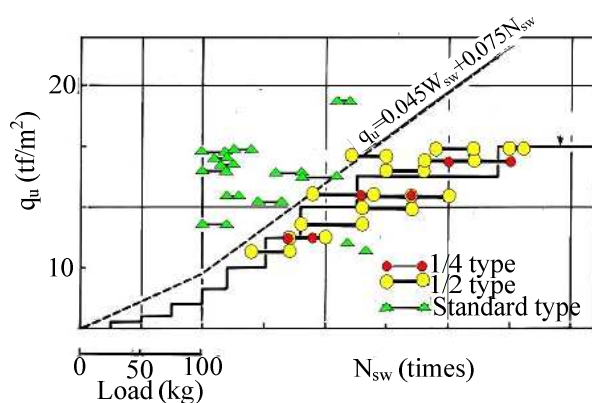
Fig. 5 Relationships of  $N_{sw}$  to  $q_u$   
: Swedish sounding test

Fig.5 shows a correlation between strength of unconfined compression tests ( $q_u$ ) and the half-rotation number obtained from the sounding test ( $N_{sw}$ ) at borehole No.9. The value of  $N_{sw}$  is plotted by a pair of symbol marks against  $q_u$ -value since  $N_{sw}$  was observed at every 10 cm, whereas  $q_u$  was measured every 50cm to 100cm.

A step-like relationship between  $N_{sw}$  and  $q_u$  for the sounding test with 1/2 of the standard weight, as shown in Fig.5, is adopted. The dotted line in the figure was presented by Inada (1954) for the standard tester, however, this equation gives comparatively higher  $q_u$ -values than results obtained from an unconfined compression test carried out on the clay.

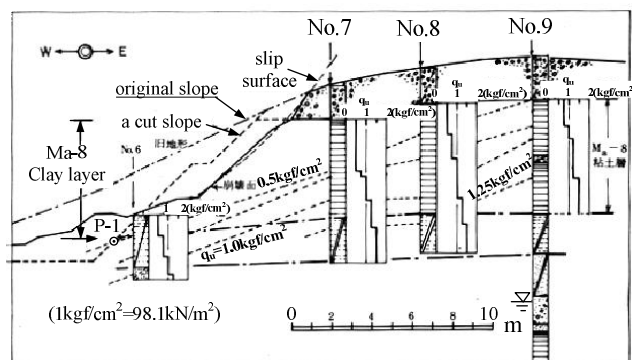
Fig. 6 Cross section of the slope and strength distribution

Fig.6 shows a cross-section through the central part of the landslide and the strength distribution of the sounding tests. Broken lines with dots separate zones with an increment of  $0.25 \text{ kgf/cm}^2$  ( $\div 25\text{kN/m}^2$ ) of  $q_u$ . These show values observed by the sounding tests. It is found that strength contours in the clay layers are almost parallel to the original topography, though the Ma-8 clay layer is located almost horizontally, namely, the parallel distribution of strength to the original topography is expected to be. It is supposed that some degree of weathering must have taken place as the decrease of the strength which should occur perpendicularly to the original hill surface.

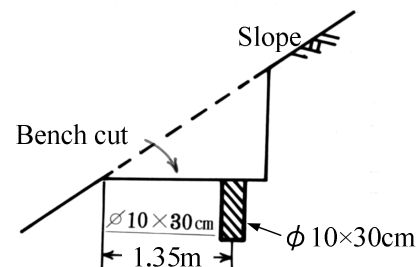
Fig.8 Bench cut and sampling tube

Un-weathered and undisturbed samples for a series of direct shear tests were taken from borehole No.9 and others were taken from the horizontal surface of a bench cut near the failure zone by driving thin walled tubes measuring 100mm in diameter and 3000mm in length (see Fig. 8). Samples from the bench cut shown had a light-brown color suggest

ing that it weathered more than those sampled from the borehole.

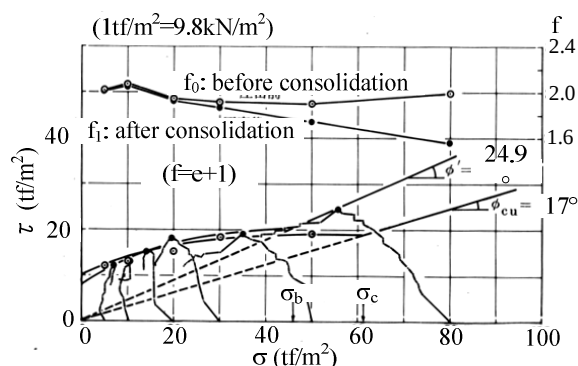
Fig.9 Relationships of shear stress to vertical stress and strength curves: Test-A (CU-test)

Table 2 shows the testing program, and procedures followed for the JGS guide line on the CU-test using the direct shear apparatus (Takada, 1993). Fig.9 shows the effective stress path of tests obtained in terms of shear stress,  $\tau$ , and vertical effective stress,  $\sigma'$ . The strength parameters,  $c'$  and  $\phi'$ , are obtained from a strength envelope connecting  $\tau_{max}$  and  $\sigma'$  on stress paths. The envelope line is divided into two parts at a stress of  $\sigma'_b$ , where the stress  $\sigma'_b$  is the stress representing influence of consolidation yield stress (Mochizuki, 1996). It is known that the envelope generally shows an upward curve for a stress range less than  $\sigma'_b$ , whereas a higher strength stress range than  $\sigma'_b$  gives a straight line which passes through the origin of the graph.

Hence, the strength parameters,  $c_{cu}$  and  $\phi_{cu}$ , are obtained from an envelope passing through stresses characterized by the maximum shear stress,  $\tau_{max}$ , and the consolidation stresses of soil,  $\sigma'_0$ . The envelope for CU-condition is also divided into two parts at a stress of  $\sigma'_c$ , showing an upward curve for  $\sigma > \sigma'_c$ , and a straight line for  $\sigma'_c > \sigma$ . Here, stress,  $\sigma'_c$ , is named as 'yield stress from a CU-shear test', and is regarded as being equivalent to the consolidation yield stress,  $\sigma'_y$ . This test denoted as Test-A, and the strength obtained is termed as Strength-A, which will be dealt with as an index strength for Strength-B to E, which will be shown in the following section. 2.4

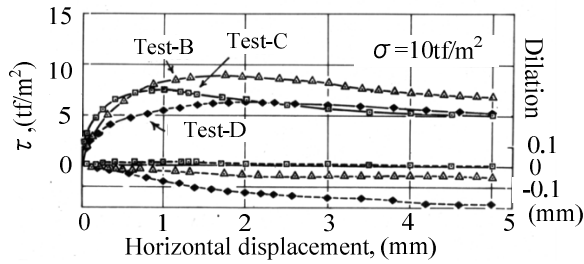
Fig.10 Relationships of shear stress to displacement: *Test-B, C, D*

Fig.10 shows stress-strain curves for Test-B to Test-D. Fig. 11 shows shear strength,  $\tau_f$ , plotted against consolidation stress,  $\sigma_0$ , and the strength envelopes from all of the tests. Results of unconfined compression tests,  $c_u$  ( $=qu/2$ ) are also plotted. These envelopes show a decrease in strength from Test-A to Test-E. At stresses higher than  $\sigma'_b$ , the  $\phi_d$  defined by Test-B, -C and -D ( $\phi_d=27.6^\circ$ ) almost coincide with  $\phi'$  of Test-A ( $\phi'=24.9^\circ$ ), whereas  $\phi'$  is slightly smaller. It is found that curves in a stress level less than  $\sigma'_b$  are almost parallel corresponding in Strength-B to D. Strength-B shows almost half shear strength of Strength-A, and Strength-D is almost a quarter of Strength-A.

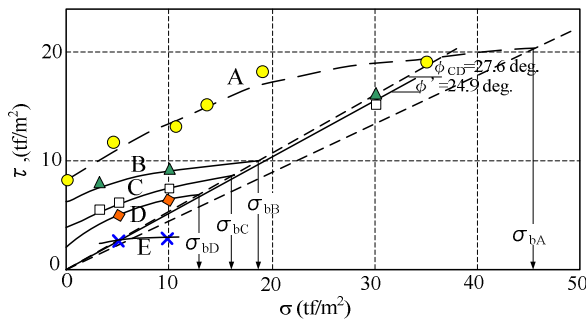
Fig.11 Strength curves obtained from *Test-A to E*

Residual strength is found to be smaller than Strength-D, and shows much smaller inclination of the strength curves. It is apparent that the residual strength does not belong to the scheme of strength curves in other tests.
