## Landslides in Kisawa area, Tokushima Prefecture during the 2004 Typhoon Namtheun

Gonghui WANG, Akira SUEMINE, Gen FURUYA,  
Masahiro KAIBORI\*, and Kyoji SASSA

### Synopsis

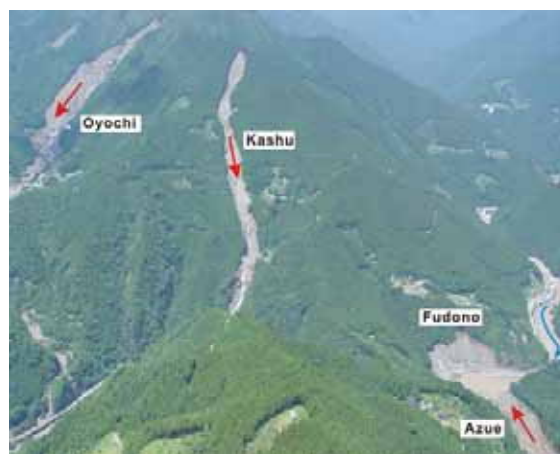
The Oyochi and Kashu landslides occurred on the same ridge and side of the mountain (Photo 1).

Photo 1 Oblique aerial view of the Oyochi, Kashi, and Azue landslides (photo by Shikoku Development Bureau, MLIT, Japan)

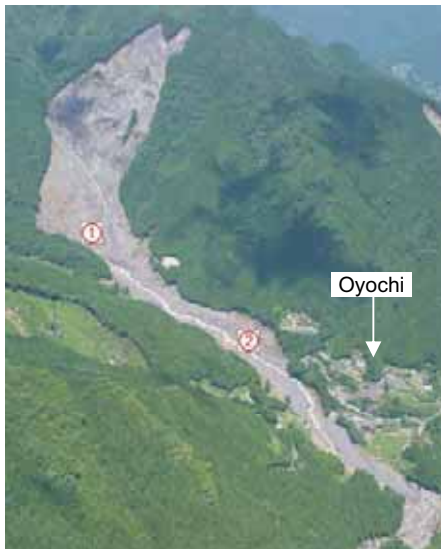
Oyochi landslide was triggered mid-slope on the mountainside, about 1 km from the Oyochi settlement (Photo 2) at approximately 20:30 hr, August 1. Two people were caught up in this landslide, and their bodies have not been found. The head scarp is situated at an altitude of about 1000 m, while the join of the slope to the Oyochi valley is about 560 m. The slope angle averaged 34 degrees. The displaced materials of about  $0.5\sim 1 \times 10^6 \text{ m}^3$  from the cover and weathered bedrock moved downslope to the river, and hit the opposite side of the channel. A part of the displaced mass crossed a ridge on the opposite slope (area ① in Photo 2), and transformed into a large debris flow, traveling a further 2 km along the valley (area ② in Photo 2). In this area, the bedrock is mainly composed of greenstone and serpentinite with visible cracks. Immediately below the source area, the displaced mass is meters thick, and contains some huge boulders (Photo 3). The deposited mass could be liquefied by stamping feet, indicating the highly liquefiable character of the landslide materials.

Photo 2 Oblique aerial view of Oyochi landslide (photo by Shikoku Regional Development Bureau, MLIT, Japan)

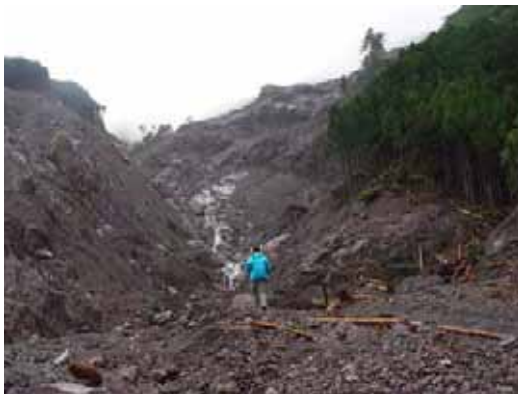
Photo 3 Deposits of landslide mass at Oyochi

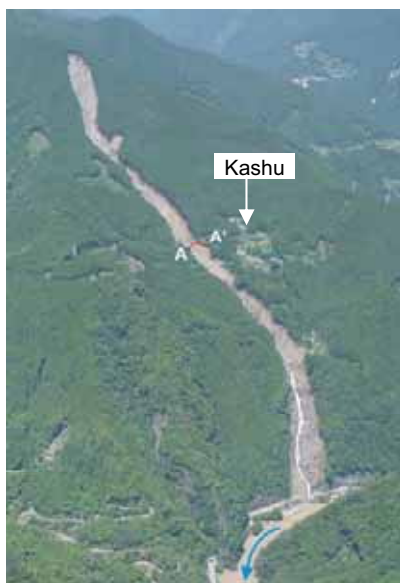
Photo 4 Oblique aerial view of Kashu landslide (photo by Shikoku Regional Development Bureau, MLIT, Japan)

Kashu landslide (Photo 4) occurred on the same slope near the Oyochi landslide, and almost at the same time as the Oyochi event. The head scarp is situated at an altitude of about 910 m, while the altitude of river floor is about 300 m. The slope angle averaged 27 degrees. According to a local resident, Kashu landslide started on the lower valley slope near Kashu settlement (below A-A' in Photo 4), and was followed by another two failures, finally retrogressing almost to the ridgeline of the mountain on August 2.

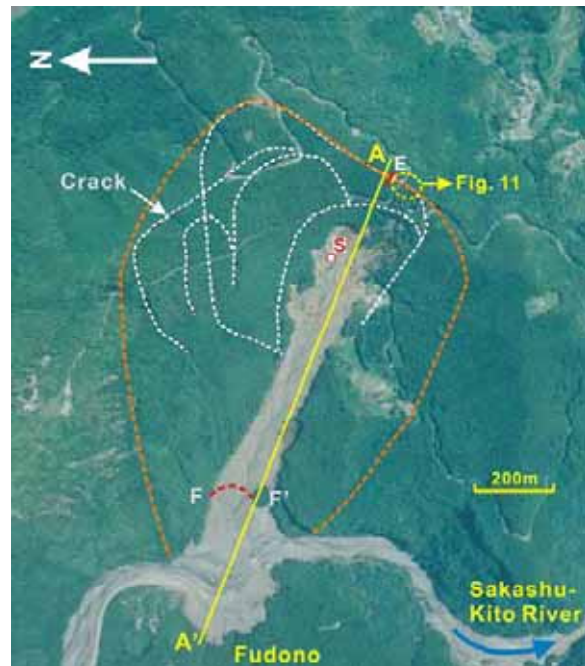
Photo 5 Oblique aerial view of Azue landslide and the unstable blocks after the August 1, 2004 event (photo by Nakanihon Sky Service Station, Japan). The broken brown line outlines the area of the ancient landslide

Azue landslide is located on the left side of Sakashu-Kito River, in front of the Kashu landslide (Photo 5). A remarkable scar indicating an ancient landslide is also visible at the same site (Photo 5 outlined approximately by the brown broken line). We also found a small-scale linear depression on the mountain top during our survey. The new landslide occurred near the southern boundary of the old landslide scar within the weathered bedrock layer. Azue landslide has a width of about 130 m, a horizontal length of about 1 km, and a depth ranging from 10 to 20 m. The volume of the displaced material was estimated to be about  $1\sim2 \times 10^6 \text{ m}^3$ . The displaced material slid down the slope, crossed the river, and rose up the opposite mountain slope to about 30 m (immediately below the Fudono area), destroying and carrying away the Fudono bridge, which was built on the national road (Photo 6).

We were told that a landslide occurred 5 years ago on the area below the curve of F-F' shown in Photo 5, also during heavy rain. We noticed that a smooth surface of relatively hard bedrock crops out (below F-F' on Photo 5), which strikes N45°E and dips north (Hiura, et al, 2004). We infer that this surface formed an impermeable or less permeable layer, which facilitated a rapid rise in the local ground-water table during the storm, which in turn triggered the slope failure.

Above the main scarp of Azue landslide, another huge block moved slightly. After the landslide, numerous cracks with significant displacements were found on the slope above the main scarp (and along the scarp of the old landslide). The white dashed lines that were made basing on the observed cracks outline the boundary of each landsliding sub-block. The road on the left hand side of the old landslide scar was severed by a crack, where there was subsidence of about 2.0 m (Photo 7). The subsidence increased to 2.5m over about two weeks. It exposed a well-consolidated sliding surface of the old landslide (see Photo 8), which originated in the bedrocks and strikes N44°W and dips 48°W.

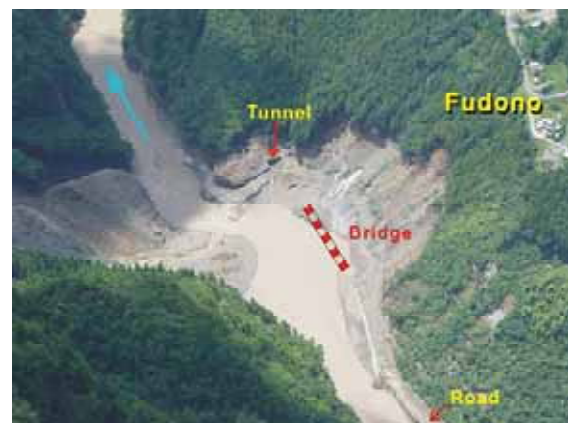
Photo 6 Oblique aerial view of the Fudono area after the landslide (photo by Shikoku Regional Development Bureau, MLIT, Japan)

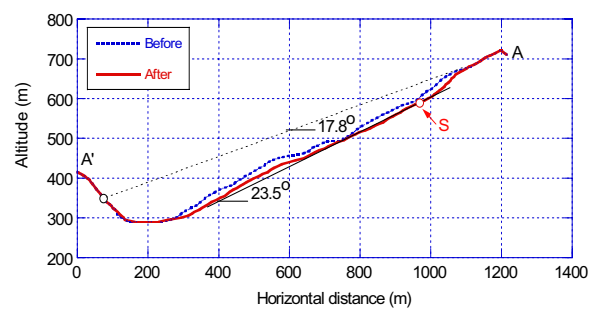
Fig. 4 Longitudinal section of the Azue landslide (A-A' in Photo 5; S is sample point for grain size analysis and ring-shear test)

A longitudinal section of the landslide (Fig. 4), was plotted using data from an airborne laser scanner after the failure (performed by Aero Asahi Corporation), and the pre-failure topography was obtained from a forest map with 2-m contour. The landslide originated on a slope of approximate 23.5 degrees with an apparent friction angle of about 17.8 degrees (Fig. 4). From the travel distance and the height reached on the opposite slope, the speed of the displaced landslide material was estimated to be very fast ( $>20 \text{ m/s}$ , Hiura, et al, 2004).

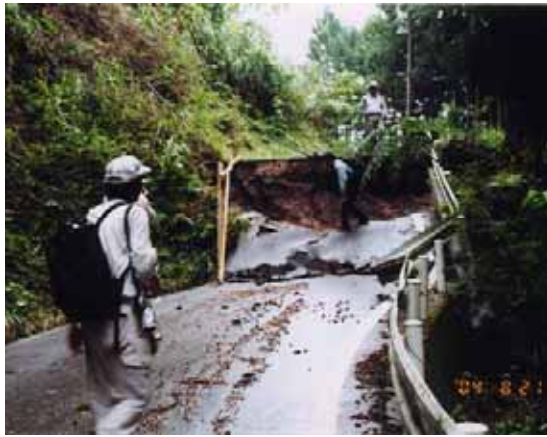
Photo 7 Subsidence on the left hand side of the landslide locating on the upper part of the Azue landslide scarp (yellow dashed region in Photo 5)

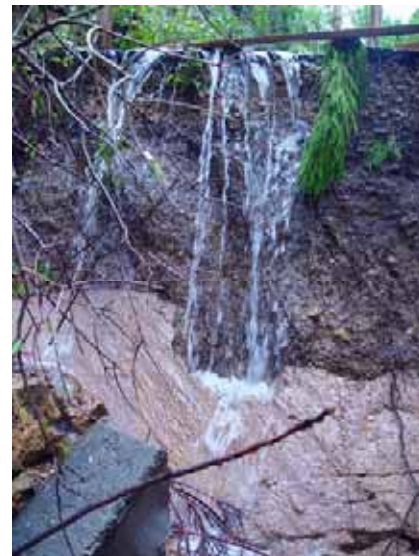
Photo 8 Exposure of the sliding surface beneath the old landslide. The materials above/below the sliding surface are weathered green stone

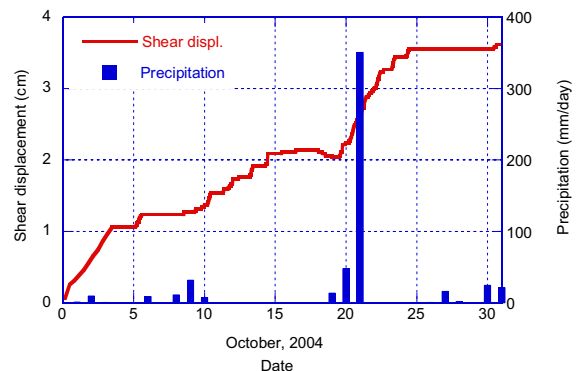
Fig. 5 Observed shear displacement and daily precipitation on October 2004 for the unstable block above the Azue landslide

Preliminary bore-hole data indicate that the unstable block ranges from 20–50 m in thickness. Therefore, the unstable landslide mass was estimated to be in the order of  $10^6 \text{ m}^3$ . This landslide mass is still deforming, and measured displacements by the installed extensometers show that its movement is very sensitive to rainfall. This can be seen from Fig. 5, where the monitored shear displacement on October 2004 by means of an extensometer located on point E in Photo 5 is plotted together with the daily precipitation. A detailed account the deformation of this landslide mass is beyond the scope of this report and will be presented elsewhere.

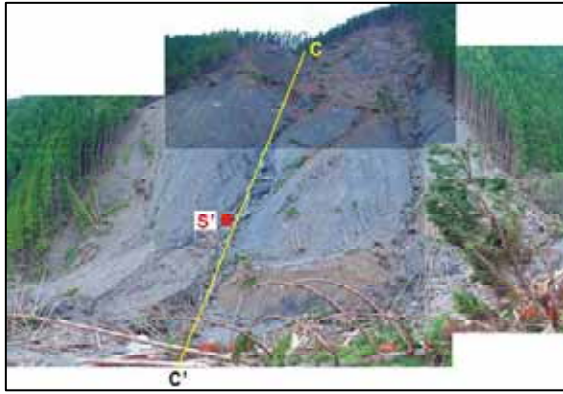
Photo 9 A general view of Kamagatani landslide. S' marks the sample site, and the red dashed cycle marks the site of Photo 10

Kamagatani landslide (Photo 9) is located on the right slope of the valley of Kamagatani River, the upper tributary of Sakashu-Kito River. This landslide is about 7 km north of the three landslides discussed above.

The landslide originated on a slope of about 33 degrees. It has a width of 120 m, a length of 200 m, and a depth of 10–15 m. The displaced landslide mass was estimated to be about  $2 \times 10^5 \text{ m}^3$ . The source area consists of mudstone, which is overlain by sandstone and ancient colluvial deposits. The failure occurred within the outer layers of these strata. In the middle part of the source area, a ridge-shaped roll existed, suggesting the presence of hard rock. A large amount of groundwater discharges near the mudstone-

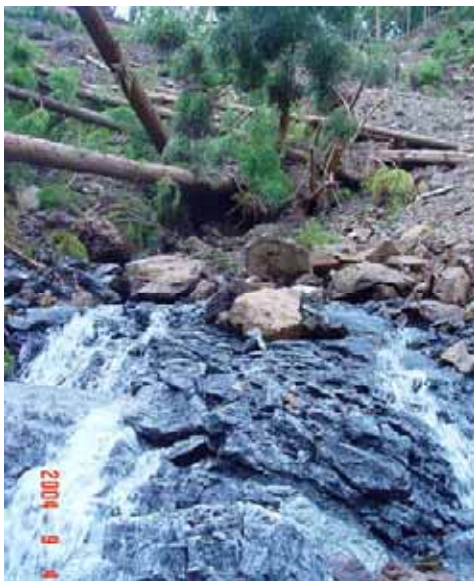
Photo 10 A close view of the location marked by the red dot in Photo 9. This is the location of the cool ground-water resurgence

sandstone boundary (Photo 10). The landslide carried away a soil-conservation (check) dam that previously stood on the toe of the slope. A large block of concrete from the dam is now on the top of the slope ridge on the opposite slope across the valley (Photo 11). This is where we placed the total-station measurement system to measure the landslide's longitudinal profile (point C' on Fig. 6). The displaced soil mass reached and dammed Kamagatani River. The landslide dam had been eroded by the river before our investigation, but we have inferred from the deposit profile remaining on the river banks that the displaced material was deposited with a final slope angle of about 9 degrees. From the height of the concrete block and elevation of deposits on the slope opposite to the landslide, the displaced landslide material was estimated to have had a speed greater than 17 m/s when it reached the valley bottom.

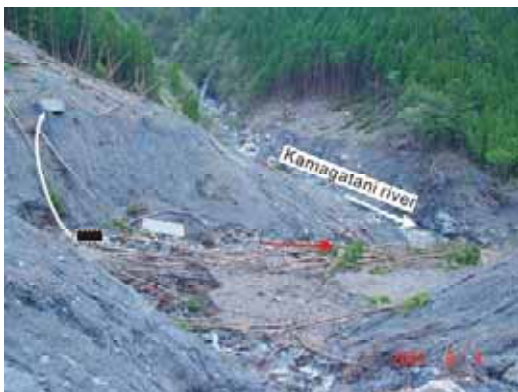
Photo 11 A displaced concrete block from the soil-conservation (check) dam (Black area outlined by the broken white line) on the slope opposite the landslide source (Red arrow: downstream of the valley; White curved arrow: move direction of the block)

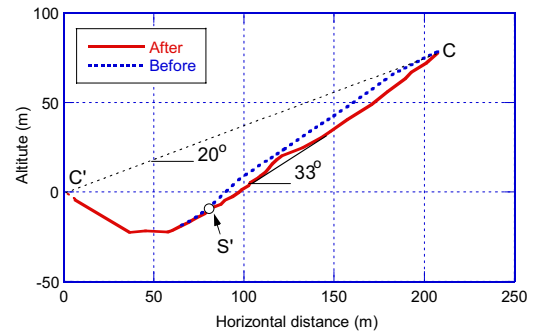
Fig. 6 Longitude section of the Kamagatani landslide (S' is sample point; the pre-failure topography was obtained from neighboring slope)

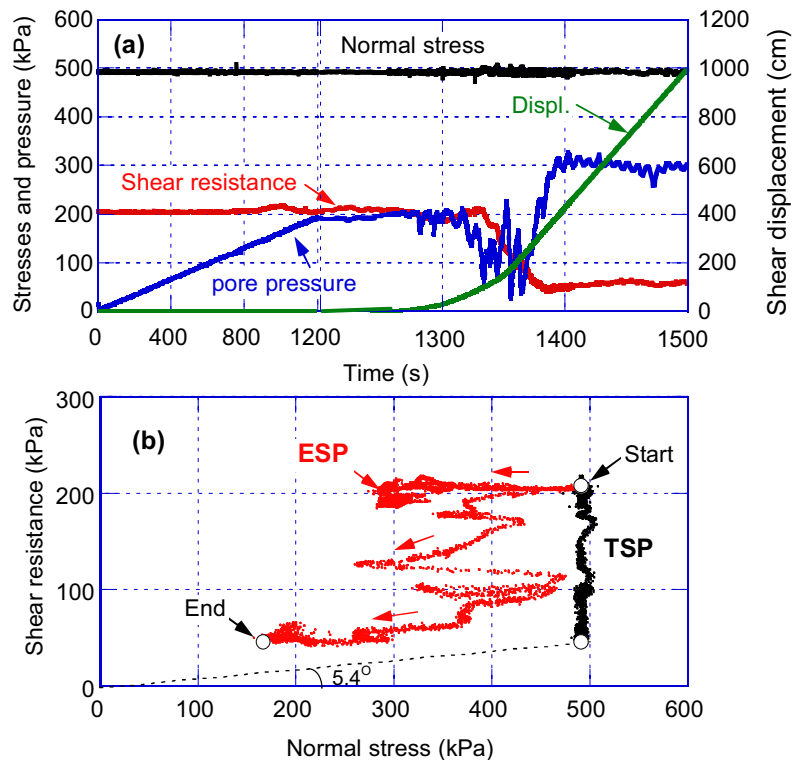
For Azue landslide, the sample had a specific gravity of 2.94 in the field, and dry density of 2.08 g/cm<sup>3</sup>. Because the test aim was to examine the shear behavior of the landslide material before and after failure, a soil element was selected from the sliding surface where the overlying soil was 25-m thick. The initial normal stress and shear stress acting on the soil element were calculated to have been 488 kPa and 212 kPa, respectively. The test results are presented in

the form of time-series data (Fig. 8a) and effective stress path (Fig. 8b). Shear failure was triggered when the pore-water pressure was increased to a certain value (Fig. 8a). The monitored pore-water pressure after failure showed a brief reduction and thereafter increased with further shearing. During this period, shear resistance was greatly reduced. The effective stress path fluctuated widely (Fig. 8b), probably due to problems in measuring pore pressure (as detailed in Sassa et al 2004b). The final apparent friction angle was very small, about 5.4 degrees.

Fig. 8 Results of a ring-shear test on a sample from the Azue landslide. (a) Time-series data for normal stress, shear resistance, pore-water pressure and shear displacement; (b) stress path (ESP: Effective Stress Path; TSP: Total Stress Path) (Pore-pressure parameter,  $B_D = 0.96$ ,  $e = 0.425$ )

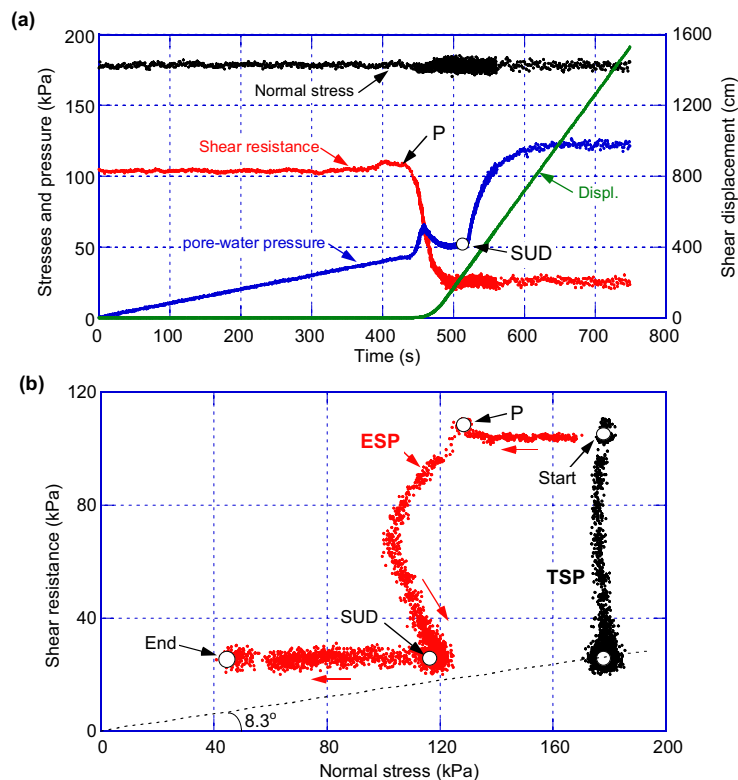
A similar test was performed on a sample from the Kamagatani landslide. Time-series data (Fig. 9) show that shear failure was triggered when the pore-water pressure was increased to point "P". After failure, pore-water pressure showed a sharp increase and then decreased. To measure the pore-water pressure within the shear zone, the shear box was switched to an undrained condition after point "SUD". The pore-water pressure increased with progress of shearing. The shear resistance showed almost no change in the final shear stage, indicating no further build up in excess pore-water pressure within the shear zone. The apparent friction angle was about 8.3 degrees (Fig. 9b). Although the final shear resistance shown in Fig. 9 is smaller than that in Fig. 8; the greater apparent friction angle in Fig. 9b is considered to be due to the smaller initial normal stress. The initial consolidated normal stress usually does not affect the shear resistance at steady state when a sample is subjected to undrained shearing, if other test conditions are the same (Castro & Poulos 1977; Kramer 1988).

Fig. 9 Results of a ring shear test on a sample from the Kamagatani landslide. (a) Time-series data for normal stress, shear resistance, pore-water pressure and shear displacement; (b) stress path ( $B_D = 0.97$ ,  $e = 0.513$ )
