## Piping Failure of a Metro Tunnel Construction

**ABSTRACT:** In this paper, the forensic investigation of a subway tunnel construction failure occurred in Kaohsiung, Taiwan is presented. The studied construction failure occurred during a cross-pass tunnel excavation of a shield tunnel construction work of the Kaohsiung Mass Rapid Transit system, and had resulted in severed tunnel collapse and extensive ground failure that even reached to ground surface 30m above the tunnel depth. In order to investigate such a serious construction failure, particular soil testing programs and geophysical testing methods were carried out to access the possible failure scenario of the investigated case. Information presented in this paper is hoped to be helpful to improve engineers' knowledge for preventing similar construction risks.

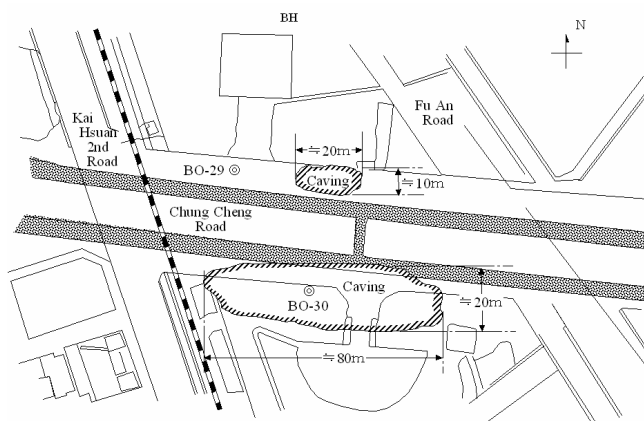
Figure 2. Features of the cave-in in plan view

The location of the collapse is shown in Figure 1 and the feature of the cave-in on the ground surface is displayed in Figure 2. A bird-eye view over the cave-in is displayed in Figure 3. The plan and side view of the tunnel are shown in Figure 4. It is to be noted that there was an underground roadway called Chung Cheng underpath just above the subway tunnel. The dual tunnels were constructed by the tunnel boring machine (TBM) which can advance by rotating a large steel disk equipped with cutting blade, while the cutting face is balanced by the mud pressure.

portal and the adjacent segment. The length of the tunnel in which the debris packed in the entire cross section was as long as 130m on the west side and 80m on the east side in the up-line on the south, as shown in Figure 13(d). Thus, another cave-in occurred on the north side, as seen in Figure 2. The amount of soils and concrete dumped to fill the caves was  $12,000\text{m}^3$  and the volume of water inflow from the 60cm diameter water main lasting about 18 hours until 11:50 p.m. next day was approximately  $2,000\text{m}^3$ . Thus the total amount of debris was as much as  $14,000\text{m}^3$ .

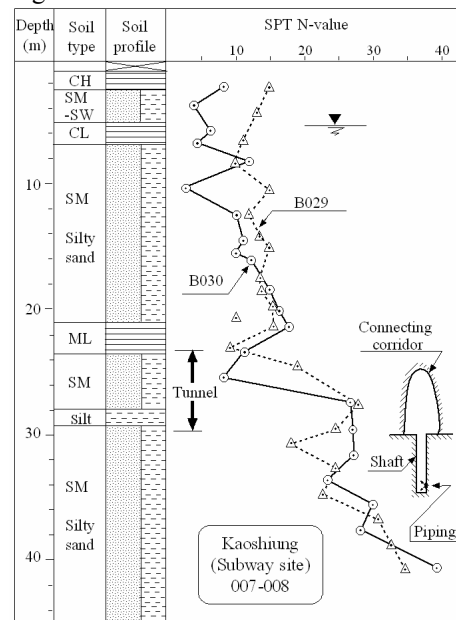
Figure 5. Soil profile at the site of collapse

The soil profiles at the locations BO29 and BO30 shown in Figure 2 are indicated in Figure 5, where it can be seen that the deposits are comprised predominantly of silty sand with occasional layers of low-plasticity clay (CL) to a depth of 40m. The blow count, N-value, in the standard penetration test is shown to increase with depth and to have a value of 20 to 30 at the depth where the sump for water collection was excavated.

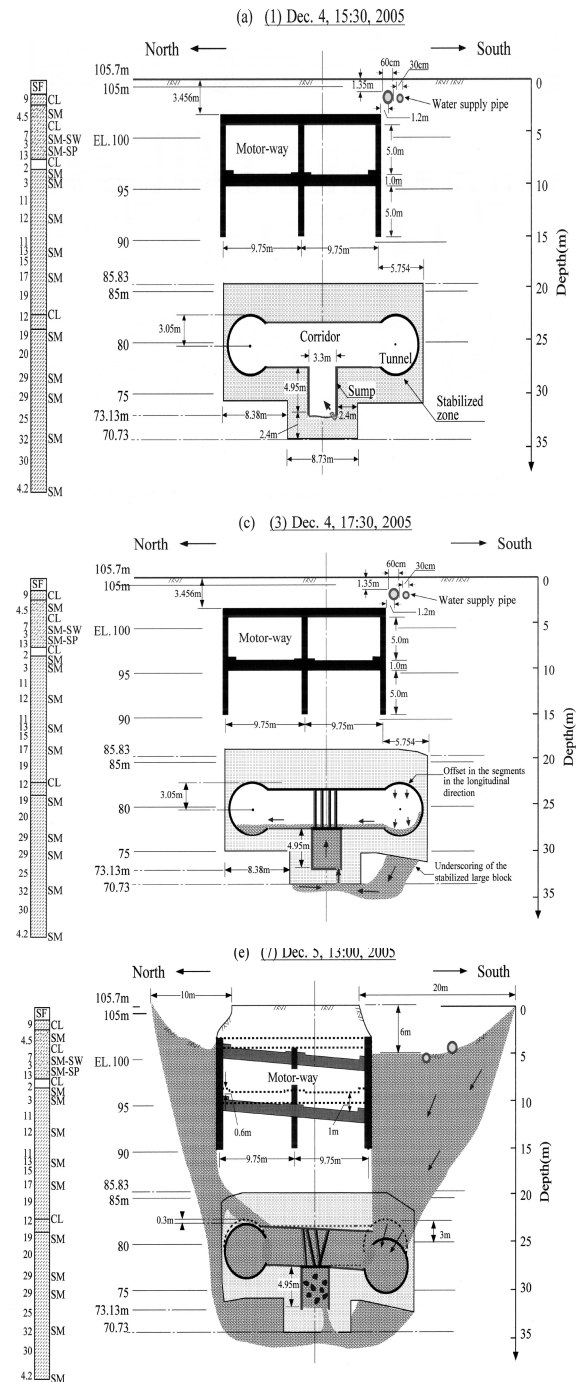
Figure 9. A sequence of likely scenario for progressing the piping failure.

A sequence of the events after triggering the piping which are likely to have occurred is illustrated in the cross sections in Figure 9. The blackish mud water continued to come out in the sump with increasing volume. Two men at work at the bottom strove in vein to clog the hole by dumping sand bags from the corridor. About one hour later, the sand bags were seen moving around in the sump as illustrated in Figure 9(b). At this stage, the workmen closed the entrance to the sump by placing a steel lid and several bars for its support as illustrated in Figure 9(c).

It is believed that the mud water flowed into the sump from the bottom through a single hole probably with a diameter of about 30cm. This assumption would hold true in the light of the fact that the zone stabilized by the jet grouting could not so easily broken down in the horizontal direction, and a weak zone might have existed in the form of vertical pipe.

About two hours later, engineers at spot heard squeaking sounds of breaks at segment joints of the tunnel on the south, accompanied by mud water cascading from the ripped joints of segments at the ceiling. It appears likely that because of the under-scoring of the bottom portion, the stabilized zone subsided together with the tunnel body, resulting in the stepwise settlement in the longitudinal direction. The probable feature of the breakage at this stage is illustrated in Figure 9(c).

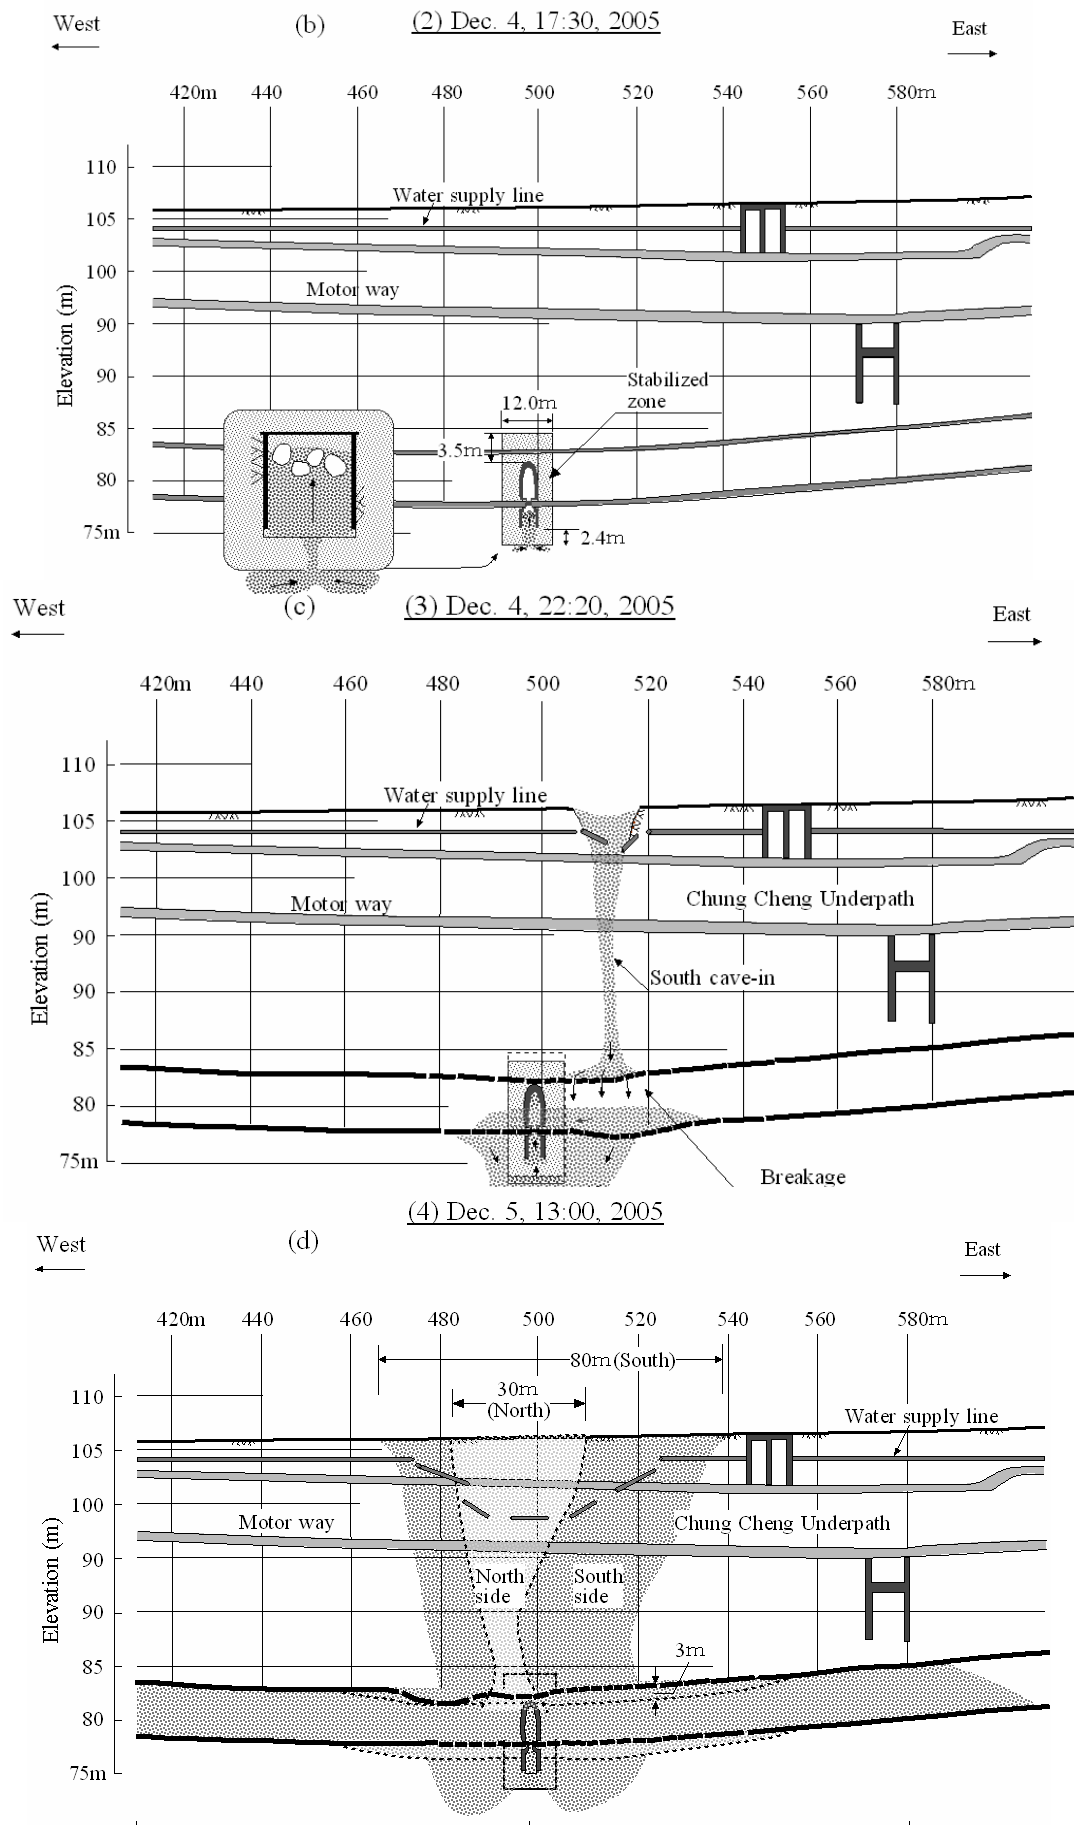
Figure 13. A sequence of likely scenario in the longitudinal direction

The feature of the collapse propagation as above would be understood more vividly by visualizing the sequence of events that might have occurred in the longitudinal direction. These features are described in Figure 13(a) through 10(d). Figure 13(c) and (b) shows the progress of the collapse from 3:30p.m. to 5:30p.m. on December 4, 2005. Figure 13(c) indicates the breakage of the tunnel, segment by segment, resulting in the fall-off the debris from the offsets of the segments in the ceiling on the east side. On the north side undermining of the tunnel body did occur as well as shown in Figure 9(d), resulting in the sinking of the tunnel together with the large block of the stabilized zone. This led to the breakage of the segment joints on the north side and allows the mud water cascading mainly through the opening at the junction between the

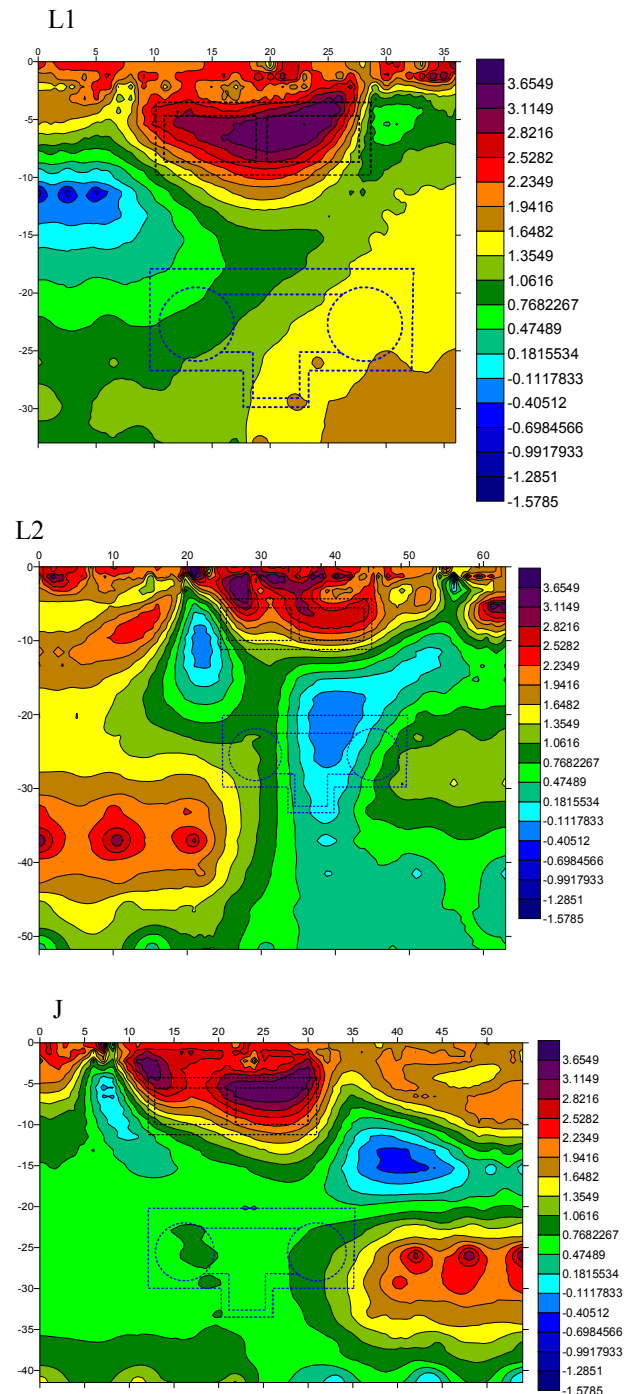
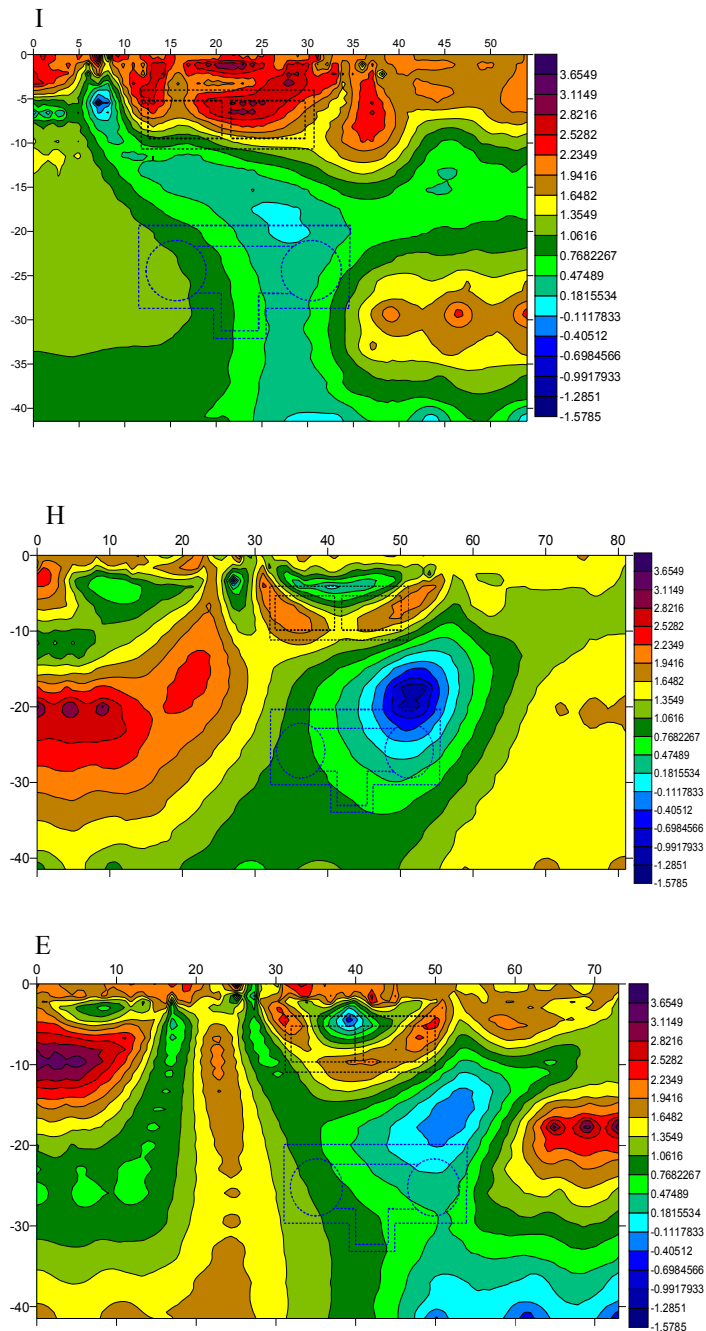
Figure 12. Results of RIP tests

Figure 12 shows the results of 2D RIP in cross sectional profiles. In the figures, cold colors, from green to deep blue, represent low resistivity materials as the disturbed ground with larger volume of ground water content. On the contrary, warm colors, from yellow to red and brown, represent high resistivity material such as grout materials or cemented backfill. Underground structures shown in imagines of 2D RIP tend to be distorted from rectangular shapes into upward shell shapes. As depicted in Figure 12, despite the imagine distortion, area in between the underground carpass and the subway corridor were identified as in seriously disturbed condition. At locations of Line L2 and Line E, which are the east and west boundaries of the soil improvement block of the damaged corridor, soil beneath the subway tunnels was also found to

be severely agitated by the piping failures. This observation implied that the subway tunnels outside the grouted area might subside and resulted in dislocations of tunnel ring segments. Images shown in Figure 12 also indicate that immediate remediation grout treatments have effectively reached both sides of the corridor as displayed in warm color. By interpreting the 2D RIP results, failure schemes shown in Figure 9 were possibly pictured to pursuit causes of the failure. Borehole probing was also conducted at the same time when 2D RIP survey was performed in an effort to validate the scale of the damaged tunnel portion.

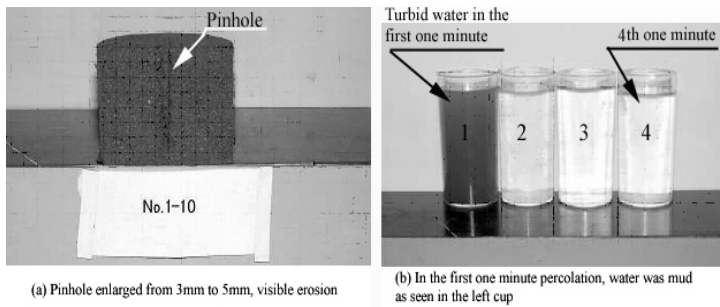
Figure 17. Silt-contained sample from Kaohsiung

In the first series, the tests were conducted on disturbed samples, one from Kaohsiung and another from Japan. The result of the pinhole tests on a disturbed sample is presented in Figure 17. For the disturbed silt-containing sand sample from Kaohsiung, the pinhole is seen enlarging to a diameter of 5mm from 3mm as displayed in Figure 17(a). Correspondingly, the drained water from the bottom was muddy for the first one-minute period of water percolation as seen in the water colour in the left-side cup of Figure 17(b). The result of the pinhole test on the Japanese silty sand is shown in Figure 18. In contrast to the Kaohsiung soil, the circulation of water through the Japanese soil did not exhibit any appreciable change in colour in the first one minute of percolation as seen in Figure 18(b). There was no change in the pinhole diameter for the Japanese soil before and after water permeation except for a local collapse at the top. Thus, it may be conclusively mentioned that the silty sand from Kaohsiung is potentially susceptible to internal erosion as compared to the soil from Chiba, Japan, although they had almost the same grading. This is believed to stem from the highly non-plastic nature of the Kaohsiung silt contained in the sand.

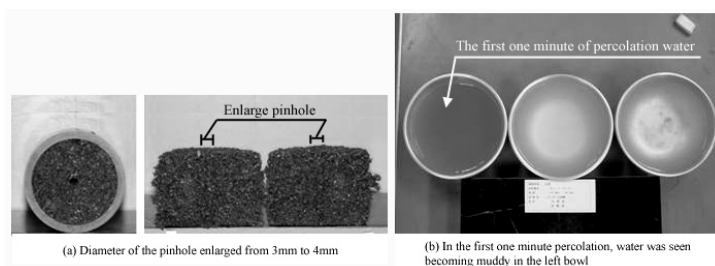
Figure 19. Pinhole tests on undisturbed samples from Kaohsiung

In the subsequent series, similar pinhole tests were conducted on undisturbed samples. The undisturbed sample from the depth of 14m in Kaohsiung also demonstrated dirty blown colour in the first one-minute of percolation accompanied by the enlargement of the pinhole from 3 to 4mm, as displayed in Figure 19.
