# BUILDING DAMAGE IN 2010 CHILE OFFSHORE MAULE EARTHQUAKE NO.4 FOURTEEN STORY RESIDENTIAL BUILDING IN VINA DEL MAR

Building Damage in 2010 Chile Offshore Maule Earthquake No.4 Fourteen Story Residential Building in Viña del Mar

Niwade LUMLERDLUCKSANACHAI, Susumu KONO and Taiki SAITO

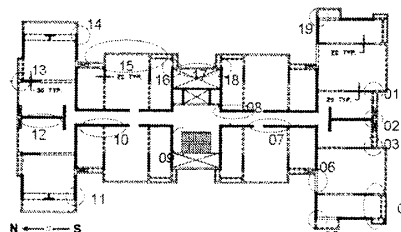
Fig.4 Damaged locations on 1st floor

| Location | Damage description |
|---|---|
| 1, 2, 3 | Wall edge crushed in the vertical direction. Vertical reinforcement at edge buckled. |
| 4 | Cover spalling due to compression in the vertical direction. Minor damage. |
| 5 | Cover is about to spall due to compression in the vertical direction. Minor damage. |
| 6 | Shear cracks next to window opening |
| 7, 8, 10 | Walls failed in shear. Supplemental walls on two faces constructed after 1985 EQ came out due to insufficient anchorage |
| 9 | A plastic hinge formed at the north side of an external staircase at each floor. |
| 11 | Wall edge crushed in the vertical direction. Too many vertical reinforcement was lap spliced to make congestion and concrete may not have been consolidated. Windowpanes were broken. |
| 12 | Wall has horizontal cracks. |
| 13, 14 | Finishing mortar spalled |
| 15 | Windowpanes were completely taken out probably due to heavy damage |
| 16 | Finishing mortar spalled. Added column crushed in compression near the ground. |
| 17 | The wall behind the elevator has multiple diagonal shear cracks. |
| 18 | Wall edge crushed in the vertical direction near the ground. Vertical reinforcement at edge buckled. |
| 19 | Finishing mortar closed to the ground spalled |

shows the damaged location on 1st floor. The damage descriptions correspond to the damaged location numbers in Fig.4 are shown in Table 1

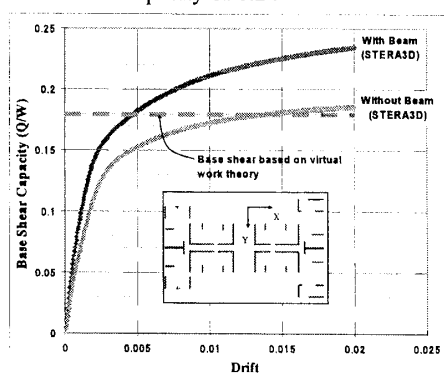
Fig. 6 Building capacity (North bound loading)

The capacity of building in X-direction by STERA3D is compared to the base shear based on the virtual work theory assuming the identical failure mechanism. The capacities are close to each other for models without beams. However, beams were connected shear walls to shear walls in reality, hence the model with beams is considered close to the real behavior. Fig.6 shows the base shear capacity of 0.24

As shown in Fig.6 the capacity based on flexure failure mode (Wall base) of building is 24% of the building weight while capacity based on shear failure mode (All walls) is at least 43% of building weight. Therefore, the flexure failure mode should be dominant but the shear failure of walls occurred in reality. The difference is considered due to dynamic effects.

From Table 3 the period of first and second modes are close to the period at peak value of pseudo velocity response spectra which the first mode is X-translation and second mode is torsion. The failure mechanism may occur in the combination of the first two modes. However the real failure modes cannot be simulated
