## Seismic Performance Evaluation of Nonstructural Components: Drywall Partitions

Tae-Hyung LEE, Mikiko KATO\*, Tomohiro MATSUMIYA, Keiichiro SUITA,  
and Masayoshi NAKASHIMA

### Synopsis

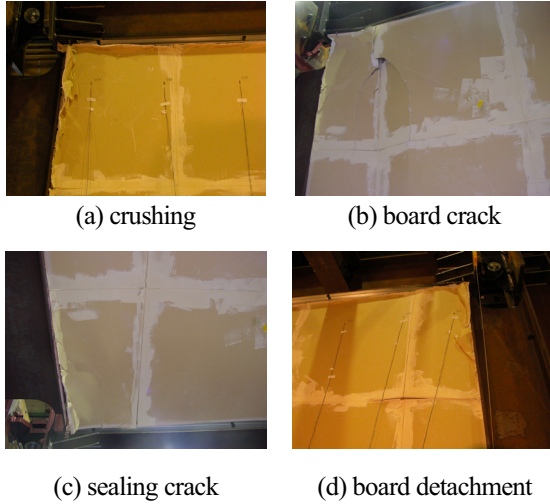
Fig. 5 Damage patterns.

This section describes the damage to the specimens observed by eyeball inspection, which is followed by the analysis of strain measurements. Observed damage patterns include crushing of boards, sealing cracks, board cracks, and out-of-plane deformation of boards whose parts around screws were crushed. Fig. 5 shows pictures of various damage patterns of the drywall partition.

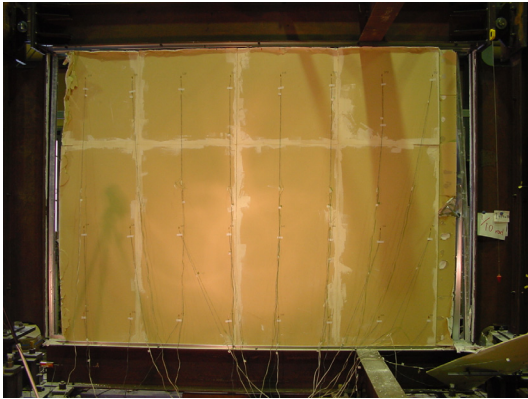
Fig. 6 Specimen No. 1 after the test.

No damage was observed in Specimen No. 1 as long as the story drift did not exceed 0.01 rad. The partition could slide without experiencing damage due to the connection detail of studs and runners and the initial gaps between the partition and the columns. The lateral rigid movement of the partition by 15mm (initial gap of one

side) in addition to the initial gap of 15mm on the other side prevented the partition from being damaged up to 30mm of the story drift that corresponds to 0.01 rad (30mm/2800mm). At 0.015 rad story drift, a room for the sliding was not available any more due to geometry and the column started to crush the neighboring gypsum board. Damage to the specimen is mainly due to compressions from the columns and beams, rather than the shear force. Fig. 6 shows a picture of Specimen No. 1 at the end of the last loading.

It is noted that the damage is concentrated at the boundaries of the partition, particularly the four corners, while the inside portion of the partition only suffers from relatively minor damage. To support this argument, the average strains of the inside portion, the boundary and the four corners of the partition are compared in Fig. 7(a),

Specimen No. 1 need not be repaired as long as the story drift is not greater than 0.01 rad because it only slid without being damaged. Therefore, at story drifts of 0.005 rad and 0.01 rad, which are considered the expected demands for Levels 1 and 2 earthquakes in Japan, respectively, no repair was needed. At the story drift of 0.02 rad, the cost ratio is already as high as 0.94. At the story drift of 0.04, the repair cost exceeds the initial cost. From the story drift of 0.015 to 0.04 rad, only

gypsum boards are to be replaced. At the 0.06 rad story drift, all parts except for the base steel frame are to be replaced. After the 0.08 rad story drift, the whole wall needs to be replaced and the cost ratio is 2.36.

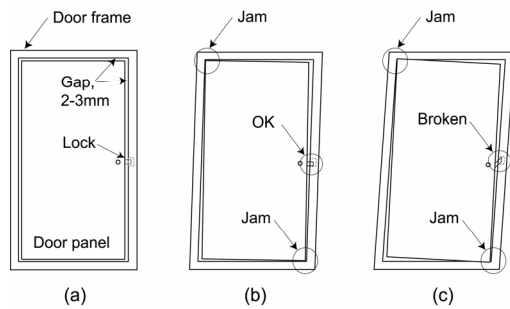
The feature of Specimen No. 2 is the door in the partition. The functionality of the door is of interest as well as damage to the partition for the safety issue. During the test, the door was jammed at story drift of 0.01 rad. As shown in Fig. 9(a), the gap exists between the door panel and the doorframe. At the story drift of 0.01 rad that causes 0.006 rad shear distortion of the doorframe itself, the gap was closed because of the rotation of the door panel to cause the door to jam, as shown in Fig. 9(b). However, when the load was removed to the zero story drift, the door panel and the doorframe recovered their original shapes and the door was working. At the story drift of 0.02 rad, the door lock was broken as well as the door jammed due to the door panel's rotation, as shown in Fig. 9(c). It was not recovered even at the zero story drift and the door was permanently jammed. It is noted that the shear distortion of the doorframe that caused this was 0.01 rad.

Fig. 9 Functionality of the door in the drywall partition; (a) initial configuration of the door; (b) deformation of the door under 0.01 rad story drift; (c) deformation of the door under 0.02 rad story drift.

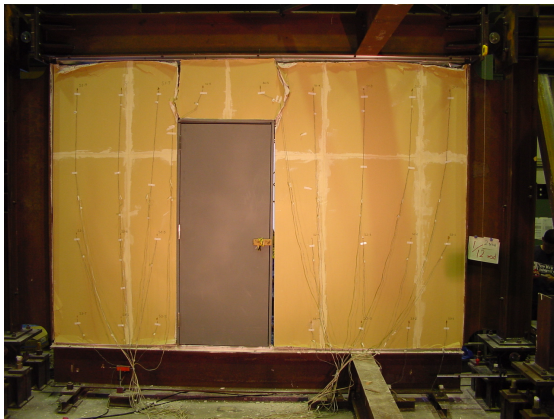
Fig. 10 Specimen No. 2 after the test.

Fig. 10 shows a picture of Specimen No. 2 after the test. It is clearly visible that the entire partition is completely divided into three panels by cracks: the left, above, and right side of the door. Fig. 11 shows the comparison of the average strains of the inside, boundary, and corners of the partition. Similar to Specimen No. 1, the corners suffer from higher strain than the other part of the partition up to the story drift of 0.02 where some of

Specimen No. 2 need not be repaired as long as the story drift is not greater than 0.005 rad. Some cracks were observed at the story drift of 0.005, but they were considered insignificant and not requiring repair. At the story drift of 0.01 rad, the cost ratio is 0.43. The cost ratio is 0.79 at the story drift of 0.02 rad, which includes the replacement of the doorknob. At the story drift of 0.04 rad, the repair cost exceeds the initial cost. After the 0.04 rad story drift, the door needs to be replaced, which causes an additional rise in the repair cost. It is noted that 50% of the initial cost of this specimen is the installation of the door. After the 0.06 rad story drift, the whole partition needs to be replaced and the cost ratio is 1.84.

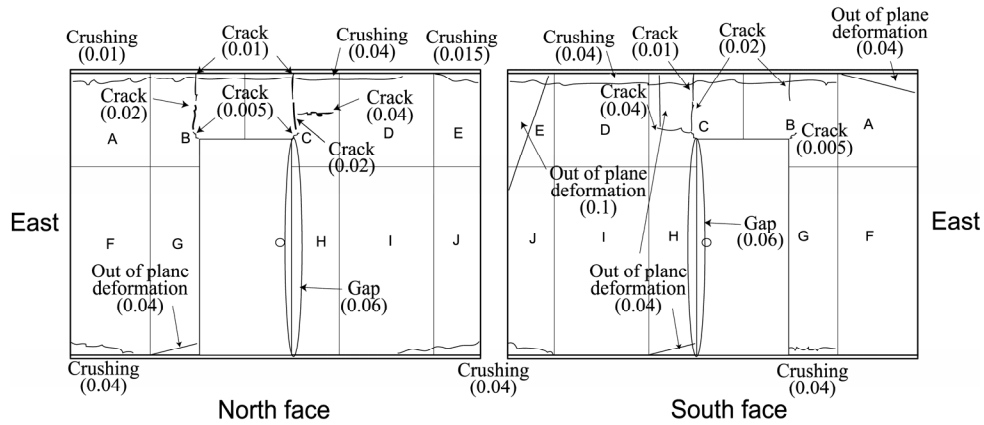
Fig. 12 Damage to Specimen No. 2.

the strain gauges at corners failed due to damage. Moreover, the boundary of the partition shows 150% higher strain than the inside. Damage to Specimen No. 2 is depicted in Fig. 12.

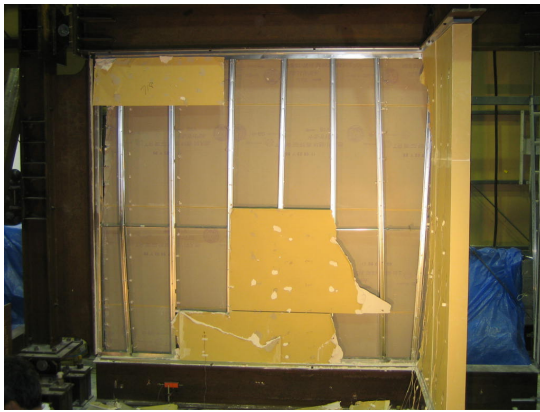
Fig. 13 Specimen No. 3 after the test.

The feature of Specimen No. 3 is an intersecting partition. The partition perpendicular to the loading direction is referred to as the orthogonal partition. The parallel (to the loading direction) partition did not show any significant damage up to story drift of 0.06 rad. At the next loading cycle (0.08 rad story drift) some of the gypsum boards were completely detached from studs and all the gypsum boards of the north face of the partition fell completely to the floor at the last loading cycle (0.1 rad). Fig. 13 shows the damage to Specimen No. 3. The damage to the orthogonal partition is relatively small. This is verified by the analysis of strain measurements.

Specimen No. 3 needs to be repaired as long as the story drift is greater than 0.0025, which is earlier than any other specimen. This is caused by the damage to gypsum boards and joint mixtures near the intersection of the parallel and orthogonal partitions. At the story drift ratios of 0.005 rad and 0.01 rad, the cost ratios are 0.08 and 0.24, respectively. At the story drift of 0.02 rad, the cost ratio is 0.85. From the 0.02 to 0.04 rad story drift, the orthogonal partition also needs to be repaired. From the 0.06 rad story drift where the repair cost exceeds the initial cost, almost all parallel partition needs to be repaired. However, this specimen does not require the whole replacement of the partition whose cost ratio is 2.02 because some parts of the orthogonal partition are intact.

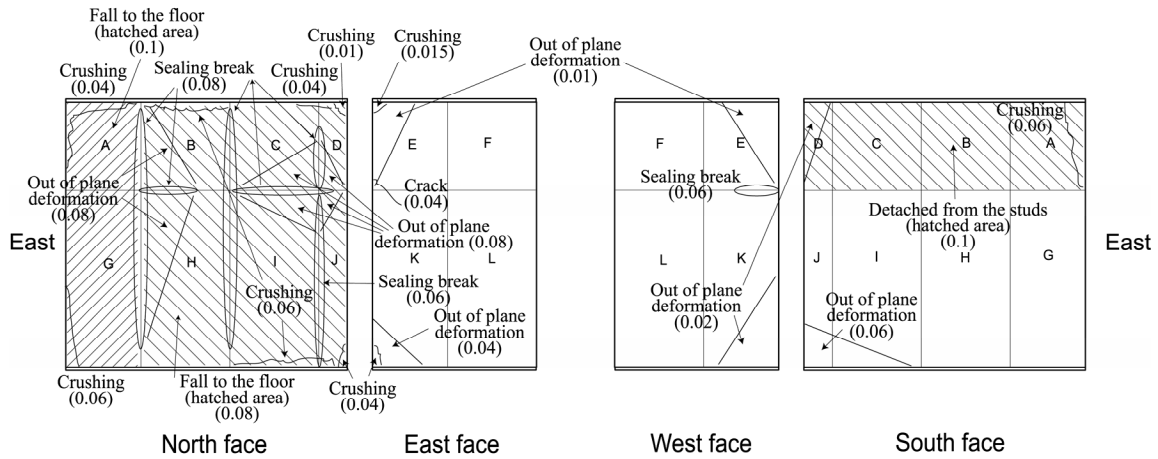
Fig. 15 Damage to Specimen No. 3.

Fig. 14 shows average strains of the parallel and orthogonal partitions. It should be noted that strain measurements near the intersection of the two partitions are excluded in the computation of the average strains. The average strain in the parallel partition is twice as high as that in the orthogonal partition. Damage to Specimen No. 3 is depicted in Fig. 15.

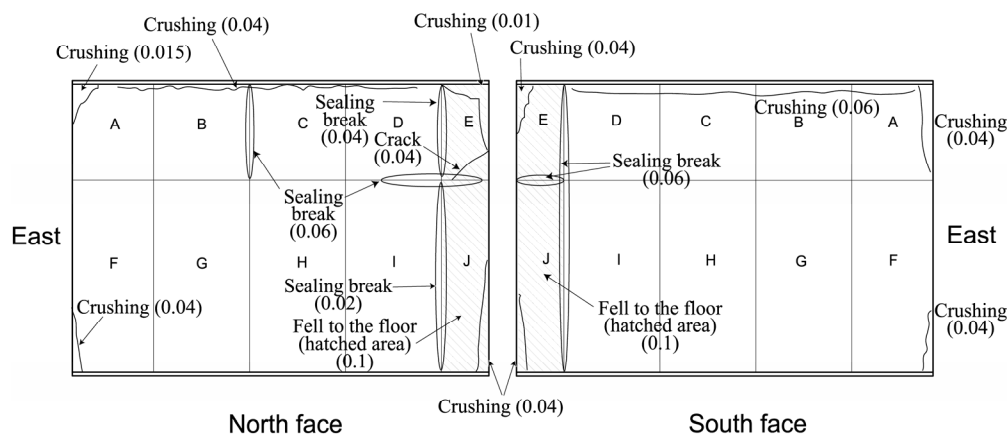
Fig. 18 Damage to Specimen No. 4.

A series of dynamic loads, as described in a preceding section, is applied to Specimen No. 4, which is identical to Specimen No. 1 in design. Unlike the tests of the other specimens, damage inspection was carried out at the end of each loading cycle (two dynamic cycles with the same
