## Forensic analysis of failure of shoring piles

N. Santosh Rao

*Nagadi Consultants Private Limited, India*

**ABSTRACT:** Shoring piles had been provided to support the sides of a deep excavation carried out for the construction of a shopping mall having three basements. A section of the shoring piles failed suddenly when the lowest basement had already been constructed and partial backfilling had been carried out. As the failure occurred when the loads and moments on the shoring piles were lower than what they had earlier been subjected to, the cause/s for the sudden failure were not apparent and nor readily discernable. Therefore, forensic analysis of the failure of the shoring piles was carried out by collecting various data which included construction records, collation of eyewitness accounts and study of post failure conditions. Back analysis of the shoring pile system was carried out by formulation of an alternate method of analysis of the shoring piles. Finally, a hypothesis regarding the failure mechanism was developed and tested for possible inconformity.

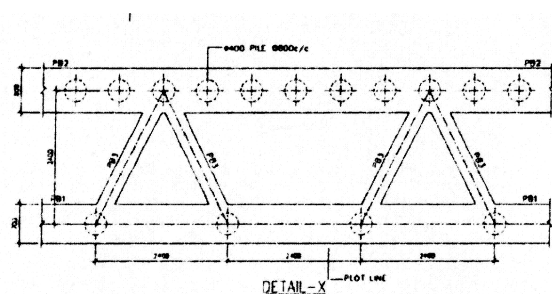
Fig. 1 Pattern of shoring piles

The shoring piles had been provided in a pattern as shown in fig.1. As per discussions held with the structural designers for the project, the front / facing row of shoring piles were provided for retaining the soil while the rear row of piles, lesser in number (i.e. one rear row pile for every 3 front row piles) were provided as anchors for the front row of piles with the anchoring ties provided at the top end of the piles in a triangular pattern as seen in the above figure. Capping beams had also been provided along the top of both the front and rear row of piles

Notably, the centre point of the collapsed portion of the shoring piles more or less lies at the break/shift in the continuous line of shoring pile system as indicated by the circle marked in fig. 1. This break/shift in the continuous line of the shoring pile system is critical in that any defect in the construction at this location can prevent the proper functioning of the shoring pile system as a two-dimensional system and instead make the shoring piles at this location act as free standing piles and consequently, cause a reduction in factor of safety against structural failure eventually leading to the structural failure of the piles at this location.

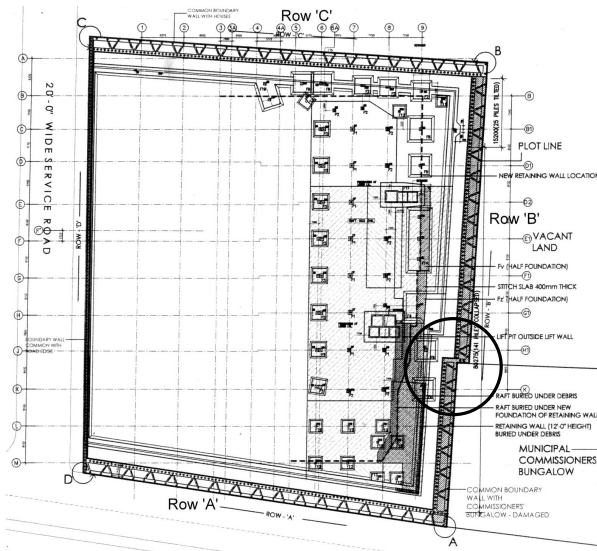
Fig. 2 Schematic site layout

The shoring piles along the site boundary in which the collapse occurred (i.e. row B; marked by shading in fig. 2) had been constructed by drilling the pile bores using the traditional DMC (i.e. drilling mud circulation) method and temporary liner/casing of about 6 to 8m length had been used during the drilling.

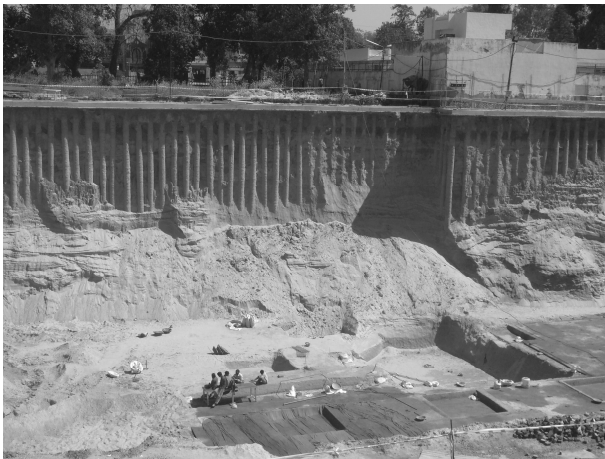
Fig. 3 Shoring piles prior to failure

Photograph showing the shoring piles prior to the failure is given in fig. 3. This photograph had apparently been taken prior to the guniting of the face of the shoring pile system. The photograph also shows clearly the sloping soil surface between the shoring piles and basement line.

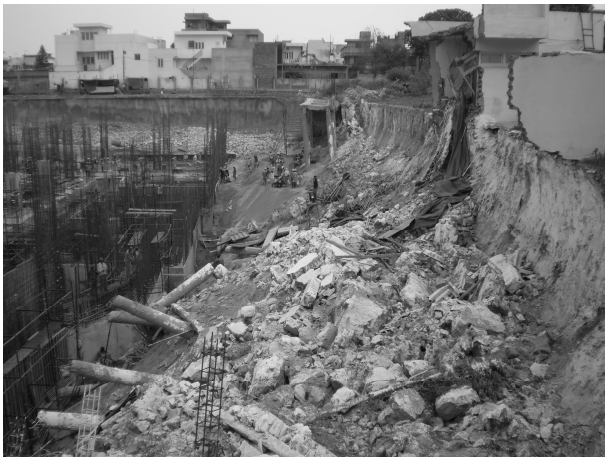
Fig. 4 Post failure conditions

- a. The piles are observed to have bent forward as seen from the photograph in fig. 4.

- b. The failure surface in the soil behind the line of shoring piles is only a few metres distance from the line of shoring piles and is almost vertical in the upper portion as seen from the photograph in fig. 4.
- c. Other views of the collapsed area very clearly show the bent and broken piles in photographs in figs. 5 & 6. The orientation of the bent piles indicates that the bent portion of the piles is only a few metres in length.
- d. The guniting adopted in the upper part and the sand bags provided in the lower part for preventing the soil behind the shoring piles from flowing out can be seen in the background in the photograph in fig. 4.

1. The collapse was sudden and without any warning signs whatsoever in the form of observed bending of piles and/or of the top capping beams. This is typically indicative of brittle failure, the type of failure associated with concrete.
2. The observed collapse is indicated to be in the form of bending and consequent breaking of the shoring piles and not by overturning.
3. The length of the bent portion of the shoring piles is approximately 6 to 8m as indicated by

4. The observed failure surface in the soil behind the shoring piles is similar to that normally observed in relatively dry silty sand soil in a medium dense state, in that the failure surface is vertical in the upper part and is only a few metres behind the line of shoring piles. Had the soil been saturated, the failure surface is likely to have been a proper slope with evidence of flow of the soil having taken place.
