## Detection of Collapse Position in Mountainous Slope by Underground Sound Method

Yasuyuki TADA<sup>\*</sup>, Masaharu FUJITA, Daizou TSUTSUMI,  
Takenobu OKUMURA<sup>\*\*</sup>, Kan KOYAMA<sup>\*\*\*</sup>, Takayuki KAWAI<sup>\*\*\*\*</sup>

### Synopsis

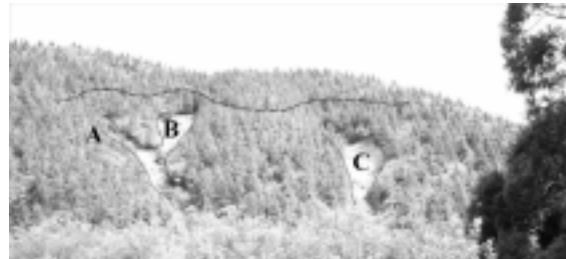
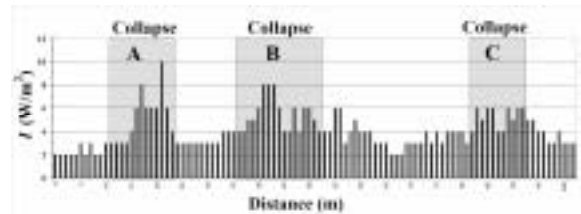
#### [2] Natural slope B (photo 7, Fig. 9)

catchments. Collapse A was 12m in width, and 2.0m in depth. Collapse B was 16m in width, and 2.0m in depth. Collapse C was 10m in width, and 1.0m in depth. All collapses were occurred on the bedrock as a boundary. And all collapse had no spring.

The underground sound in collapse position was bigger than other positions. And, collapse B and C was divided two blocks in scarps. Correspondingly, these collapse had two underground sound peaks. The collapse positions and the underground sound peaks

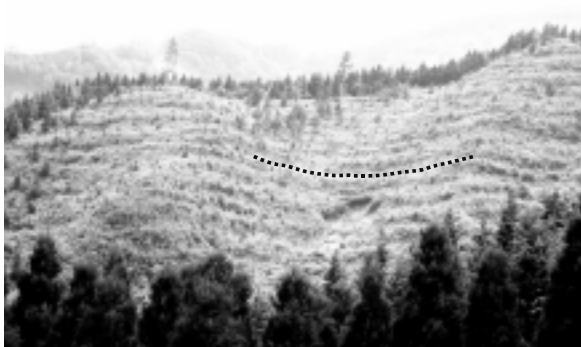
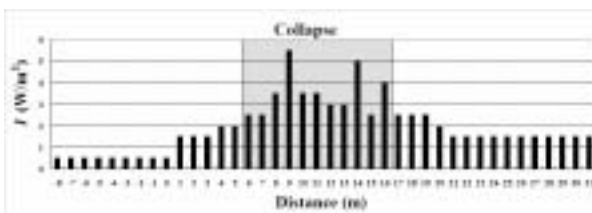
#### [1] Natural slope A (photo 6, Fig. 8)

Natural slope was catchments landform, and had one collapse. Width of collapse was 10m, depth was from 1m to 1.5m. Soil mass above the bedrock was collapsed. These were no spring when this site was inquired.

The underground sound in collapse position was bigger than another positions. And, Collapse position had 3 sound peaks. The collapse was divided into three blocks in photograph 6. And, each blocks was corresponding to each sound peaks.

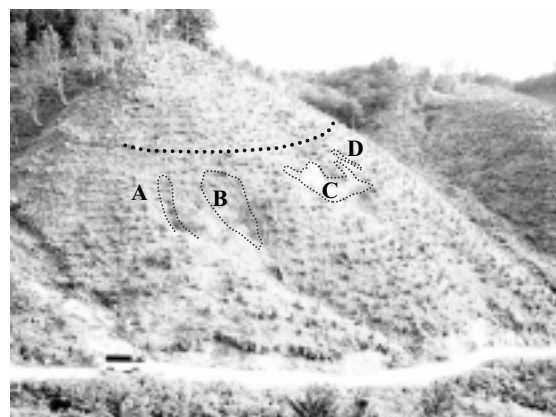
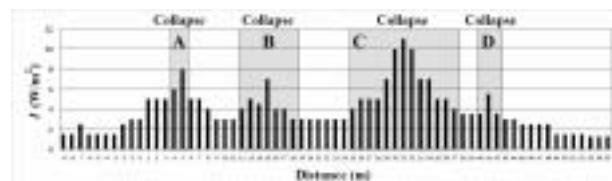
### [3] Natural slope C (photo 8, Fig. 10)

Four collapses occurred in natural slope C. The geographical feature was ridge. Collapse A was 2m in width, and 1.0m in depth. There was one spring under the collapse. Collapse B was 6m in width, and 1.0m in depth. There were two springs under the collapse. Collapse C that was collapsed the soil mass above the bedrock was 12m in width, and 1.0m in depth. This collapse had no spring. Collapse D was 2m in width, and 1.0m in depth and also had no spring.

The underground sound in collapse position was bigger than another position. And, there were two sound peaks in collapse B that had two springs

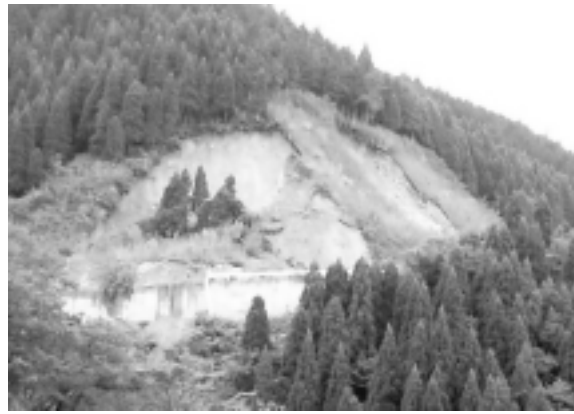
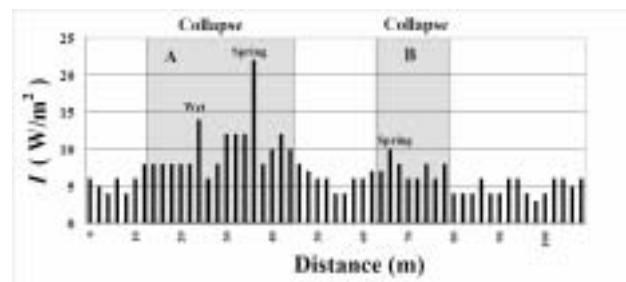
#### [1] Road cut slope A (photo 9, Fig. 11)

Two collapses occurred in ridge of forest road. Collapse A was caused by typhoon No.23 in 2004. Collapse B was caused by typhoon No.21 in 2004. Collapse A was 30m in width, and 5.0m in depth. One spring and wet zone were detected in the investigation immediately after the collapse. Collapse B was 14m in width, and 1.0m in depth. One spring was detected in the investigation immediately after the collapse.

The underground sound in collapse A and B were bigger than another position. And spring and wet zone in collapse A were corresponded with underground sound peaks. The underground sound between collapse A and B was smaller than underground sound in collapse A and B.

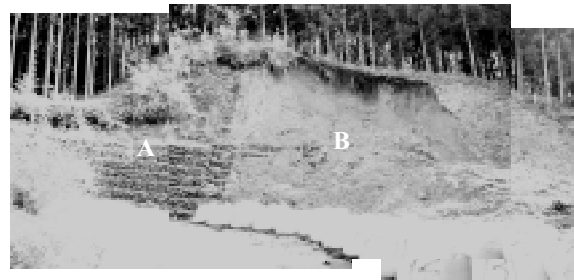
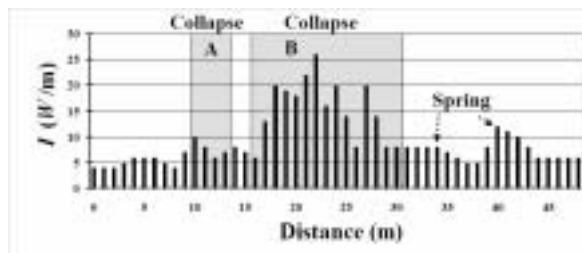
#### [2] Road cut slope B (photo 10, Fig. 12)

Two collapses were occurred by Typhoon 21 in 2004. Collapse A was 3.0m in width, and 0.5m in depth. There was no spring in this collapse. Collapse B was 14m in width, 1.0m in depth. There was no spring in collapse B. The underground sound in collapse A and B were bigger than another position.

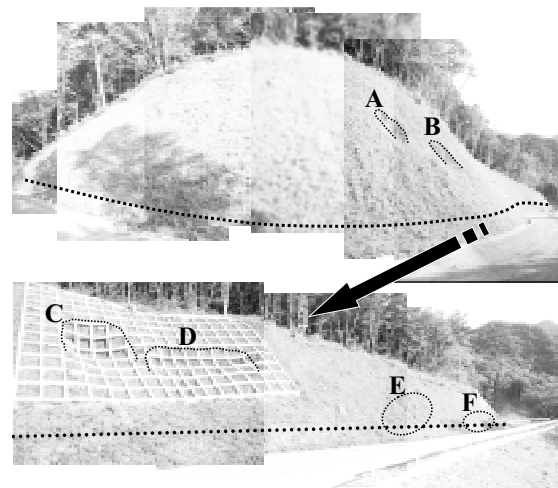
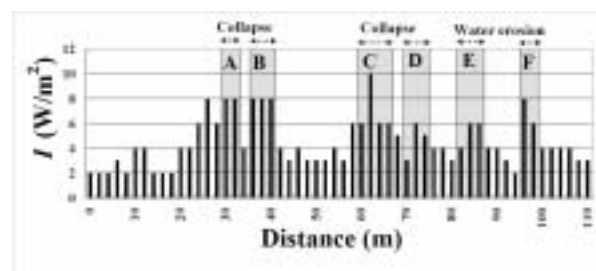
#### [3] Road cut slope C (photo 11, Fig. 13)

Four collapses and two water erosions were occurred in planting road cut slope. Collapse C and D was made by grating crib works. Collapse A was 2m in width, 1.0m in depth, and had no spring. Collapse B was 4m in width, 1.0m in depth, and also had no spring.

Collapse C was 6m in width, 1.0m in depth. Spring water occurred in heavy rainfall event in collapse C. Collapse D was 4m in width and 1.0m in depth. There is no spring in collapse D. Water erosions occurred in Position E and F.

Underground sound was big in each collapse positions and also big at position E and F that water erosion occurred

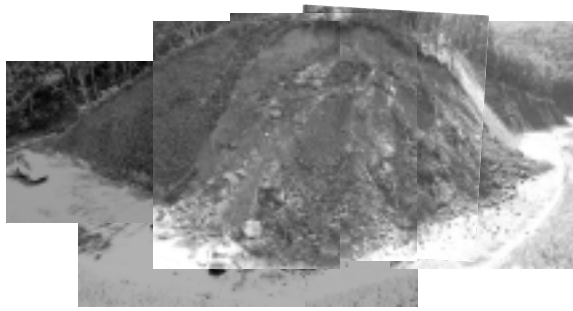
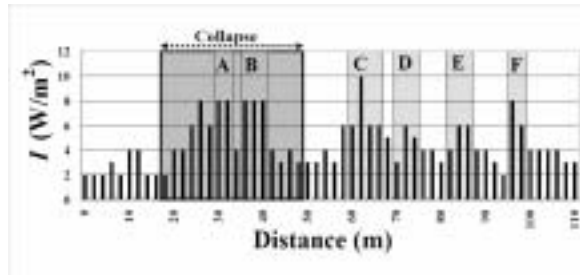
Photo 12 Road cut slope C after the Typhoon

Appearance of load cut slope C after the typhoon was shown Photograph 12. The road cut slope was collapsed by heavy rainfall of typhoon. Photograph 12 indicated that Collapse was occurred in left side of grating crib works. Collapse was 30m in width, and 1.5 m in depth. This collapse position was collated with the underground sound distribution chart (Fig. 15). The collapse was occurred in the part that had three peaks of underground sounds.

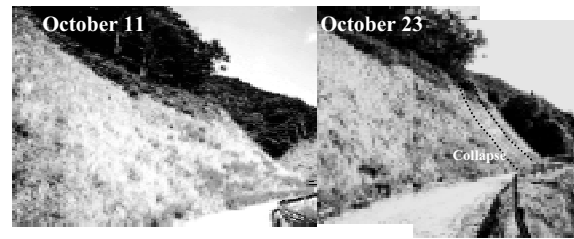
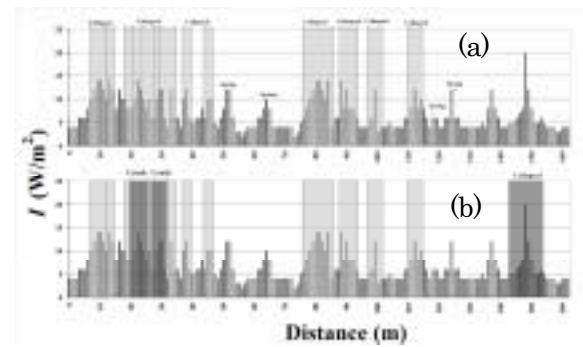
Photo 13 the appearance of road cut slope D before and after the typhoon approach

D before and after the typhoon approach. Cut slope was collapsed by the heavy precipitation. Collapse was 10m in width, and 0.5m in depth. Figure 16(a) showed the underground sound distribution that measured before typhoon approached.

Figure 16(b) showed the position of collapses and distribution of underground sound that was measured on July 12 2004 before typhoon approach. The pale hatch in figure showed the position where the collapse round had already been occurred on July 12, 2004. The dark hatch in figure showed positions in collapses and water erosions that were occurred by typhoon 23. Collapses occurred in big underground sound position.

The non-failure position that had big underground sound was collapsed by the typhoon. There is a part which underground water daily concentrates in the slope. And, water path position was collapsed by the groundwater that was supplied to torrential rains.

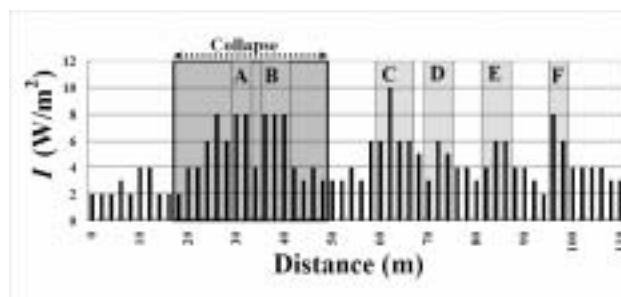
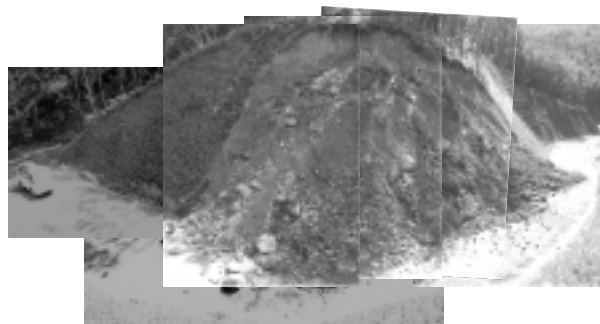
図1 地中音の分布と豪雨後に発生した崩壊の位置

自然斜面には、日常的に地下水の集中する部位（水みち）が存在し、豪雨時にその部位に多量の地中水が供給されることで崩壊は発生する。
