# **Global monitoring of large concrete structures using acoustic emission and ultrasonic techniques: case study.**

Tomoki Shiotani<sup>1</sup>, Dimitrios G. Aggelis<sup>2</sup> and Osamu Makishima<sup>3</sup>

In the specific case presented herein, a 45 m bridge span was inspected. Preliminary visual inspection and testing of excavated cores did not reveal extensive damage. However, cores are

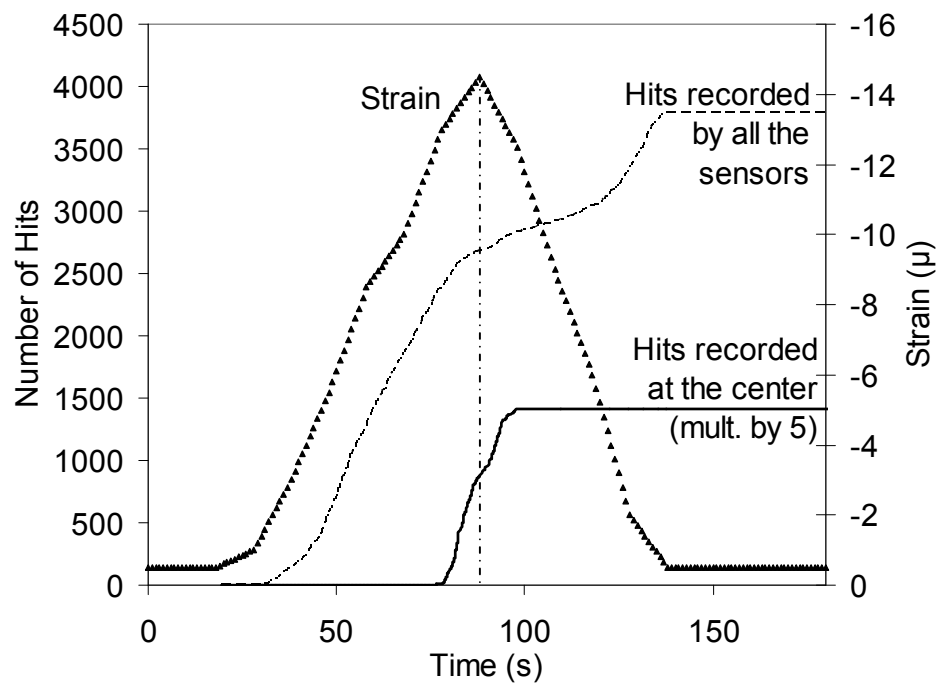
Fig. 2. Time history of strain at the center and cumulative AE hits during crane passage.

The load for the AE monitoring was supplied by a 20-ton crane, which passed over the bridge with a constant speed of approximately 0.5 m/s (see Fig. 1). As the crane moved over the bridge, the strain on the top surface of the bridge at the mid-span was monitored and can be seen in Fig. 2. The maximum strain was recorded at 88 s, when the truck was in the middle of the span, suggesting the highest tensile stress due to bending at the bottom layer of the structure, where the sensors were attached. In the same figure, the cumulative number of AE hits recorded by all the sensors is depicted for one passage. It can be seen that the rate of AE hits was more intensive before the crane reached the center of the bridge at 88 s. Up to that moment more than 70% of the total number of hits was recorded, implying that more active sources were located in the first half of the bridge. In the same figure, the cumulative number of hits recorded only by the two sensors located close to the center of the bridge is depicted. For clarity reasons they are multiplied by a factor of 5 in the figure. The hits of these sensors started at 14 s before the crane reaches the middle point, and the last hit was recorded 10 s after the crane had passed over that point, showing again higher activity at the first half of the structure.

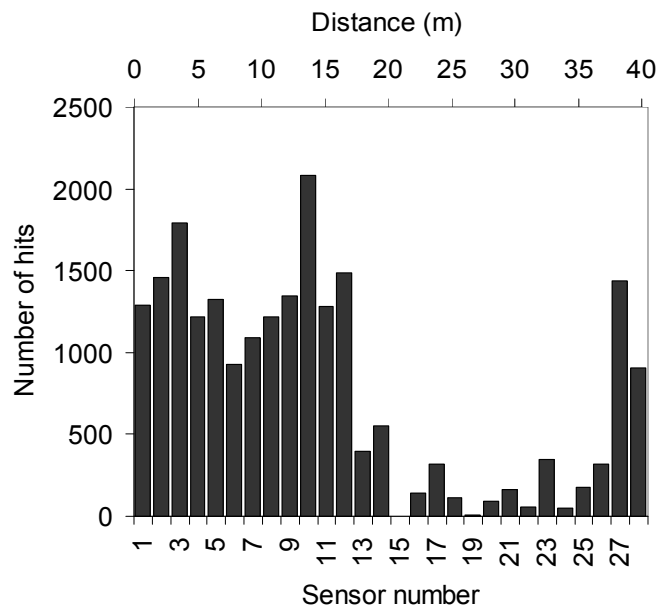
Fig. 3. Number of hits per channel and distance.

The interpretation of AE information is not always easy. This is the reason why different indices have been introduced. Some of them utilize the relative number of hits during the loading and unloading process, or the load at which the AE activity starts (Ohtsu et al., 2002, Colombo et al., 2005). Others take advantage of the amplitude distribution of AE events (Shiotani et al. 1994, Shiotani et al. 2007). However, in this case just the total number of hits during the crane passage sufficed the requirements of the test. The total number of hits recorded at each sensor during all the passages of the crane is depicted in Fig. 3. The position of each sensor is indicated by the axis on the top of the figure. It is certain that the first part before 20 m, exhibited highest rate of

emissions. Specifically, channel #10 recorded the highest number of hits. This corresponds to the distance of 14 m from the starting point. It is well known that the AE activity is connected to the extent of damage through primary (crack growth) and secondary (frictions) mechanisms. Therefore, the area near the sensor which recorded the highest activity was the most likely to have sustained more serious damage than the rest of the structure examined. Consecutively, this area was selected for the more detailed monitoring using stress waves as described in the next section.

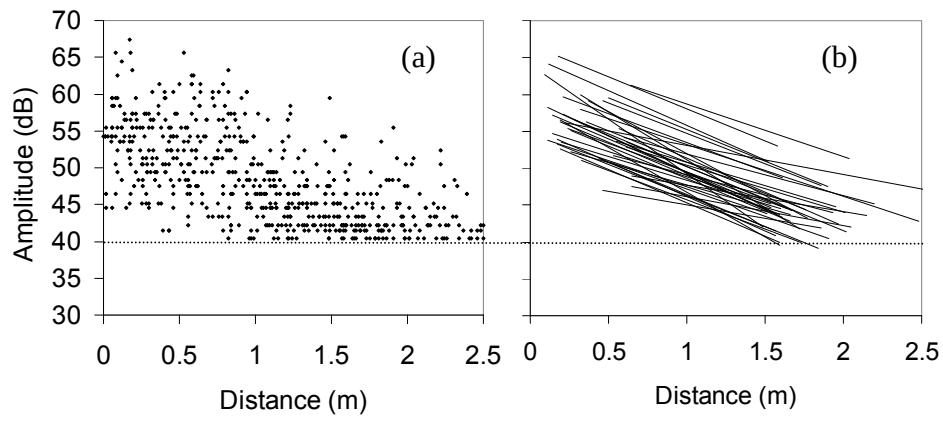
Fig. 4. (a) Hit amplitude vs. distance from event source, (b) individual attenuation slope for different events.

After location of the events, interesting conclusions can be drawn about the attenuation of the structure. In Fig. 4(a) the amplitude of the hits of all events is depicted vs. the distance from the source. The average first hit stands at an amplitude of 54 dB. In Fig. 4(b) the linear fits to the amplitude of each individual event are plotted. Attenuation can be calculated by the slope of each line. Averaging of the slopes of the events recorded from the whole structure results in -7.02 dB/m. It is seen that any “hit” propagates at least 1.5 m before being reduced below the threshold level (40 dB). Therefore, they are recorded by at least 2 sensors. This shows that the separation distance of the sensors is adequate for source location in this case. In any case, attenuation is a crucial parameter that should be seriously taken into consideration since in monitoring of most large structures, compromises must be made between the available number of sensors, time restrictions for measurement preparation and the desirable degree of detail of examination. Attenuation is a key parameter to make an adequate decision.

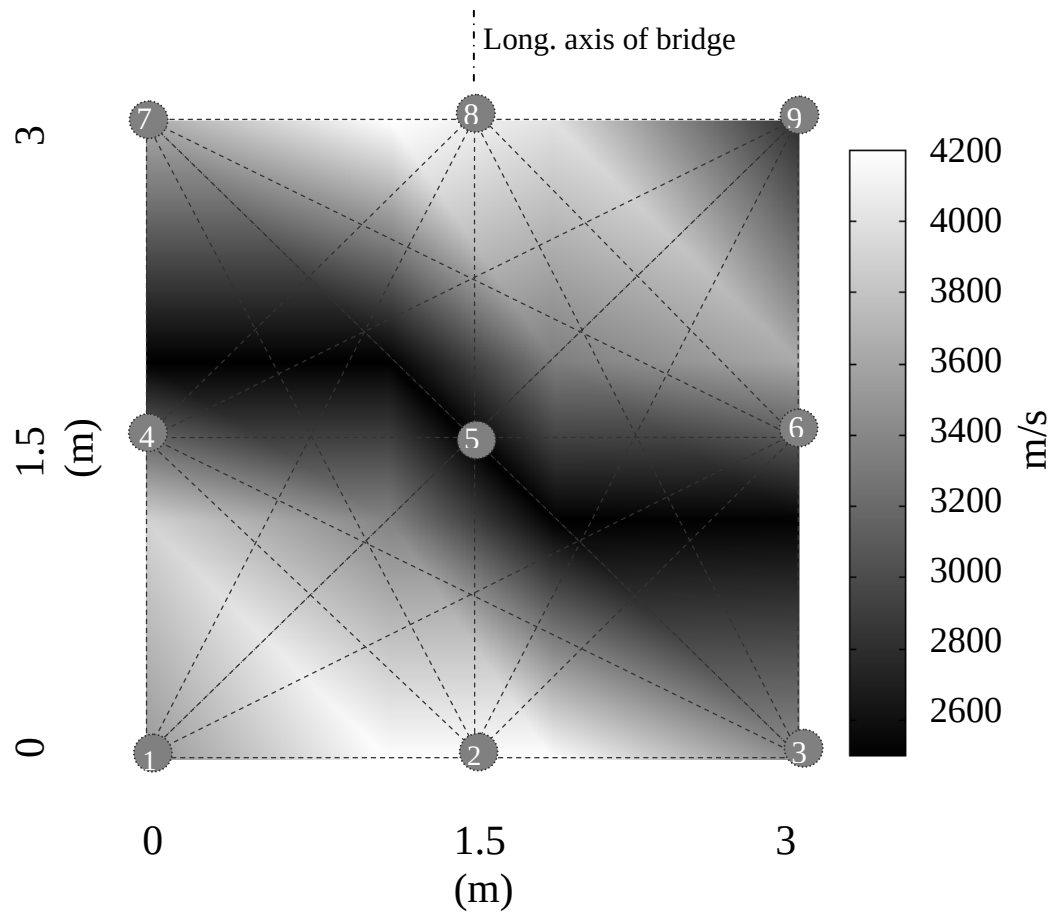
Fig. 6. Velocity structure visualization of the bottom surface of the bridge concrete. The positions of the transducers are indicated by ●, and the examined wave paths by dashed lines.

The transit times of the individual paths and the geometry were supplied to suitable tomography program (Kobayashi et al., 2006). This way the visualization of the velocity structure was obtained, as seen in Fig. 6. The tomogram supplies the information of which parts

of the surface area exhibit lower velocity than others. From this figure, it is seen that within the area of  $9 \text{ m}^2$ , considerable discrepancies of wave velocity emerge. These discrepancies correspond to different degree of inhomogeneity. Specifically, a zone approximately in the center of the selected area exhibited velocity of less than 2500 m/s, indicating poor quality, while other parts exhibited velocity higher than 4000 m/s. As stated above concerning AE activity, the events may propagate through different parts of the structure or reinforcement and their exact source could be concrete cracks, delaminations of different layers (e.g. asphalt on concrete) or friction between the tendon ducts and matrix concrete. As to the velocity measurements though, propagation took place only through the surface layer of concrete. Therefore, the velocity is characteristic of the concrete material itself indicating low quality or extensive damage on that specific area. It is reminded that the general condition of the structure was considered satisfactory after visual observation. Therefore, the low velocity is attributed to a subsurface defect.
