## Collapse of Braced Excavation in Singapore

K. Ishihara

**ABSTRACT:** After the collapse of the subway excavation in the Nicoll Highway, extensive in-situ investigations were carried out to identify causes of the accident. The results of detailed studies disclosed that lack of toe-in depth of the diaphragm wall into the stiff competent strata could be one of the causes of the incident. This aspect of the studies is highlighted in this paper.

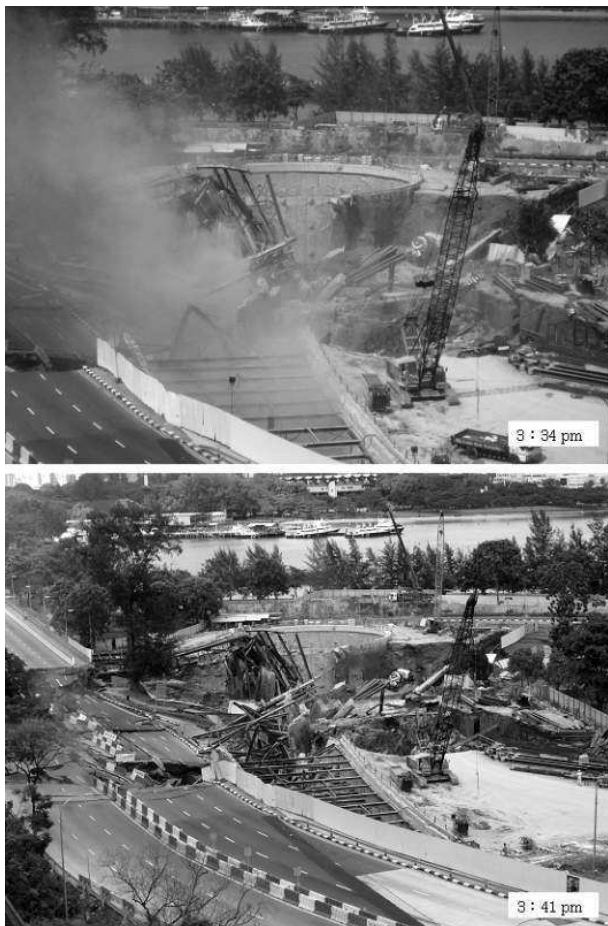
In the morning of April 20, from 9:00 a.m. to 10:00 a.m. engineers on the spot is said to have heard sounds of metallic collision near the north side of the strut S338 and observed the inner flange of H-beam waler at the 9th strut having buckled and shifted about 5 to 6cm downward. This shift aggravated to about 20cm by 2:30 to 2:45 p.m. It was also witnessed around this time that the inner flange of the waler at the 9th strut S335 on the south side had also buckled. Between 2:00 p.m. and 3:00 p.m. the sounds of metallic collision were heard more frequently and eventually the collapse took place at 3:33 p.m.

Fig. 7 Photos showing the incident at 3:34 p.m. and 3:41 p.m.

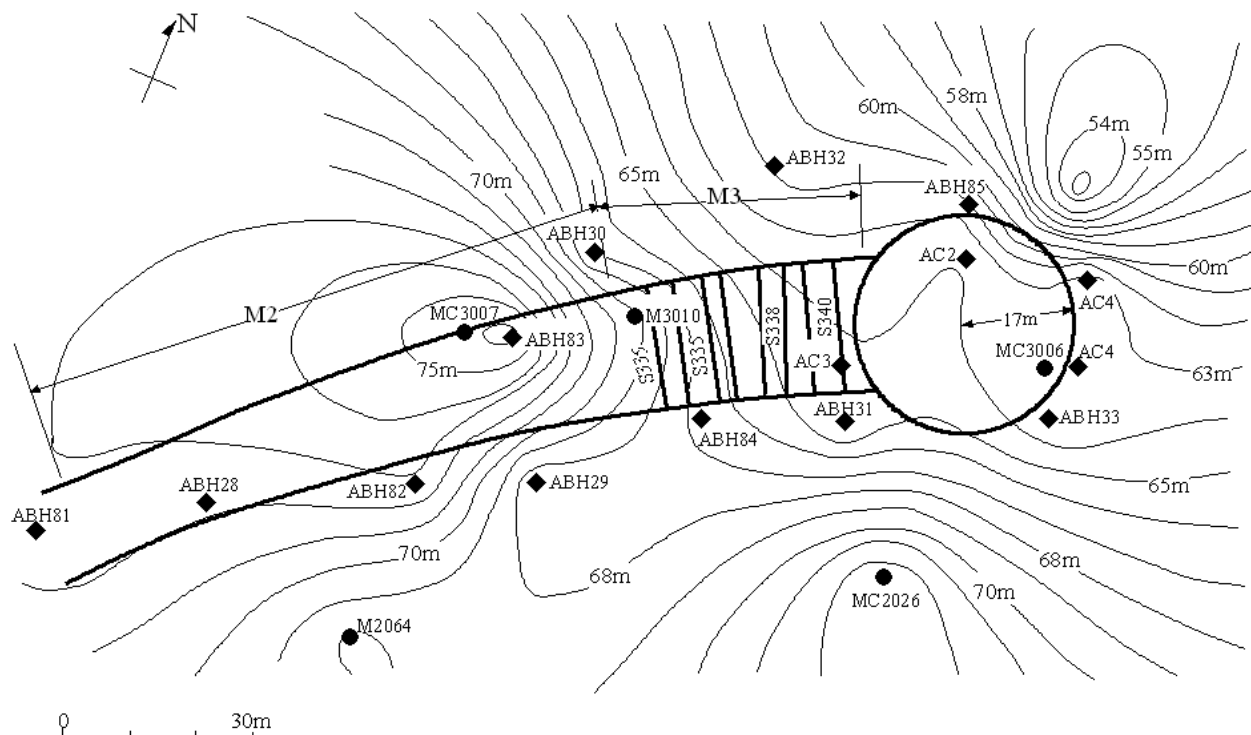
In view of its importance, the contour lines indicating equal elevations of the top of the OA layer were also drawn in Fig. 8, on the basis of the information available at the design stage. It is noted in Fig. 8 that the distance between two adjacent boring logs was no shorter than about 20m and consequently the buried valley near the southern wall close to the access shaft was not identified. This fact turned out to be vital for creating the worst situations to occur afterwards.

Fig. 8. Contours of elevation at the top of the old alluvium (OA-layer) based on boring data at the design stage.

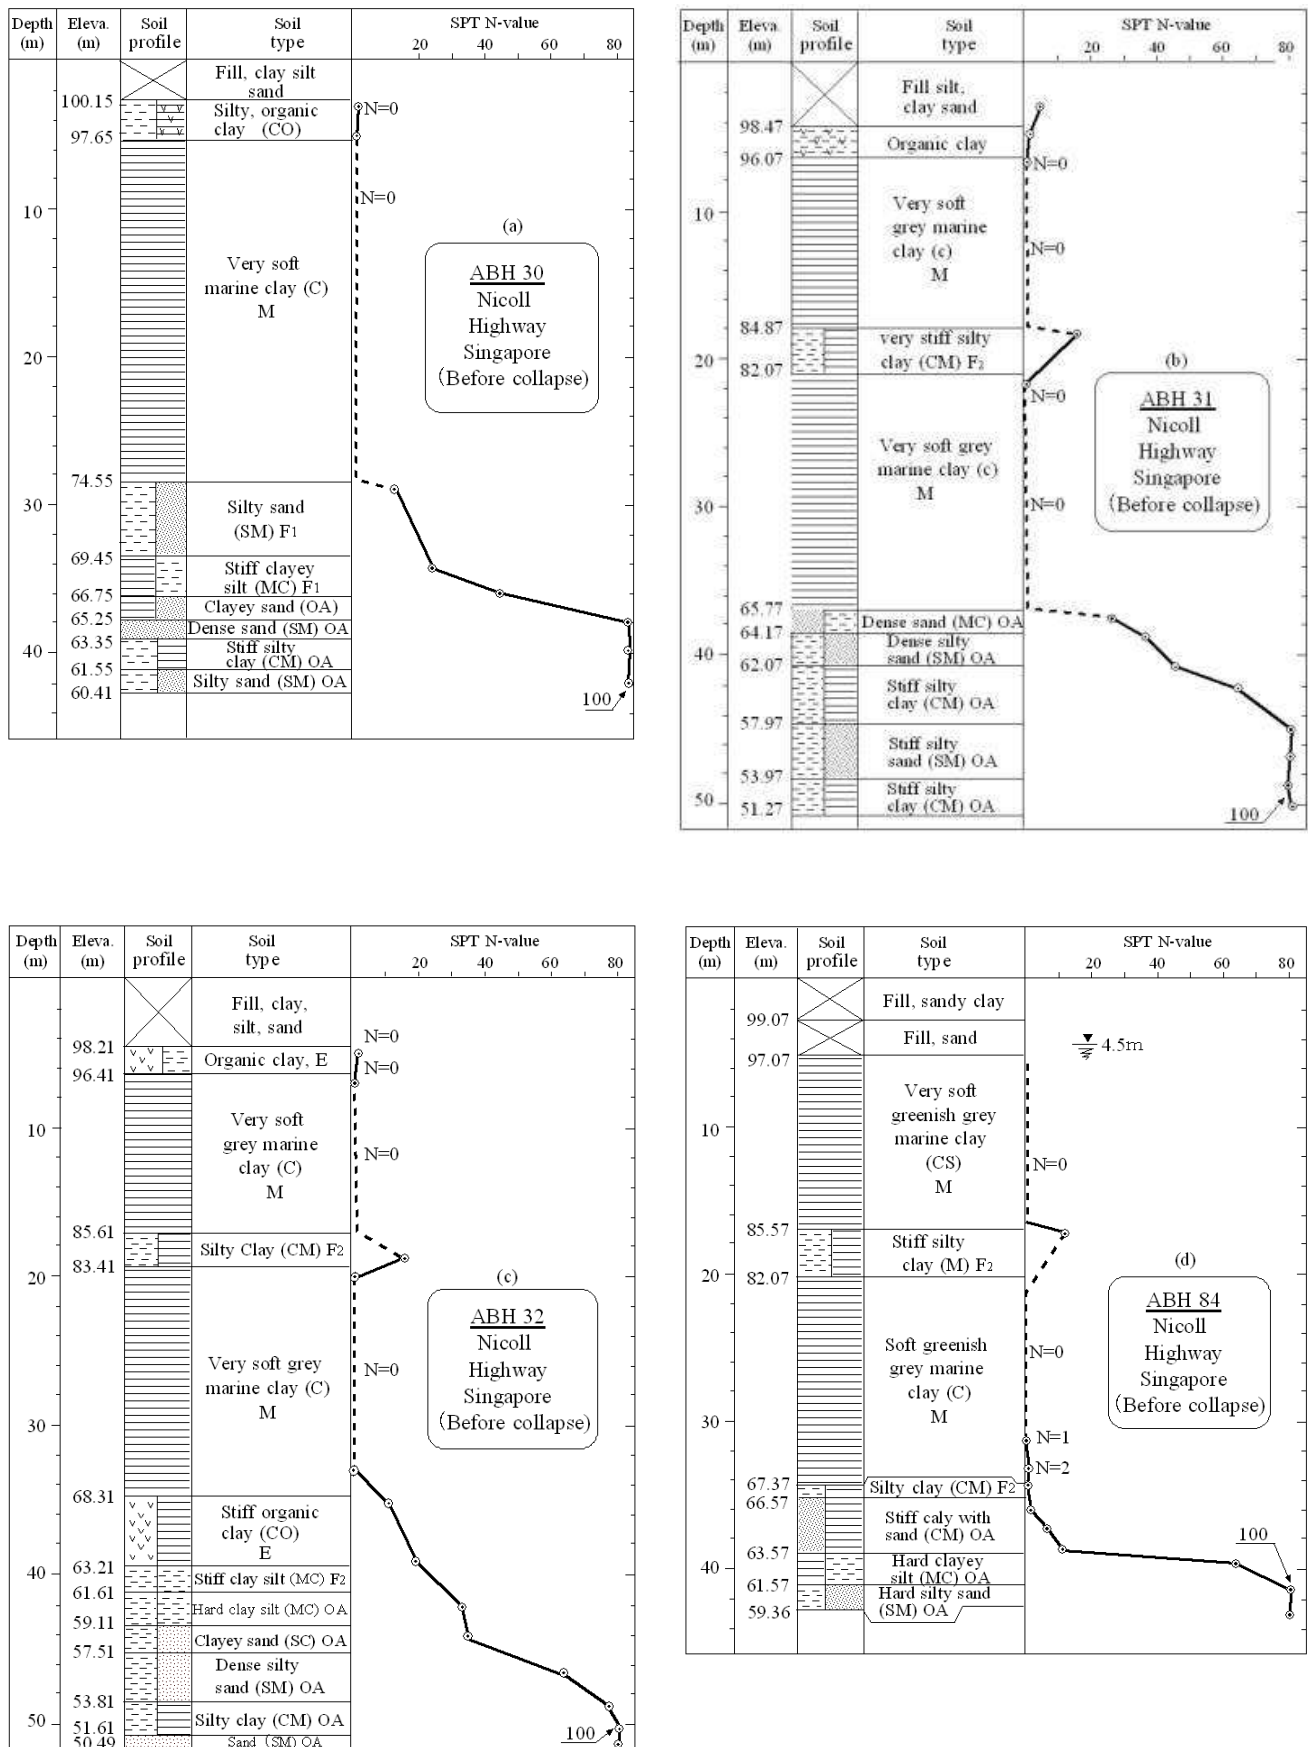
The results of the boring and SPT N-values at the site ABH30, 31, 32 and 84 are shown in Fig. 9. It may be seen that the recent fills exist to a depth of 3 to 5m underlaid by a thick deposit of soft marine clay, M, having a SPT N-value of zero. In the middle of this clay deposit, there exists a stiff silty clay layer of fluvial origin about 3m thick at the depth of 18 to 20m. This layer has a SPT N-value of 10 to 15 and denoted by F<sub>2</sub>.

Fig. 9 Soil profiles at the sites near the excavation obtained before the collapse.

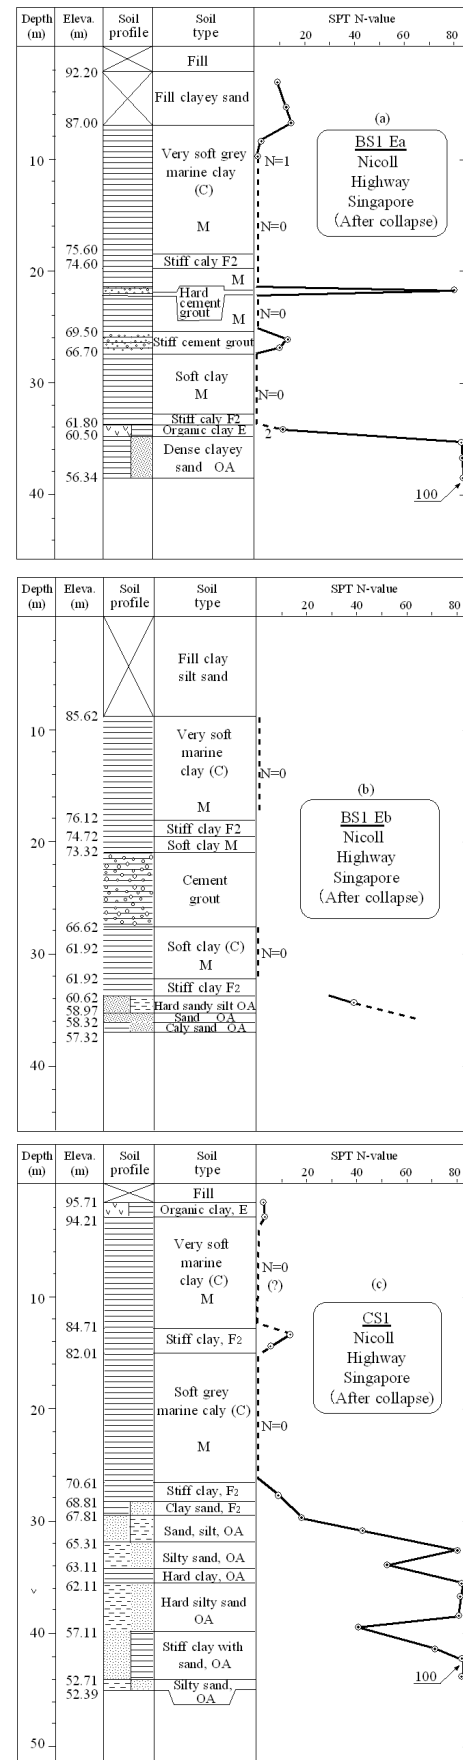
Some of the results of the borings conducted at points BS1Ea and BS1Eb about 7m south of the collapsed wall is displayed in Figs. 11(a) and (b) where it can be seen that remains of the grouted cement were encountered at an elevation of 73m and 67m RL. In another boring at CS1 shown in Fig. 11(c), the soil stratification was found to be about the same as that before the failure event.

Fig. 11 Soil profiles just south of the collapsed diaphragm wall panels.

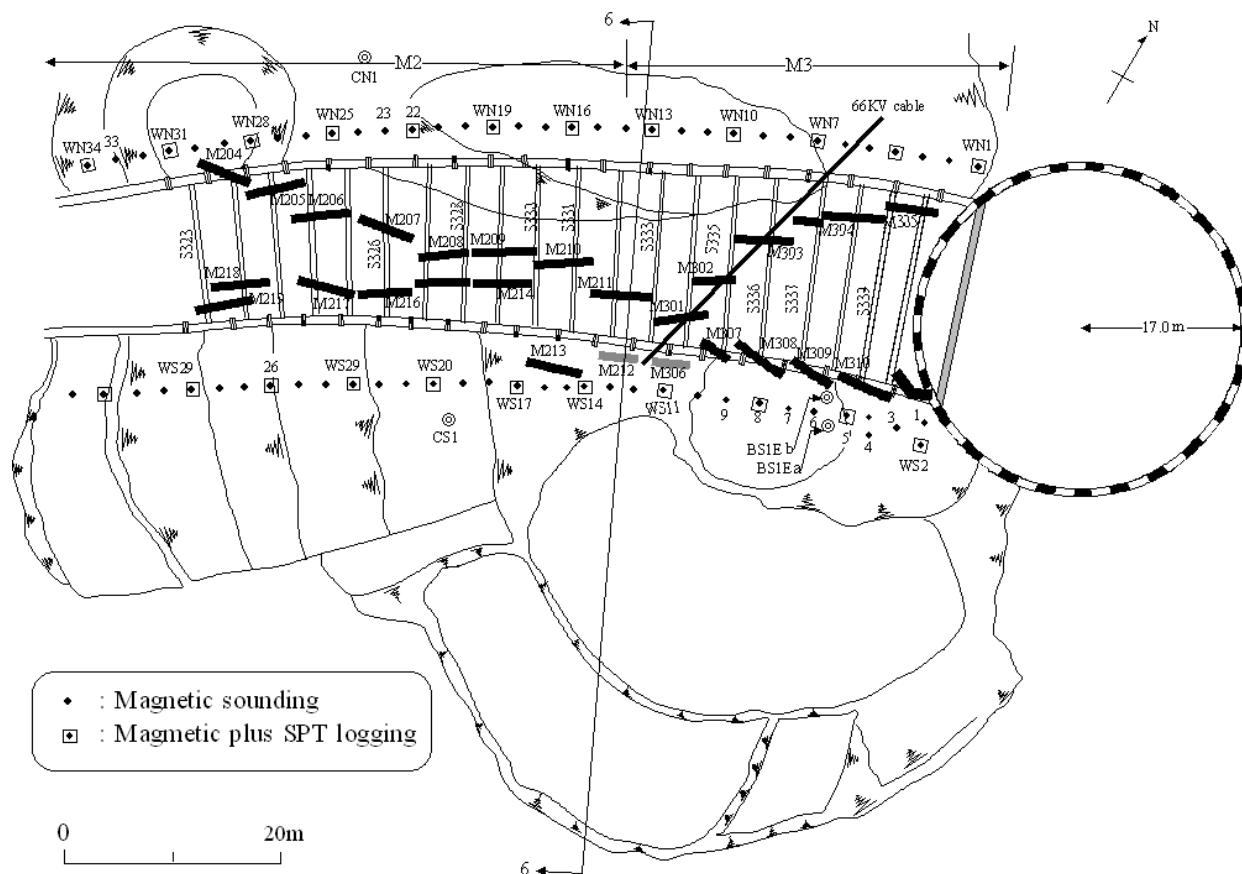
After investigating the location of the exposed top of the diaphragm wall panels, it became possible to approximately figure out the scenario of the failure. Exact locations of the panel top in plan view are shown in Fig. 12. Based on the features shown in this figure it may be mentioned that the collapse mechanism at panels M213, M212 and M306 were different from that elsewhere and almost certainly it involved the toe of the diaphragm wall panels kicking in, and flow of the soil underneath the diaphragm wall panels. This form of the failure will have allowed the maximum southward movement of the opposite north wall panels, namely M211 and M301.

Fig.12 Locations of the magnetic sounding and boring conducted after the collapse.

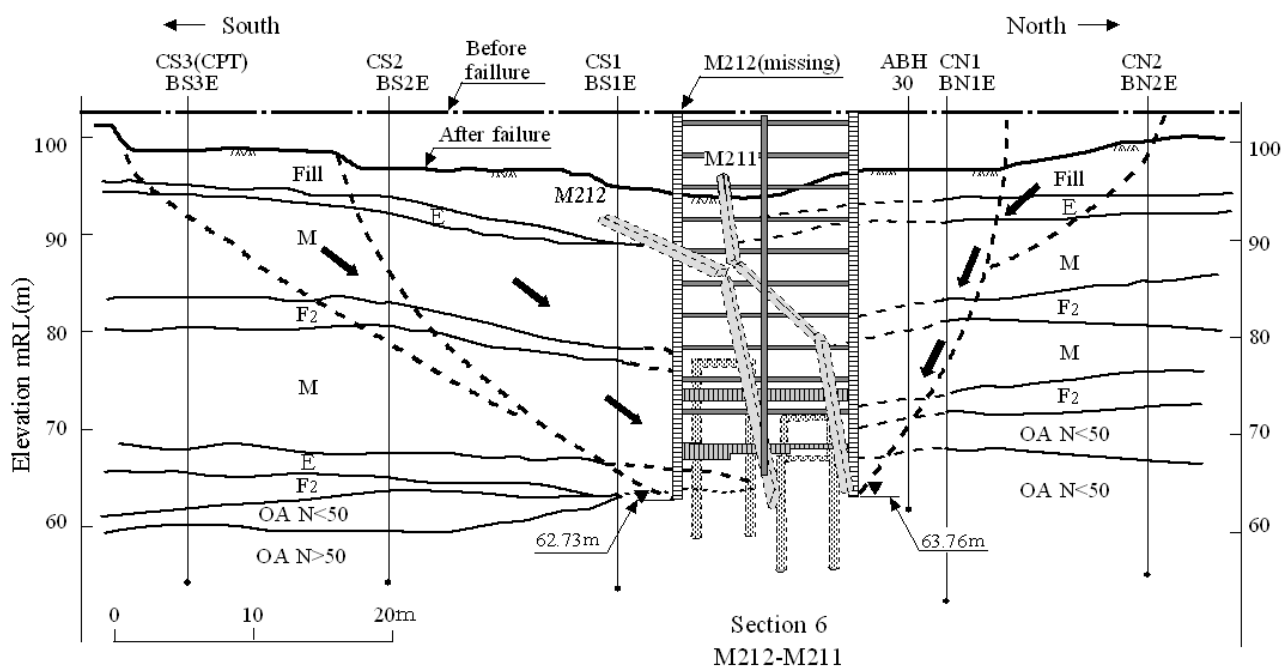
This scenario of the event was substantiated by the borings conducted after the failure in which the elevation of the intermediate layer  $F_2$  was found to be located almost 10m lower than that found by the borings before the failure. Note that prior to the collapse, the elevation of the base of intermediate  $F_2$  layer was remarkably consistent across the collapse area, and so provides a good marker for identifying the vertical displacement of the soil deposit. The location of the  $F_2$  layers after the collapse is shown in the cross-section in Fig. 11. It was then possible to depict the mode of soil movement involved in the slides on the south and north sides. The approximate locations of the sliding surfaces are displayed in Fig. 13 for the cross section 6-6 of Fig. 12.

Fig.13. Features of the ground movements towards the excavated space accompanies by the subsidence.

- (6) As a consequence of the collapse to the structural system, the diaphragm wall panels were twisted, displaced and rotated, accompanied by the slides of the surrounding ground as described in Fig. 13.

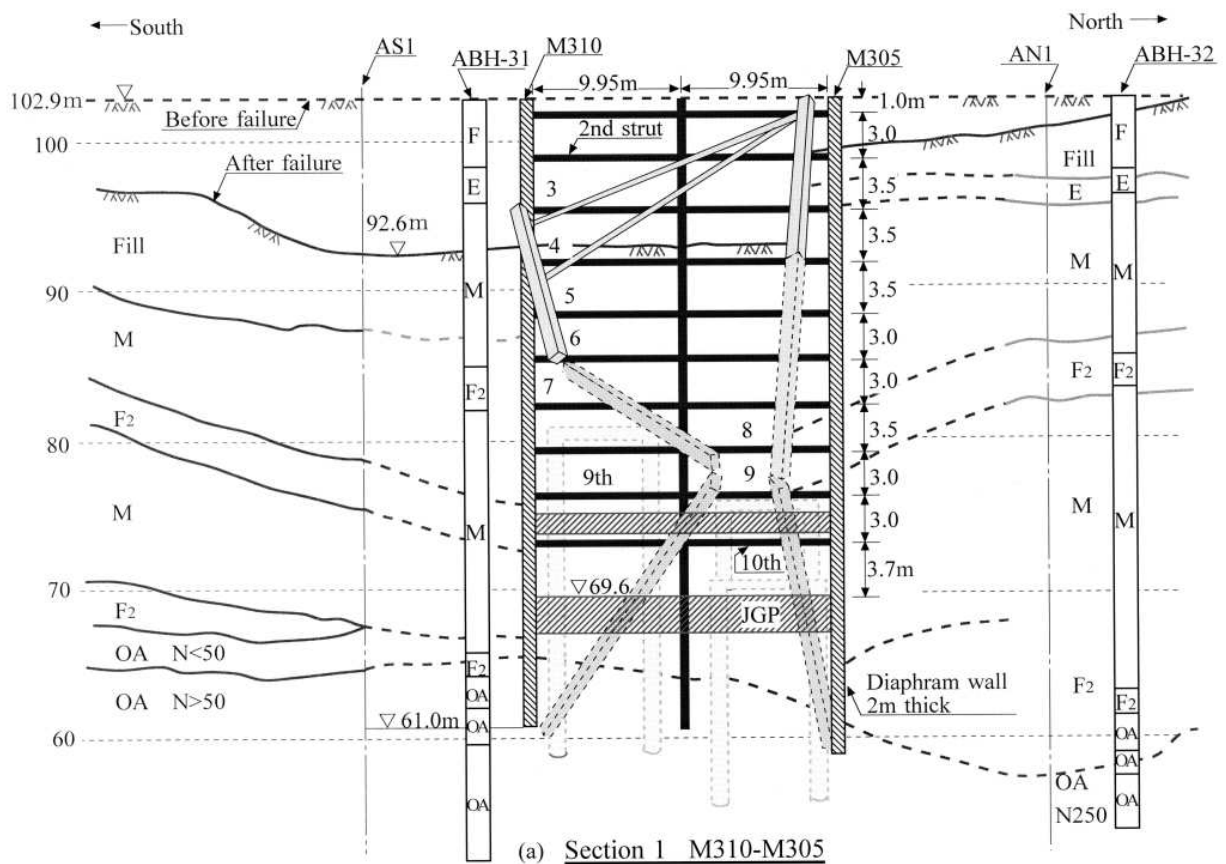
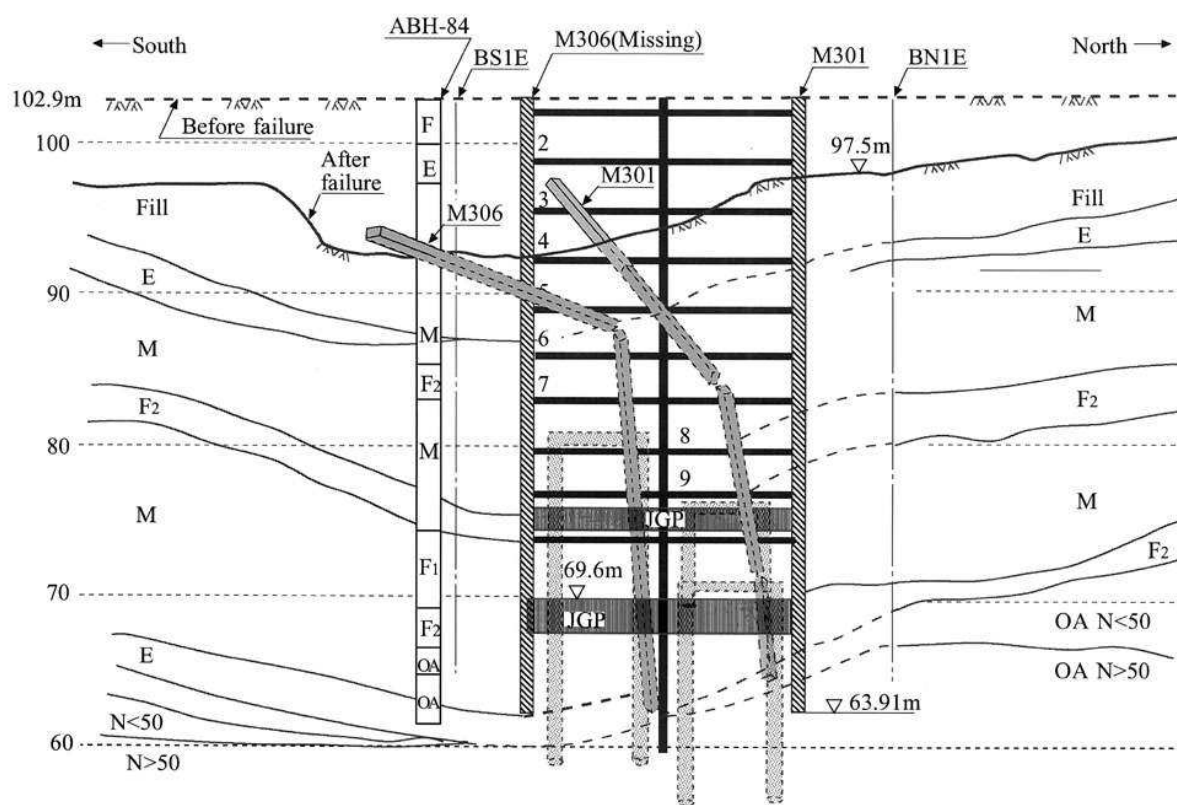
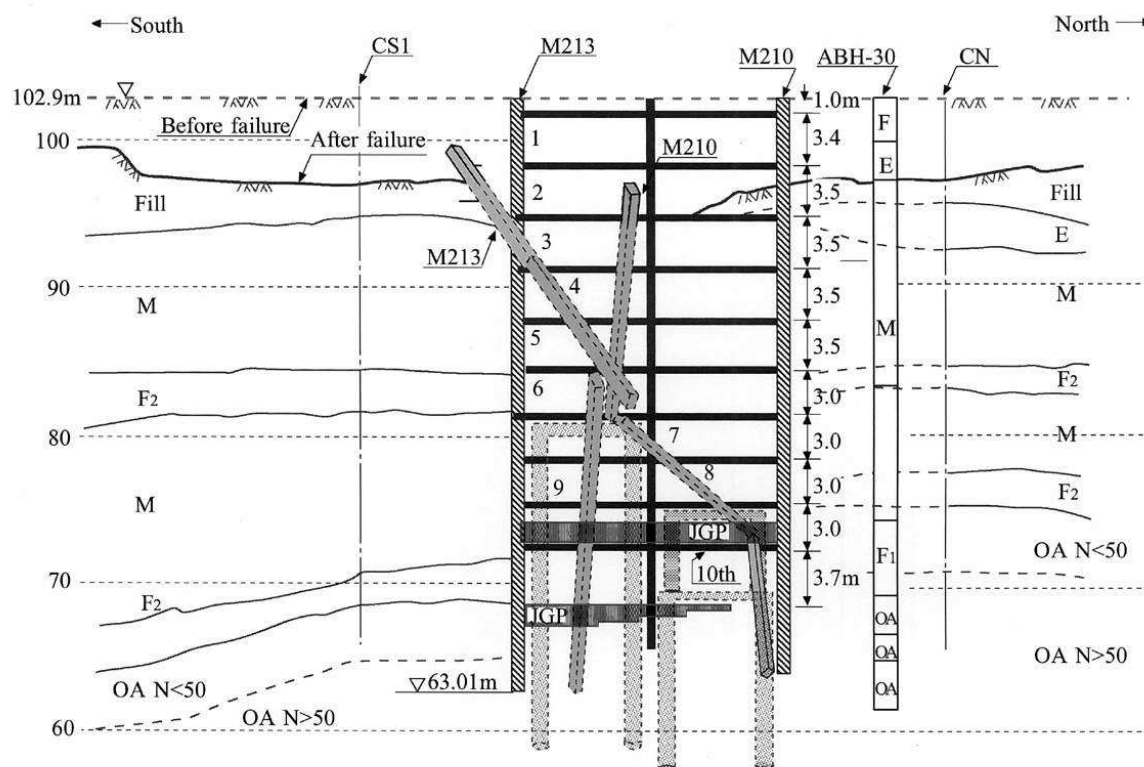
Fig.15 Cross sections showing the mode of collapse in the zone of failure.

As a result of the post-incident in-situ investigations as above, it became possible to figure out approximately the states of collapse for each of the cross sections indicated in Fig. 14. Shown in Fig. 15 are probable features of the collapsed water-strut system buried within the ground which were speculated for the cross section 1, 5 and 7. It is to be noticed that in the cross section 1 and 5, the intermediate layer  $F_2$  is inclined towards the excavation as verified by the boring data at ABH31 and 32 and also at AS1 and AN1 conducted after the failure. This is indicative of the settlement of the even deep-seated soil layer involved in the slide.

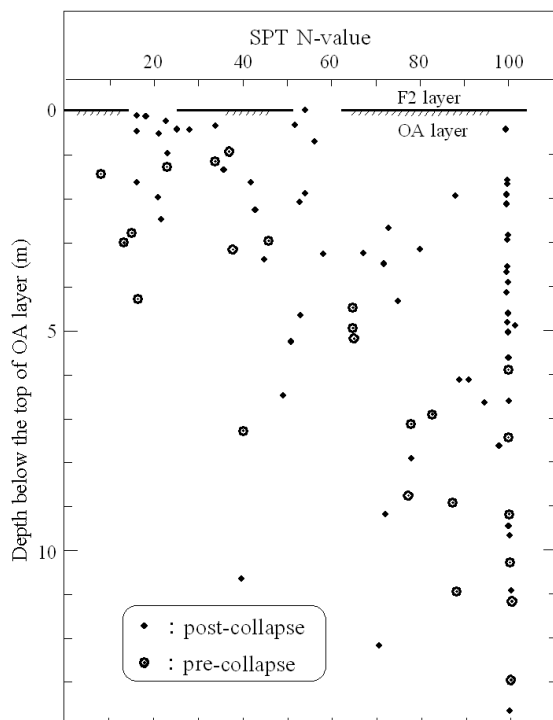
Fig.16. SPT N-values from the top of the OA layer

With regard to the latter suspect, closely-spaced soil investigations revealed that the upper part of the OA layer in the buried valley is comprised of sands, silts and clays sometimes containing organic materials with the SPT N-value not greater than 30 as demonstrated in Fig. 16. This fact indicates that the infill materials were not necessarily as competent as they had been expected at the design stage.

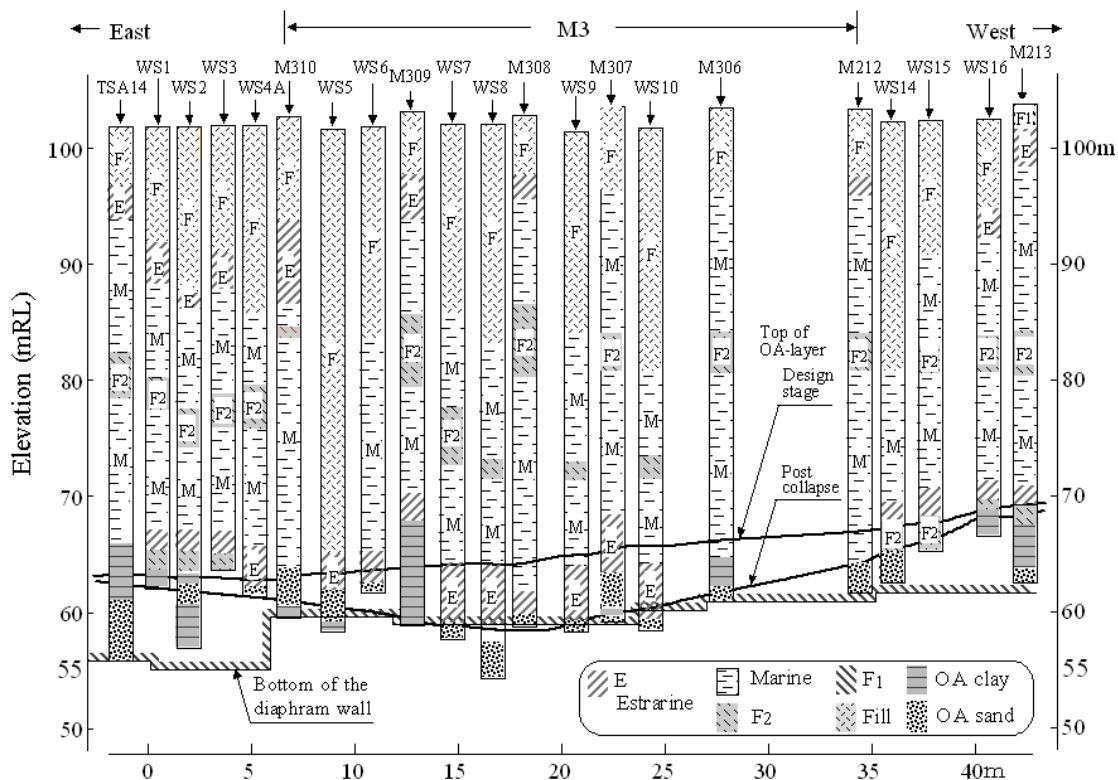
Fig. 17. Soil profile along the south wall and bottom of the diaphragm wall.

By comparing the elevations at the top of the OA layer before the collapse with those of the bottom of the diaphragm wall, it can be seen from Fig. 17 that in the eastern zone between WS1 and WS4A, the toe-in of the wall was more than 3m. In the zone of collapse between WS5 and WS16, the toe of the diaphragm wall seems not to be embedded sufficiently deep. However, the depth of embedment into the OA layer may be considered deeper than 3m in consistence with that considered in the design. It is to be pointed out, however, that the quality of the soils at the upper part of the OA layer was less competent in stiffness or strength as compared to that assumed at the time of the design. This point would have a more important bearing from the forensic point of view.

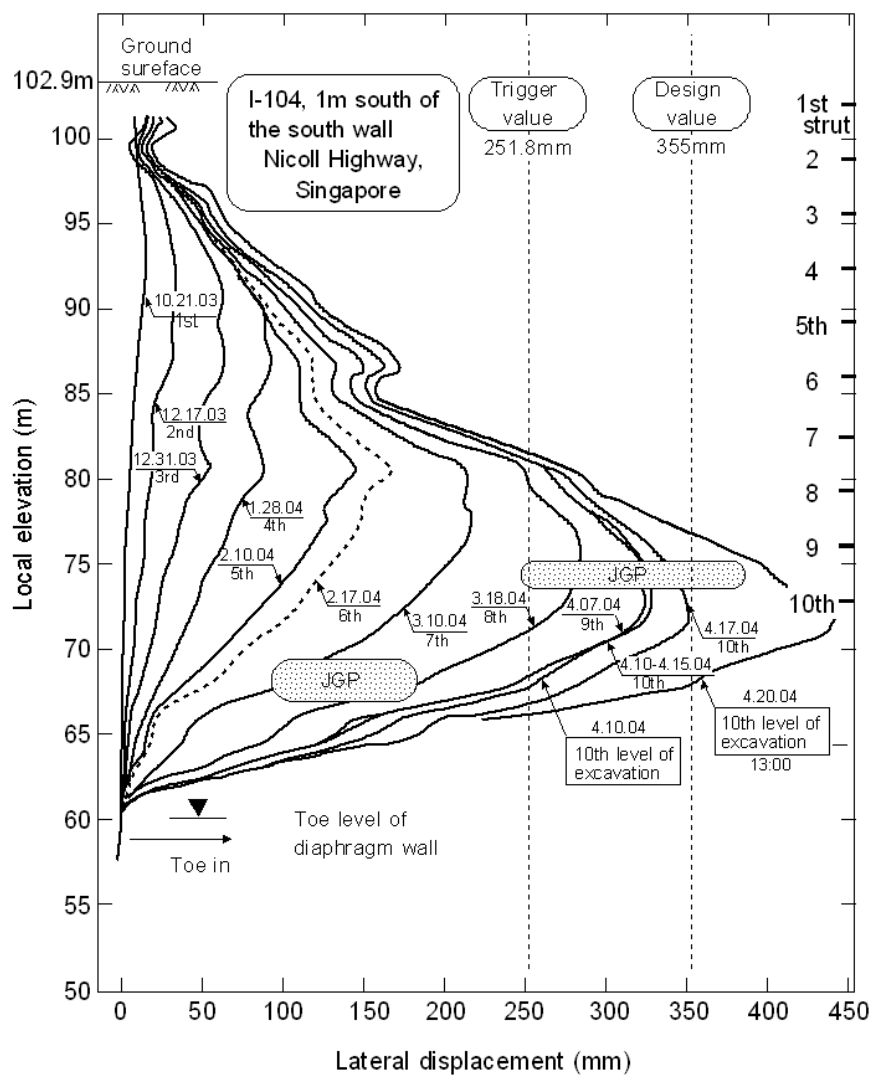
Fig. 19 Time change of depthwise distribution of the wall measured by the inclinometer in the soil deposit 1m apart from the south wall.

In the area which failed there were inclinometers at or just behind the wall at the north and south sides of the excavation. Shown in Fig. 19 is the time change of depthwise distributions of the wall deflection estimated from the inclinometer, I-104, which had been installed in the soils 1.0m apart from the south wall near M212 (Fig. 18).

It is known that the wall deflection started to increase significantly from April 17, 2004 as indicated by a dash line in the figure.

The maximum displacement measured at 13:12 on April 20, 2004 is known to have amounted to 43.5cm at the elevation of 72m. It is to be noticed that actual collapse took place at 15:33. i.e. 2 hours 21 minutes (141 minutes) afterwards. Thus, it is likely that just at the time of collapse, the maximum value of the wall deflection might have been larger than 43.5cm. It should be cautioned that the waler-strut system had sustained the deflection of at least 43.5cm for the period of 141 minutes without causing collapse.

To be noticed, moreover, is the fact that the distribution of the wall deflection shown in Fig. 19 was obtained by integration of tilts at several depths measured by the inclinometer on the assumption that the tilt at the toe was equal to zero. This assumption may not be correct in the present case, because the toe of the diaphragm wall had not been firmly embedded in a stiff base stratum. Thus, the distribution of the wall deflection shown in Fig. 19 should be taken simply as indicating the relative displacement counted from the toe of the diaphragm wall.

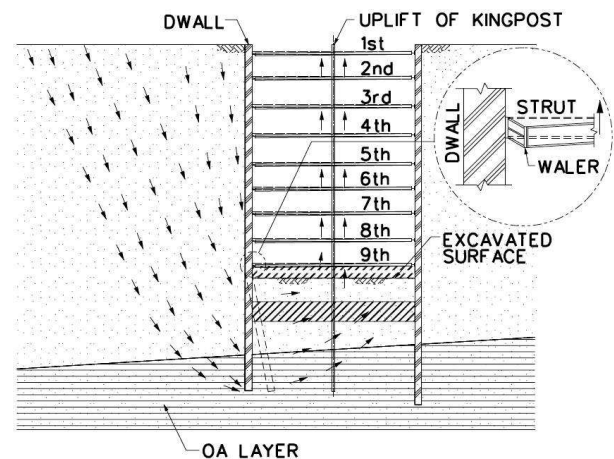
Fig. 19. Probable movements of soils near the toe of the diaphragm wall, and uplifting of the kingpost and sag of the wall leading to buckling and offset between strut and waler.

- (2) The inward movement of the wall panel toe must have caused some uplift of the soil deposits within the excavation, which induced in turn a lift-up of the kingpost in the middle of the struts. In addition, excavation has nullified

friction between the soil deposits inside and the diaphragm wall thereby inducing some sag of the heavy-weight wall. The sag must have caused the offset between the strut and walls.

- (3) This uplift, combined with the sag of the wall must have caused the local buckling or breakage of the flange of the H-beams at connection between the walers and struts, creating as much as 20cm vertical offset as illustrated in Fig. 20. As a result, the net length of the struts was shortened and diaphragm wall must have deformed further inwards.
