## A Case Study of Observational Method for a Failed Geotechnical Excavation in Singapore

Y. Iwasaki

**ABSTRACT:** Observational Method (OM) was studied based upon a case history of failed geotechnical excavation in Singapore. Several items including inclinometer provide vital information on the safety of the geotechnical construction sites. Engineer who is specialized in OM, adequate knowledge of geotechnical engineering as well as instrumentation, should be engaged during the design and construction phase. An ISO standardization is necessary to provide a basic process to implement OM.

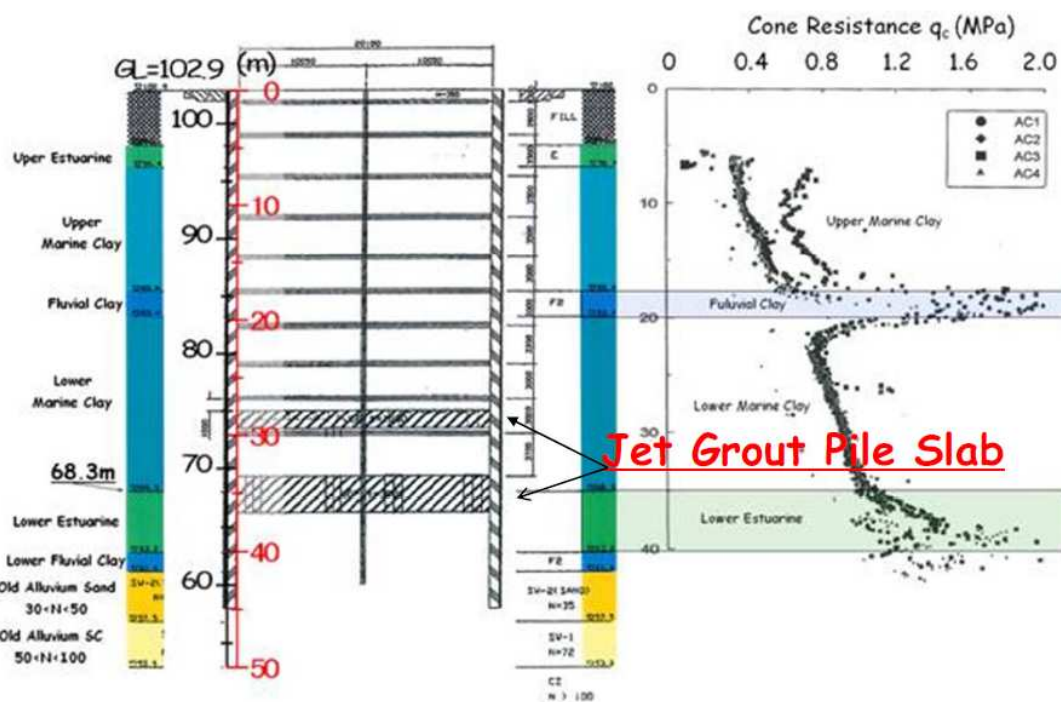
Fig.3 Design of Cut and Cover of Type M3

As shown in Fig.3, the special design was two sets of Grout slabs that had been installed before the

excavation started. The depth of the excavation was planned to GL-34.5 m above the lower grout slab. The cone penetration resistance shown in Fig.3 shows very soft soil down to 35m from the surface where stiff clayey soil continues.

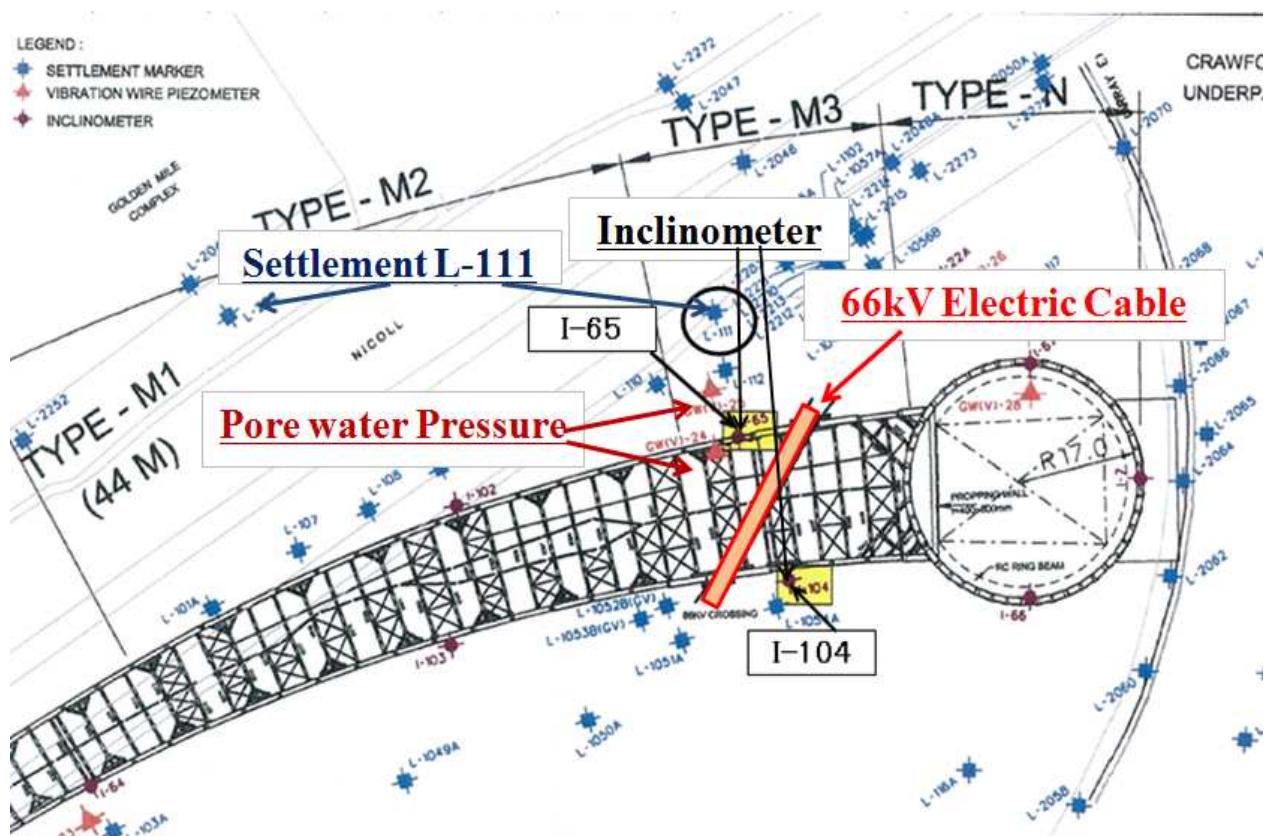
Fig.4 Instrumentation at the failed site

The site was rather well instrumented to monitor settlement, pore water pressure, strut strain, as well as inclination along diaphragm wall as shown in Fig.4. Settlement was to monitor the ground where Nicoll Highway passes north of the excavation site nearby. Decrease of pore water pressure that would cause consolidation settlement of the foundation of the Nicoll Highway was also monitored. Inclinator monitoring points at I-65 and I-104 were installed along the diaphragm wall where the electric cable of 66kVolt had been installed and the diaphragm walls were missing at the sections where the cable cross over the wall lines.

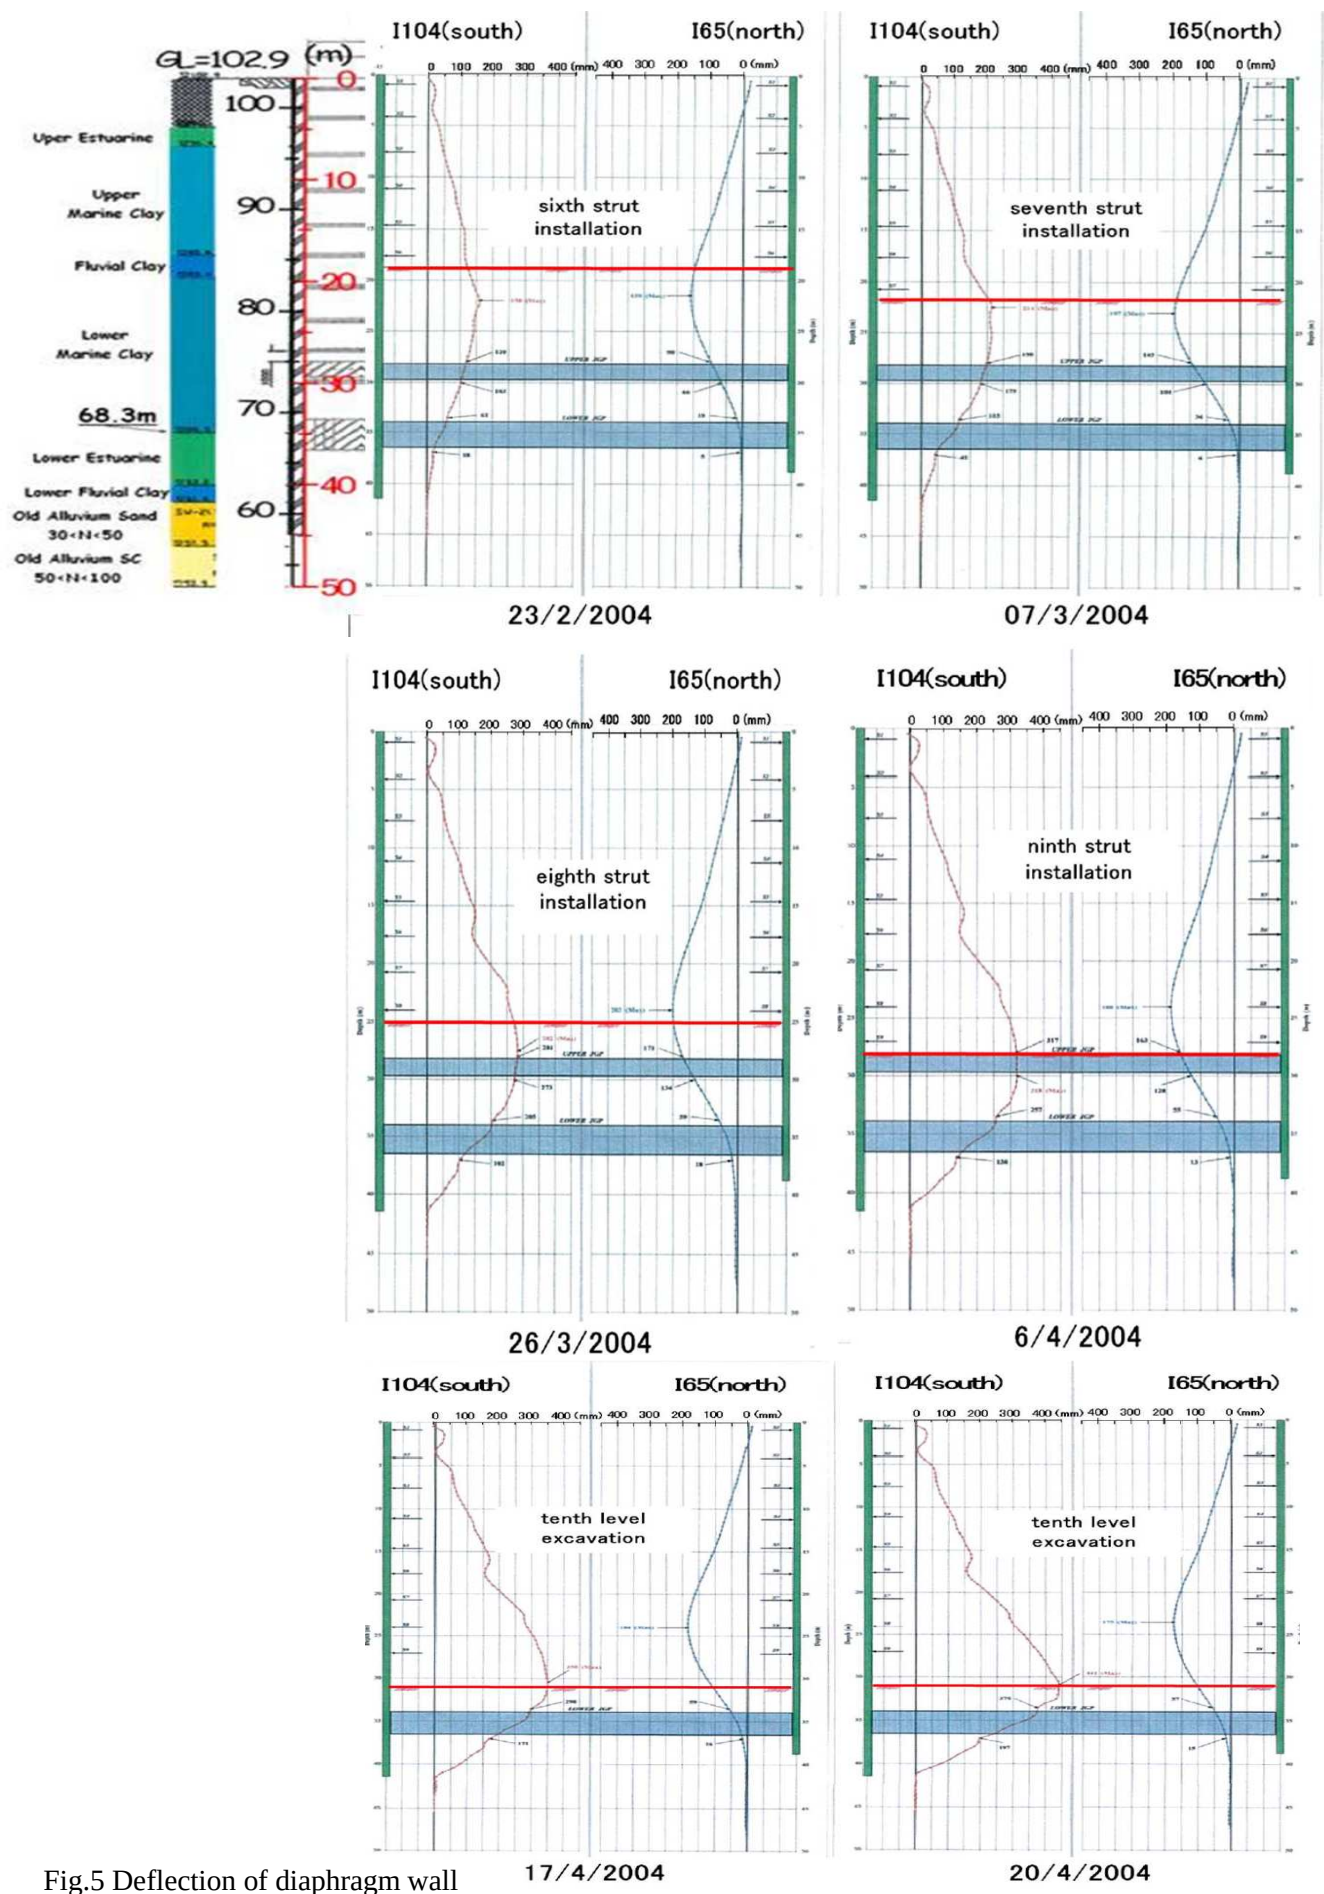
Fig.5 Deflection of diaphragm wall

Excavation started on 26 September, 2003, at the M3 Section. The monitored wall deflections from the six strut installation until before the failure took place are shown in Fig.5 as well as chronological time change of excavation with strut and the maximum deflection for I-65 and I-104 in Fig.6.

As shown in Fig.5 and Fig.6, the deflection after the sixth strut installation, the total deflection had reached 35cm, which resulted in about 1.7%.

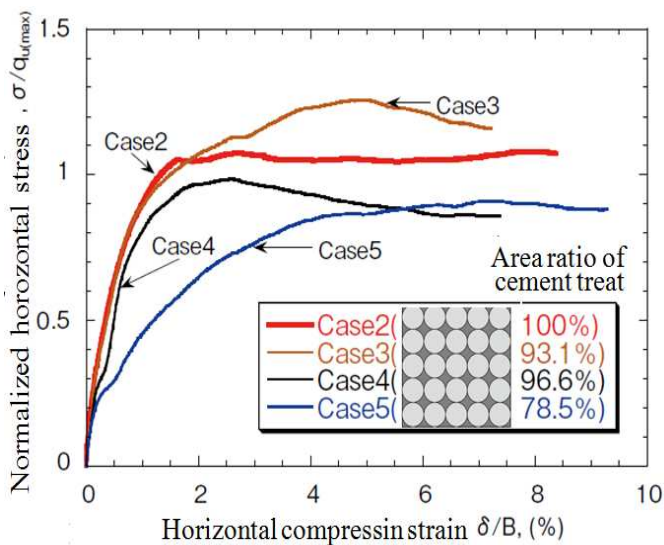
Fig.7 Stress-strain for JGP (Imamura et al.(2008))

Fig.7 shows basic stress and strain for horizontally loaded JGP obtained by laboratory tests (Imamura et al., 2008). The vertical stress was normalized by dividing horizontal stress by the unconfined compression strength of column of JGP (500kPa). Fig.7 shows the maximum allowable horizontal strain is estimated as 2%.

If safety margin is given as  $FS=2$ , the allowable deflection at the level of JGP is 1%, which is 20cm in total, or, 10cm for each side.

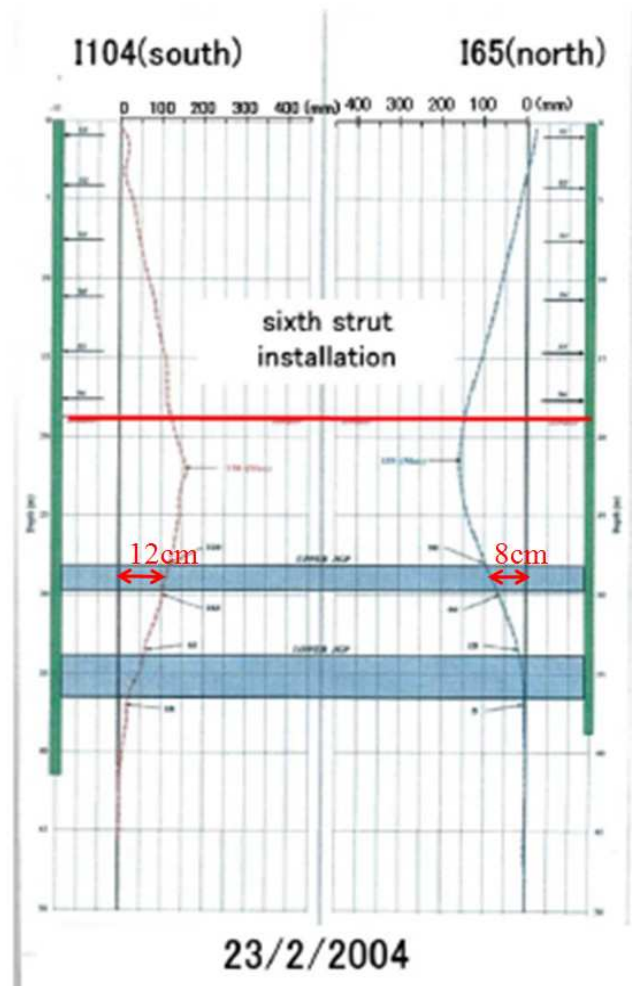
Fig.8 Wall deflection monitored after the sixth strut

As shown in Fig.8, the deflection at the level the upper JGP slab had reached 12cm for southern and 8cm for the northern side wall.

At this stage, different response of the wall deflections for north and south sides should have been noticed. The lower JGP was observed to have moved into center with about 5cm for southern side but no displacement for northern side.

When the strut 8 was completed, the displacement for southern wall had increased to 35cm (25cm for southern and 10cm for the northern wall) at the upper JGP slab, which was 1.8% almost in failure. The asymmetry of the wall deflection for north and south sides was increased with the excavation steps.

If OM should be applied, this could be the one of the critical phase when some countermeasures should be considered. The possible countermeasures include additional soil improvement in the zone above the upper JGP slab and/or additional strut installation to strengthen the temporary retaining structure.

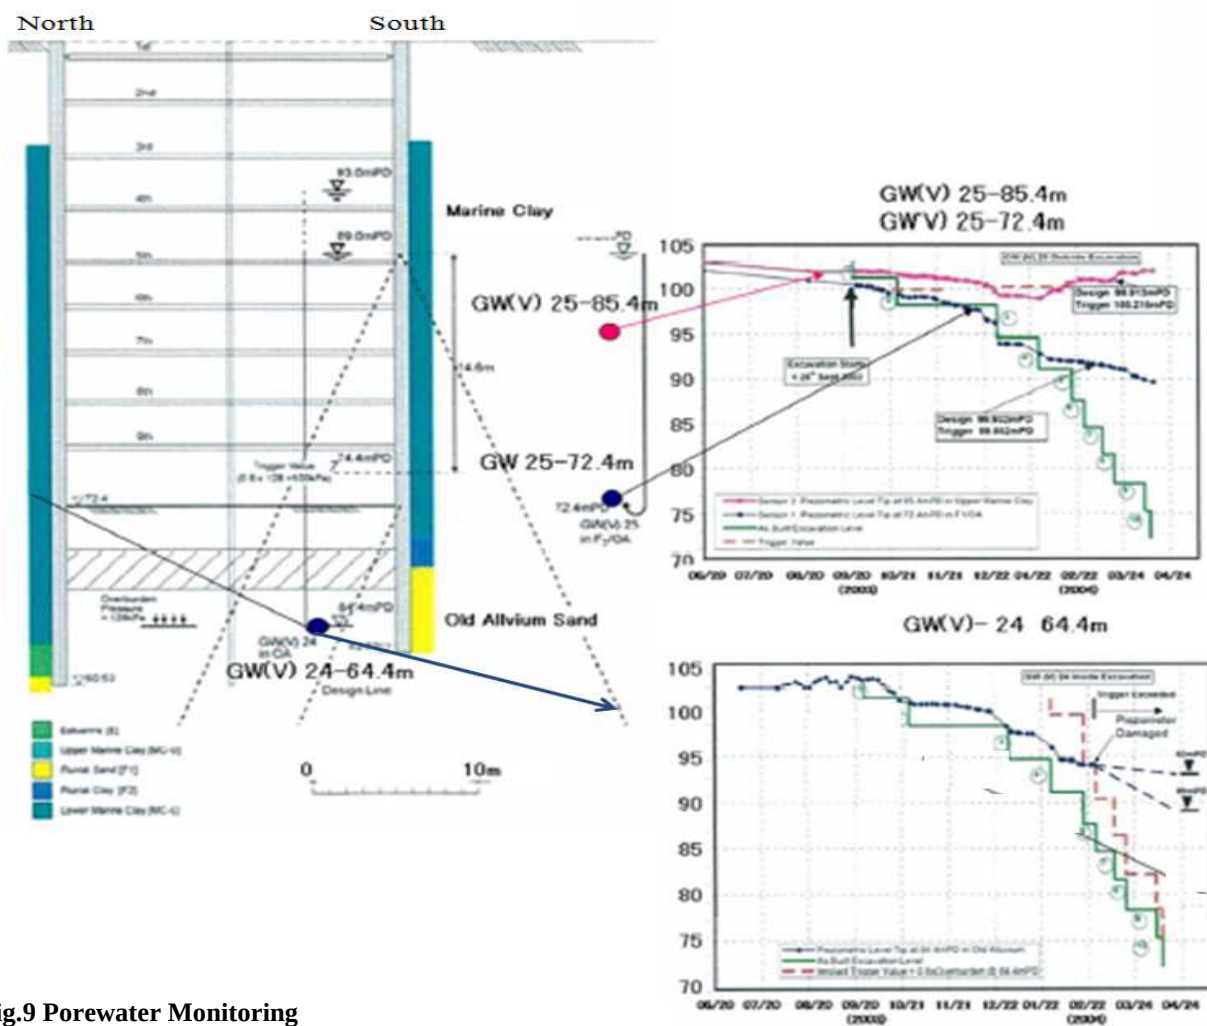
Fig.9 Porewater Monitoring

The pore water pressure was monitored at two depths at GL-17.5m and -30.5m of behind the diaphragm wall. The ground water was observed GL-2m in general in the area.

The porepressure at GL-17.5m had gradually decreased with excavation stage.

The decrease of the pore water pressure might be caused by inwards movement of the diaphragm wall that had resulted in volume expansion of the soil behind the wall.

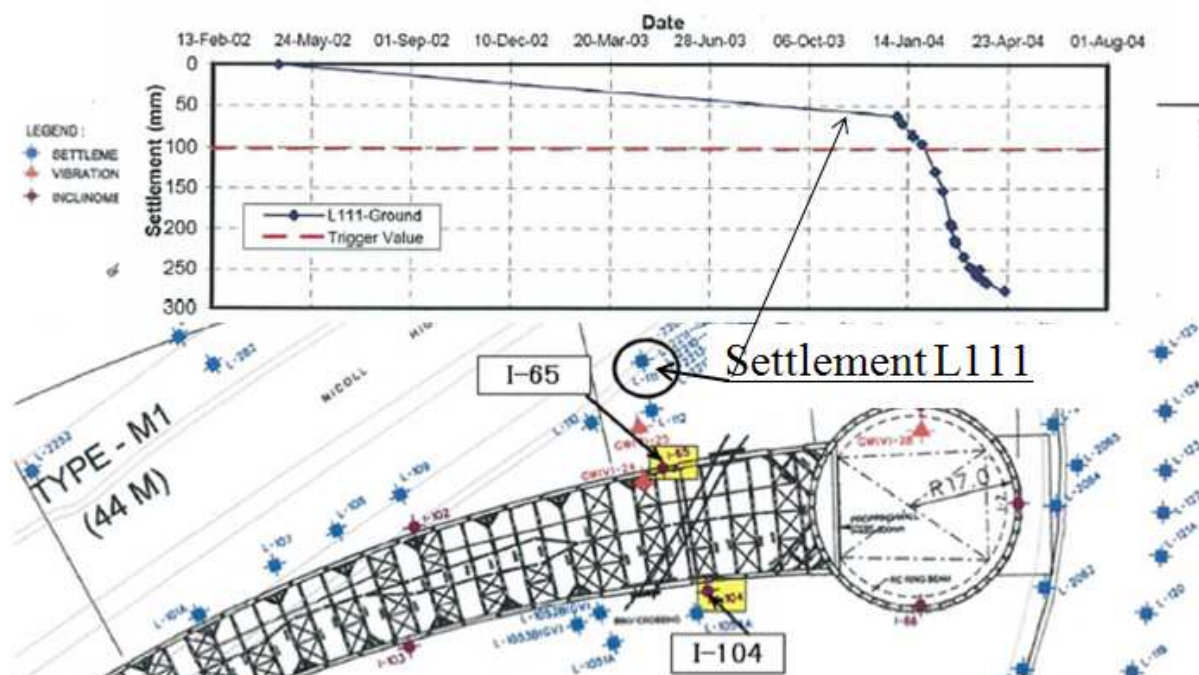
Fig.10 Settlement Gage at L111 and monitored result

monitoring had been installed for the evaluation. Pore water measurements had been also installed near the retaining wall as shown in Fig.9. One of the typical settlement installed at L111 was shown in Fig.10. The level of the ground surface was GL=+102.9m RL.

The ground settlement at L111 was gradually had taken place and reached about 10cm in January 2004. After this point, the settlement had increased rather rapidly with time.

The settlement at L111 was caused either by consolidation or displacement of diaphragm wall.

Since the settlement was increased so fast, the settlement was very likely considered by the movement of diaphragm movement.

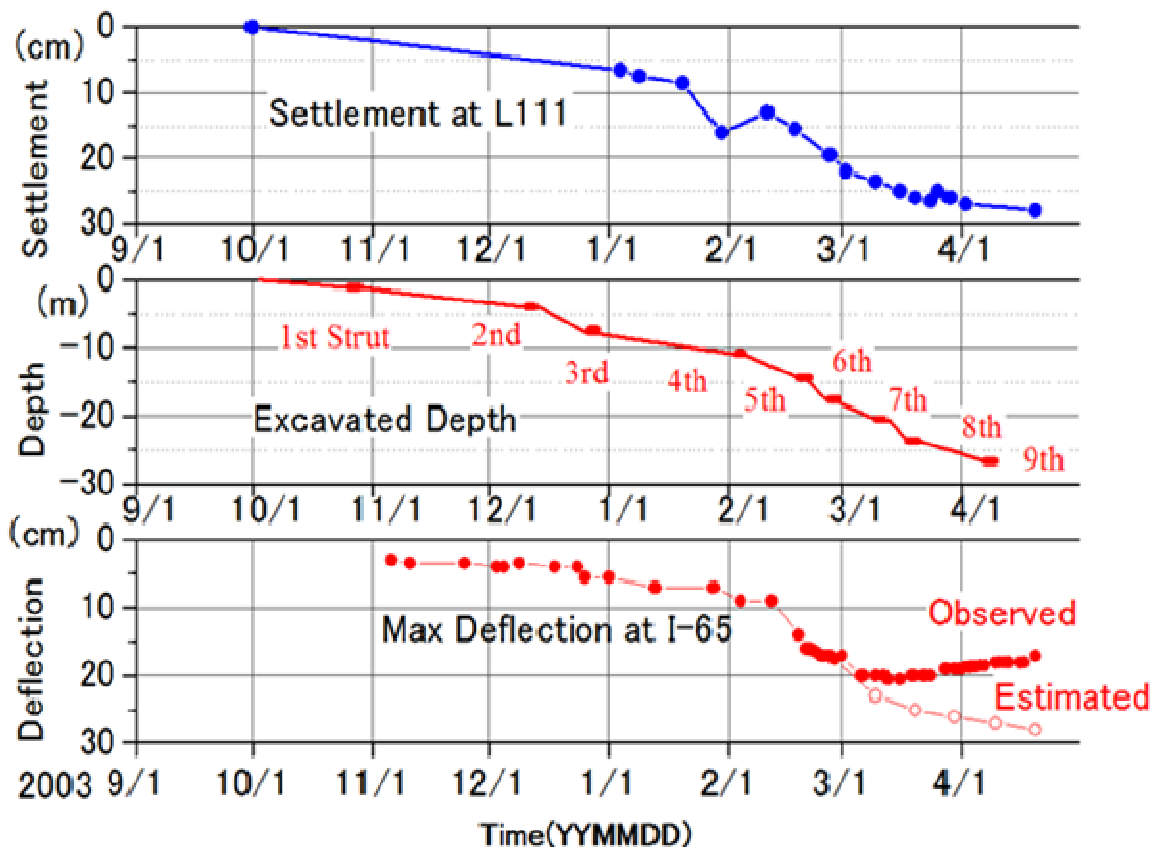
Fig.11 Settlement vs. Deflection

Fig.11 shows a comparison between the max deflection at I-65 and settlement at L-111 with the same time scale.

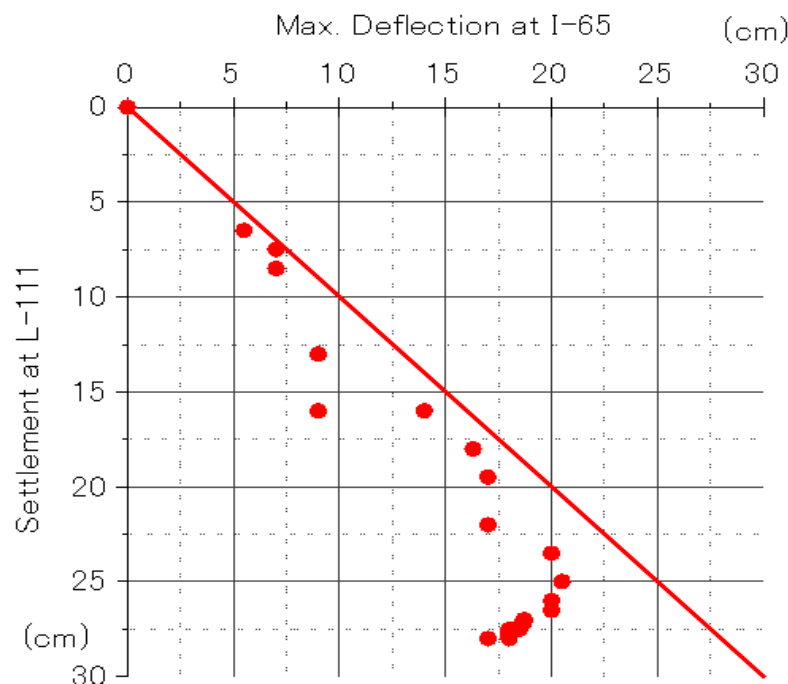
Fig.12 Max. Deflection at I-65 vs. Settlement at L-111

Fig.12 shows the relationship between the settlement and the maximum deflection. Until March 1, 2004, the settlement at L-111 is almost the same amount of the max. deflection at I-65. The direct relation of the settlement of the surface ground with the max. deflection means that the settlement is not caused by consolidation but the compensation of the soil volume caused by the retaining wall. After March 1, the settlement was continued to increase. On the other hand, the deflection had stopped and even gone backwards movement.

The backwards movement of the diaphragm wall is not easy to understand. This might be caused by the displacement assumption for the inclination calculation. It is a common practice to assume the bottom point of the inclinometer guide pipe that is embedded within rather dense sand or hard clayey layer is assumed as a fixed point. It is rather realistic to consider the bottom of the inclination guide pipe had moved. Fig.11 shows the estimated increase of the deflection assuming the linear relationship between the settlements at L-111 and the max deflection at I-65 as in Fig.12, which resulted in about 28cm..

To avoid any misguided result, the displacement of the top of the guide pipe should always be monitored when the inclinometers are measured.
