## Damages to Metro Tunnels due to Adjacent Excavations

**ABSTRACT:** Metro tunnels are vulnerable to ground movements, therefore precautionary measures must be taken to prevent potential damages to existing tunnels if excavations are to be carried out in close proximity to tunnels. Presented herein are the regulations adopted to protect the Taipei Metro and three case histories on damages occurring to metro tunnels to illustrate how tunnels respond to activities associated with excavations. It has been found that localized ground treatment would not serve the purpose of reducing wall movements and neither would a single buried cross panel in excavations with considerable lengths.

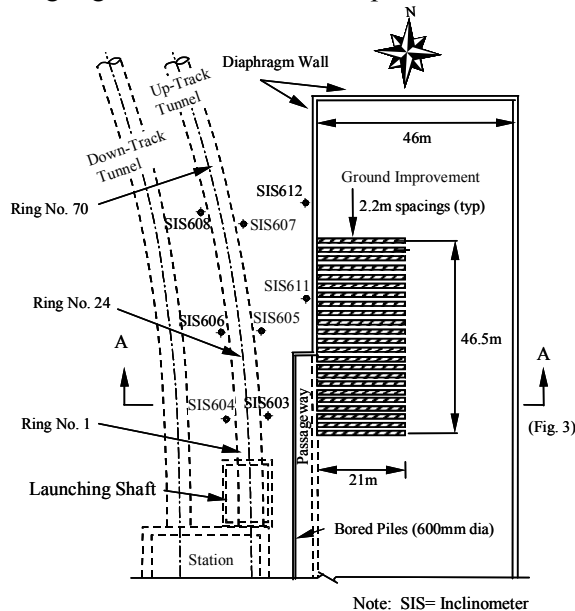
Fig. 2 Case 1 – Site plan and locations of instruments

Shown in Fig. 2 is a case in which excavation was carried out to a depth of 21.1m with a minimum distance of 12m to the nearest tunnel, i.e., the up-track (Chang, et al., 2001). The excavation was carried out in the period of 1996 to 1998 before the Regulations were amended. Specifications were not as stringent as they are nowadays, therefore, the excavation was conducted without prior approval from the metro authority and were not closely watched till cracks were observed on the linings when the excavation was about completed.

The soft deposits at surface are underlain by a thick gravelly layer at a depth of 50m. The retaining diaphragm walls were 1.2m in thickness and 36m in length. Despite the fact that, as shown in Figs. 2 and 3, jet grouting had been conducted to treat a block of soil in an attempt to reduce wall movements, lateral movements of the ground were

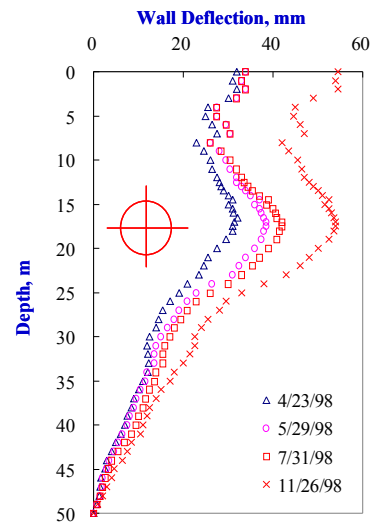
Fig. 4 Case 1 – Readings of Inclinator SIS605

quite large. As depicted in Fig. 4, Inclinator SIS605 showed a maximum wall movement of 54mm at the depth coinciding with the depth of the tunnels. Figure 5 indicates that the longitudinal axis of the up-track tunnel moved by as much as 27mm laterally and settled by 33mm maximum. As a result, the invert slab became detached from the lining segments and had to be replaced.

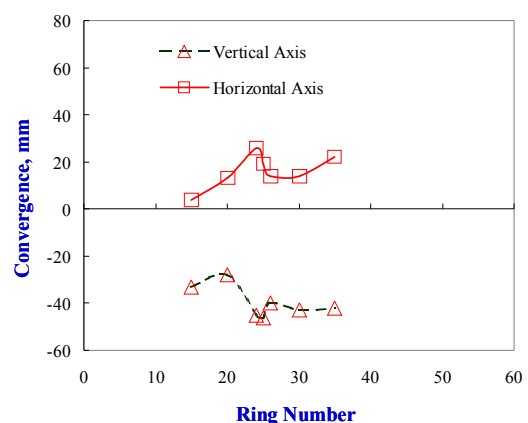
Fig. 6 Case 1 – Convergences of linings of the up-track tunnel

Shown in Fig. 6 are the convergences of linings in the tunnel obtained by configuration survey. The maximum changes in diameter were 46mm in the vertical direction and 28mm in the horizontal direction. Ring No. 24 (or, simply 24R), which appears to be the most affected, was shortened by 45mm in the vertical direction and elongated by 26mm in the horizontal direction. A total of 41 rings (10R to 50R) were severely damaged and had

to be reinforced by steel segments as a secondary lining.

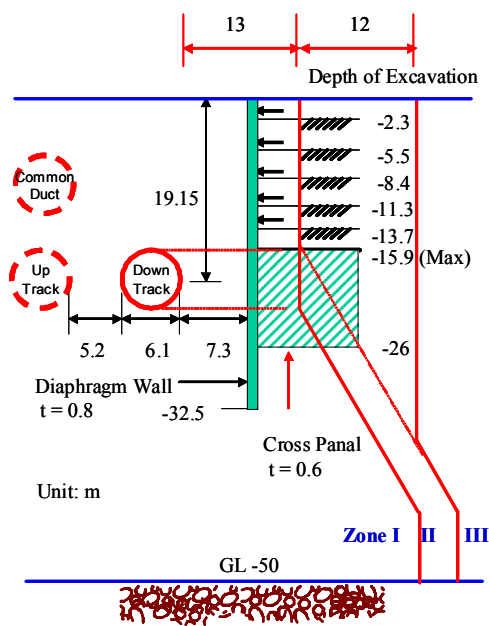
Fig. 8 Case 2- Excavation scheme

deposits at surface are underlain by a thick gravelly layer at a depth of 50m. The retaining diaphragm walls were 0.8m in thickness and 32.5m in length. As shown in Fig. 8, excavation was partly carried out in Zone 1 and measures were required for reducing ground movements. Accordingly, a cross panel, 0.6m in thickness and 10m in depth, was installed by using the diaphragm walling technique and was structurally connected to the diaphragm walls to form T-joints at its two ends.

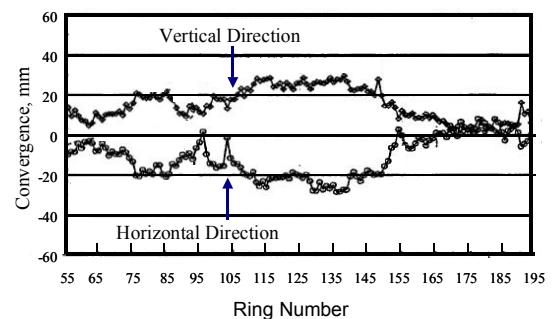
Fig. 9 Case 2- Convergence of the down-track tunnel (2010/1/18)

Ring No. 134 (or simply, 134R) was found to have lengthened by 19.9 mm in the horizontal

direction and shortened by 13.7mm in the vertical direction on 26 October 2009 when the excavation was approaching its final depth. The former already exceeded the Alert Level of 15mm. The squashing of the ring continued; and the lengthening of the diameter in the horizontal direction reached 27.5mm and the shortening of the diameter in the vertical direction increased to 21.4mm on 18 December. Since the former exceeded the Action Level of 25mm, an injunction was issued on 25 December by the metro authority and the excavation was halted. Crack gauges were mounted on 5 rings next to 134R as depicted in Figure 7 for long-term monitoring of the changes in widths of the cracks. In addition to 134R, the convergences of 137R, 139R and 141R were also monitored daily. The readings taken for 55R to 195R on 18 January 2010 are depicted in Fig. 9.

To avoid deterioration of the situation, temporary struts were installed at the B4 level in the excavation to limit wall movements and internal bracings were installed in the tunnel to limit the deformations of 99R to 155R. These measures

were completed on 25 January 2010 and were found effective as the deformations of the tunnel did not increase further subsequently.

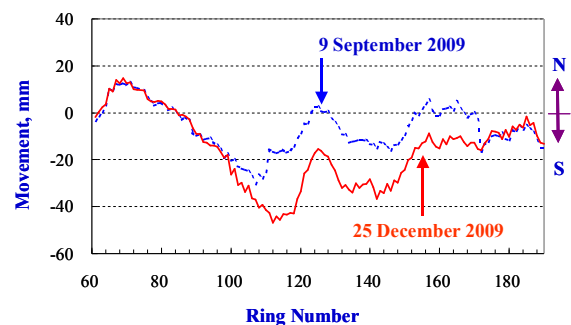
Fig. 10 Case 2- Horizontal movements of the down-track tunnel

Figure 10 shows that the longitudinal axis of the tunnel moved southward toward the excavation by, as much as, 30mm by 9 September. The section between 110R and 170R was found to have further moved by 20mm when the injunction was issued on 25 December 2009.

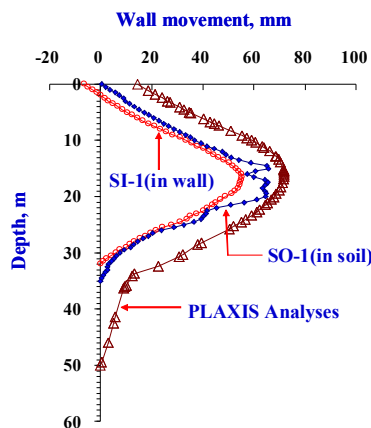
Fig. 11 Case 2- Inclinometer readings (2010//3/24)

Figure 11 compares the readings obtained by two side-by-side inclinometers on 24 March 2010 with the results of numerical analyses using the finite element program PLAXIS. It is estimated that the toes of these inclinometers moved by 10mm or so because they did not reach the bearing stratum.

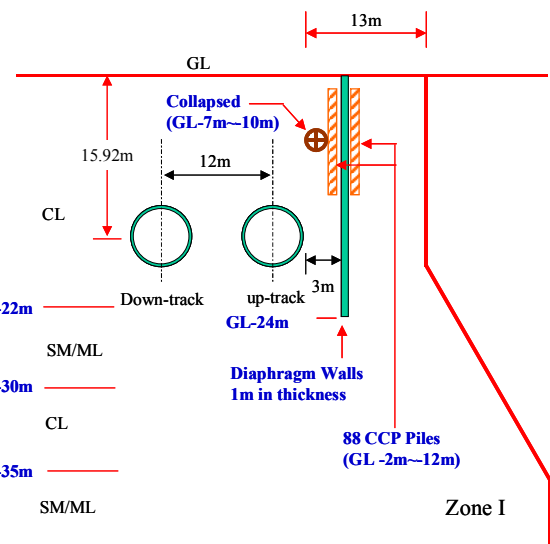
Fig. 13 Case 3 – Remedial measures

They were installed from a depth of 2m to a depth of 12m below ground surface as depicted in Fig. 13.

As shown in Fig. 13, although the upper portion of the trench was protected by CCP piles, the lower portion was not. Therefore, localized collapse could have happened thereat. Even without collapse, large lateral ground movement could have been induced as a result of the relief of the horizontal geo-stresses. As shown in Fig. 14, Units #3M, #4F, #5M and #7M (M stands for male and F

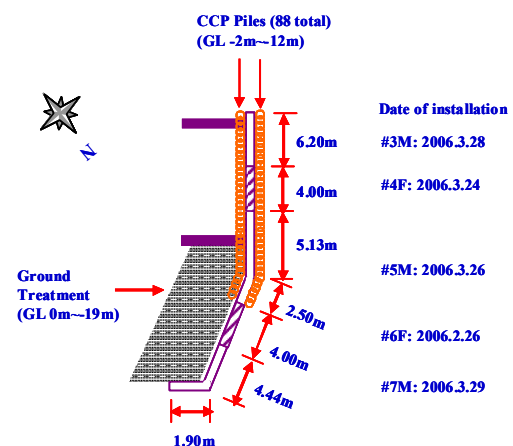
Fig. 14 Case 3- Protection measures

The diaphragm walls were 1m in thickness on the north side and 0.7m everywhere else. The trench collapsed during the installation of Panel #4 on 3 March 2006. As shown in Fig. 14, CCP piles, 400mm in diameter, were sunk on the both sides of the trench in the period between 5th and 8th March to ensure that this unit and two neighboring units could be successfully installed. They

stands for female units) were installed within a rather short 5-day period between 24 and 29 March. Ground movements could partly be attributed to the fact that trenching was carried for secondary panels before the primary panels became stable. Unfortunately, instrument readings were not taken till 20 April.

To reduce ground movements during excavation, ground treatment was carried out at the corner next to the excavation, as depicted in Fig. 14, to the same depth of the bottom of the tunnel, i.e., 19m. Two rows of cast-in-place piles were installed immediately next to the wall, followed by 6 rows of cement-soil-mixing piles giving a total of 192 piles. All these piles were of 600mm in diameter. Excavation was resumed and successfully carried out to the final depth of 11.9m.

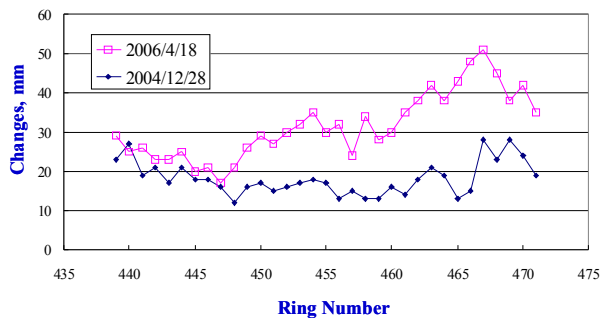
Fig. 15 Case 3- Convergences of linings

Cracks were observed on linings and configuration survey conducted on 18 April revealed that, as depicted in Fig. 15, the deviations from the theoretical diameters of the tunnels had increased from

the initial value of 28mm to 51mm for Ring No. 467 (i.e., 467R) which appeared to be damaged most seriously. Structural analyses indicated that 463R, 465R~468R and 470R had become deficient in structural capacity and had to be reinforced. It was finally decided to install steel segments in 459R to 471R as secondary lining. Because of the squash of the tunnel, the invert slab between 450R to 473R became detached from the tunnel and had to be replaced.

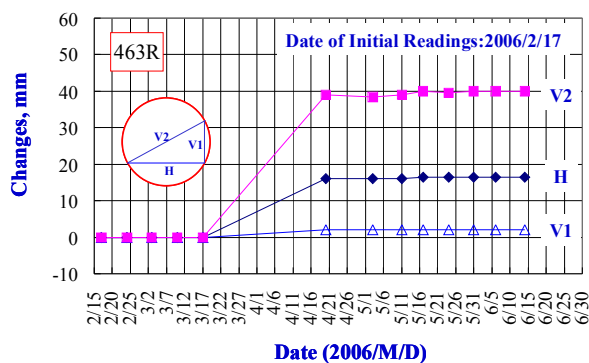
Fig. 16 Case 3- Convergences of 463R

The cause of the event is rather difficult to ascertain. It has been attributed to grouting pressure during CCP installation (Ju, et al., 2007). The accusation, however, is not supported by data. Take 463R for example, configuration survey conducted on 17 March, 9 days after the completion of CCP piles, indicated that the tunnel was stable with nil changes in diameters as shown in Fig. 16. In fact, it is inconceivable for the tunnel to be damaged by grouting carried out at positions above the crown, refer to Fig. 13, because it is very unlikely for grout to run downward except in very rare situations.
