## Distribution Relationship Between Veins of Groundwater, Slope angles, and Slope Failures at a Landslide in Crystalline Schist Area

Gen FURUYA\*, Kyoji SASSA, Akira SUEMINE

### Synopsis

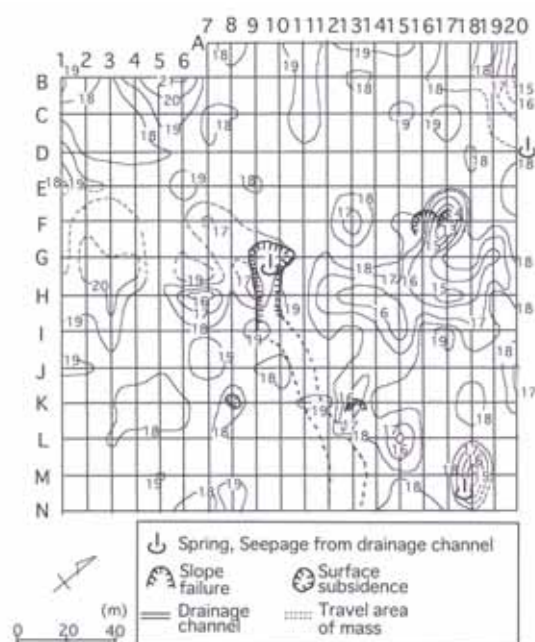
Fig. 9 Isothermal diagram at the Taishi-do area

Fig.9 shows the isothermal diagram of correction values from 12 to 22°C by 1°C at the Taishi-do area. Maximum ground temperature is 21.0°C (B6), minimum ground temperature is 12.3°C (F17), and average ground temperature is 18.2°C within this area. In this figure, the eastern part of the measurement net shows an underground temperature below the average. On the other hand, the underground temperatures in western part are higher than the average. There are three large zones with temperatures less than 18°C (i.e. slightly less than average value) at the Taishi-do area: 1) From C1 and C3 to G9 (E6 is a bit high value) which is approximately the direction from east to west, 2) From E17 to N15 through L12 direction which is approximately oriented on southeast northwest, and 3) From A17 and A19 to D20 located at north part of the measurement net. All slope failures at the Taishi-do area locate in the zone of temperatures less than 18 °C. The temperature of the slope failure at Taishi-do and K13 are a little lower than average underground temperature. However, the slope

failures at F16 and F17 locate within the low temperature zone. The slope failure at F17 is also in the zone of the minimum underground temperature. This is a characteristic fact in the Taishi-do area.

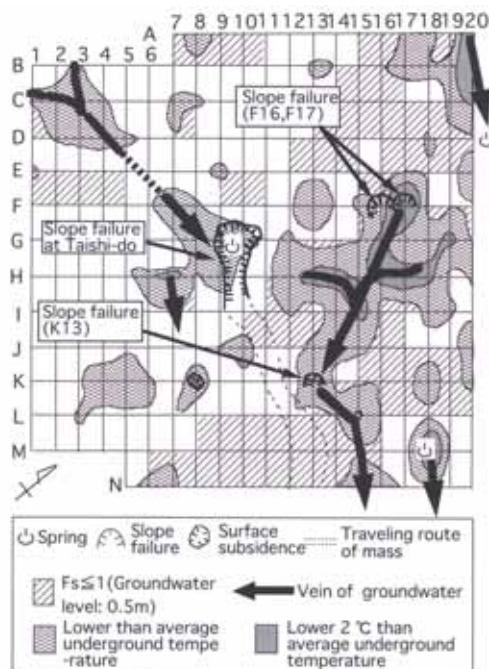
Fig.12 Distribution of veins of groundwater, safety factors, and slope failures at the Taishi-do area

into lower than average underground temperature zones (18.2°C) and zones with temperatures lower by 2°C than average underground temperature. There are five veins of groundwater at the Taishi-do area (Furuya et al., 2004): Zone 1 from C1 and C3 to G9, Zone 2 from E17 to N15 through K13, Zone 3 from A17 and A19 to D20, Zone 4 area around H7, and Zone 5 area around M18. Zone 1 and 2 are large veins of groundwater for the measurement net, however, the groundwater type is different in these two veins represent. In zone 1 the lowest value is 16.9°C at point H9 (Furuya et al., 2000) and the spring in slope failure at Taishi-do is 17.8°C as shown in Table 1. Thus the temperature in this vein is not so low compared with the average value, and is 4 to 5°C higher than the boreholes at the Z6 block. On the other hand, the lowest ground temperature at a depth of 1m in zone 2 is 12.3°C at point F17. This is also the lowest value in the measurement net, and is approximately equal to the groundwater temperature at the boreholes of Z6 block. In addition, when the ground temperature of F17 was measured, groundwater was oozing through the measurement hole of this measurement point (Furuya et al., 2000). Therefore, it may be stated that the vein of groundwater in zone 1 is of shallow origin, while the vein of groundwater in zone 2 originates groundwater from deep layers. The other veins of groundwater in the surveying area aren't widely distributed being rather than local. However, they have remarkable low underground temperature part. This may be attributed to the small scale of these veins rising from deep layers.

The slope failure at associated with  $F_s > 1$  in Fig. 5 (gentle slope less than 30°) is actually locates on the vein of groundwater corresponding to zone 1. Furthermore, the results of stability analysis indicate a stable slope even for a pore water pressure calculated from a groundwater level at 1.0m above the slip surface. Hence, it may be concluded that the slope failure at Taishi-do was caused by the increase in pore water pressure due to concentrated groundwater along the vein of groundwater in zone 1 during the heavy rainfall. The slope failures at F16 and F17 locate on and nearby the beginning of the vein of groundwater in zone 2. Recall that underground temperature at a 1m depth in point F17 is lowest, and is approximately equal to the groundwater temperature in the boreholes at the Z6 block. Thus we can consider as the outlet of groundwater originating from the deep layers. In these circumstances the occurrence of these slope failures could be related to the existence of a vein of groundwater originating from the deep layers. This vein of groundwater is flowing like underflow in subsurface toward K13. The vein of groundwater in zone 2 could also be responsible of the slope failure at K13.

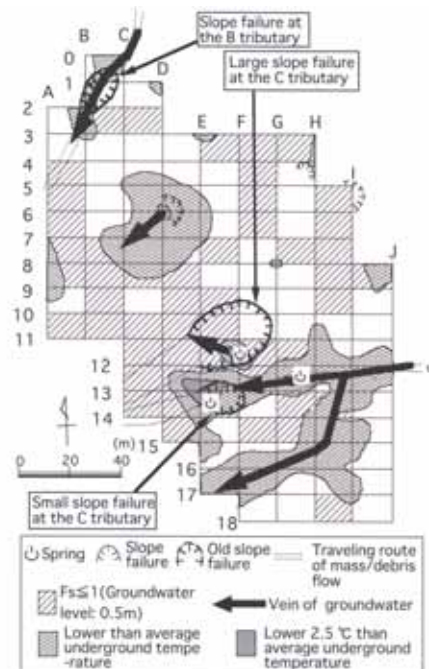
Fig.13 Distribution of veins of groundwater, safety factors, and slope failures at the B, C tributaries in Tobinosu torrent

Fig. 13 shows the coupled distributions of the low underground temperature zones, veins of groundwater, the real slope failures and the slope with  $F_s \leq 1$  at the B, C tributaries, Tobinosu torrent. The assumed water level for slope stability calculation was at 50cm

above the slip surface. This figure shows the lower than average underground temperature zones (i.e., 18.2°C) and zones with temperatures lower by 2.5°C than average underground temperature. The veins of groundwater are as follows: zone 1 along the B tributary (C0 to B3); zone 2 large slope failure at the C tributary; zone 3 upper slope of J12 to the small failure at the C tributary with branch vein at I11 to F17, and zone 4 the area within a range of approximate 40m x 40m around D6 (Furuya et al., 2001). The vein of groundwater in zone 3 is underflow type because the springs in the upper slope of the small slope failure at the C tributary are distributed over a line and these springs show a concentration of dissolved ions (electric conductivity) similar with the TB-K at the Z6 block (see the results of water quality analysis in Fig. 11). The branch stream of this vein of groundwater starting from I12 may also be of underflow type. No spring exists at the B tributary. However, it is believed that the vein of groundwater along the B tributary is flowing under the torrent bed of this tributary because the zone of low underground temperature is along the torrent bed. Hence, it can be concluded that the underflow type is the same as for TB-K at Z6 block. The low temperature distribution disappears around B3 suggesting that the vein of groundwater infiltrates into the deep zone of the torrent bed. The large slope failure at the C tributary has a spring on the lateral side at F12, which scale of vein is very small. The water quality type of this spring differs from that of the vein of groundwater in zone 3 which flows neighboring the large slope failure shown in Fig. 11. In the Zentoku area, many cracks were found on outcrops of bedrock during field investigations, as well as in the rock mass during the construction of a drainage well. Hence, the vein of groundwater in zone 2 appears to be of fissure water type. This vein of groundwater is presumed that raising steep angle from deep layers by the calculation results based on thermal conductivity type differential equation (Furuya et al., 2001). The water quality of this vein and the dissolved ion concentration are the same as at locations B14 and DB-T in Z6 block. Therefore, the vein of groundwater zone 2 is discharging from the deep layers equivalent to the slip surface at Z6 block. There is no spring around D6. However, it is believed that the deep layer of groundwater is rising nearby surface because the zone of underground temperatures lower by 2.5°C than the average is located around D6.

There are three slope failures generating debris flows in the analyzed measurement net. The common feature in these slope failures is that they occurred in the zones of low underground temperature. Among these, the slope failure at the B tributary and the small slope failure at the C tributary are related to the underflow type vein of groundwater. On the other

hand, the large slope failure at the C tributary is related to the fissure water type vein. However, it is presumed that this slope failure rather develops retrogressively towards the upper slope instead of occurring at once. There is an old slope failure at D6 that could have been caused by water rising from fissures. This study demonstrated that by coupling the results of stability analysis with the distribution of veins of groundwater within the analyzed domain, it is possible to narrow the regions associated with a high potential of slope failure.

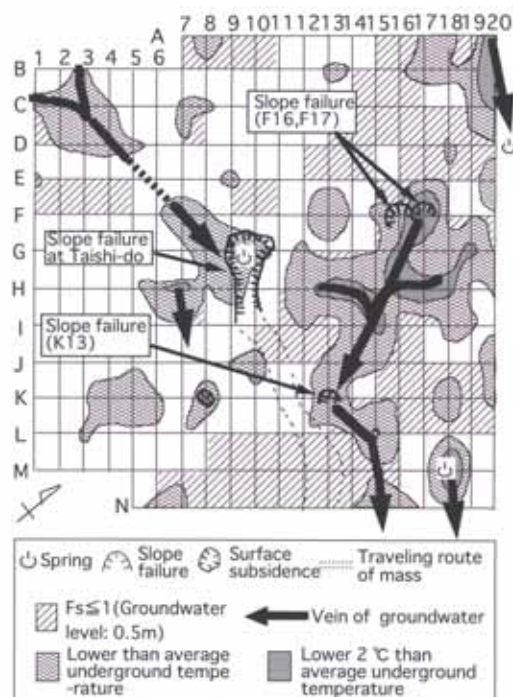
図 大師堂周辺における崩壊発生箇所、流動地下水脈および安全率1以下の分布

これらの調査対象地域の平均傾斜角は $32\sim 34^\circ$ である。斜面崩壊は従来から指摘されている遷移点（遷急点、遷緩点）周辺で発生しているが、図に示すように、すべり面上の間

隙水圧が同条件のもとで計算した結果において他の箇所（セル）よりも安定性が高いと評価される緩傾斜（ $20\sim 27^\circ$ ）の箇所でも発生している。流動地下水脈の分布に着目すると、調査対象地域では流動地下水の分布の有無による斜面傾斜角の違いはほとんど無い。斜面崩壊は土層深が著しく薄い箇所を除いて地下水脈の経路付近や斜面内部の地下水が地表面（付近）に流出する箇所が発生する傾向が高い。これは地下水が集中し易い箇所では斜面崩壊が発生し易いことを示唆する。なお、調査対象地域における斜面内部から流出する地下水は、水質調査結果よりすべり面相当深度のものであった。以上より、結晶片岩の地すべり地で豪雨時に発生する斜面崩壊の危険度を評価する際には斜面傾斜角に着目した評価だけでは不十分であり、現地の流動地下水の情報も併用する必要があると考えられる。
