**Geotechnical Study on  
Ground and Masonry Structures  
in Angkor for Safeguarding Monuments**

**September 2001**

**Yoshinori Iwasaki**

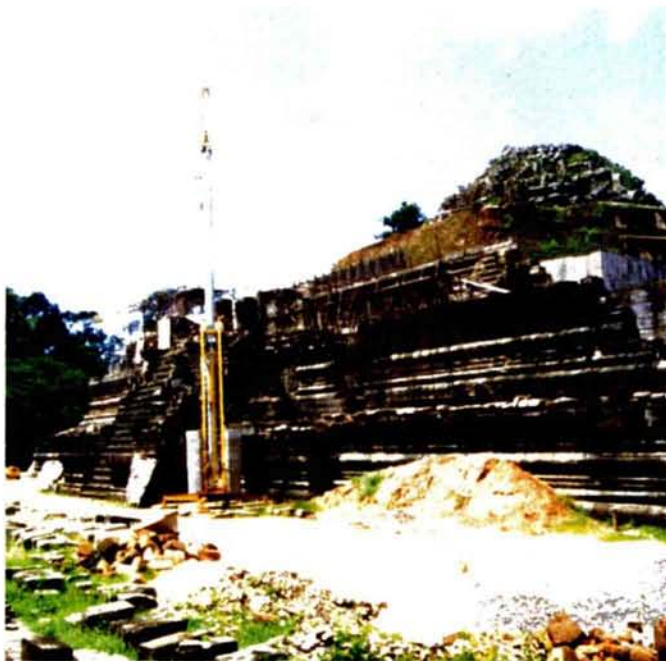
Finally, the French abandoned the anastolosis method of original embankment of filling the mound with only sand. They have modified the method introducing reinforced concrete retaining wall inside the slope surface to protect the slope failure.

Photo 2-3 Steep embankment slope with concrete retaining structure

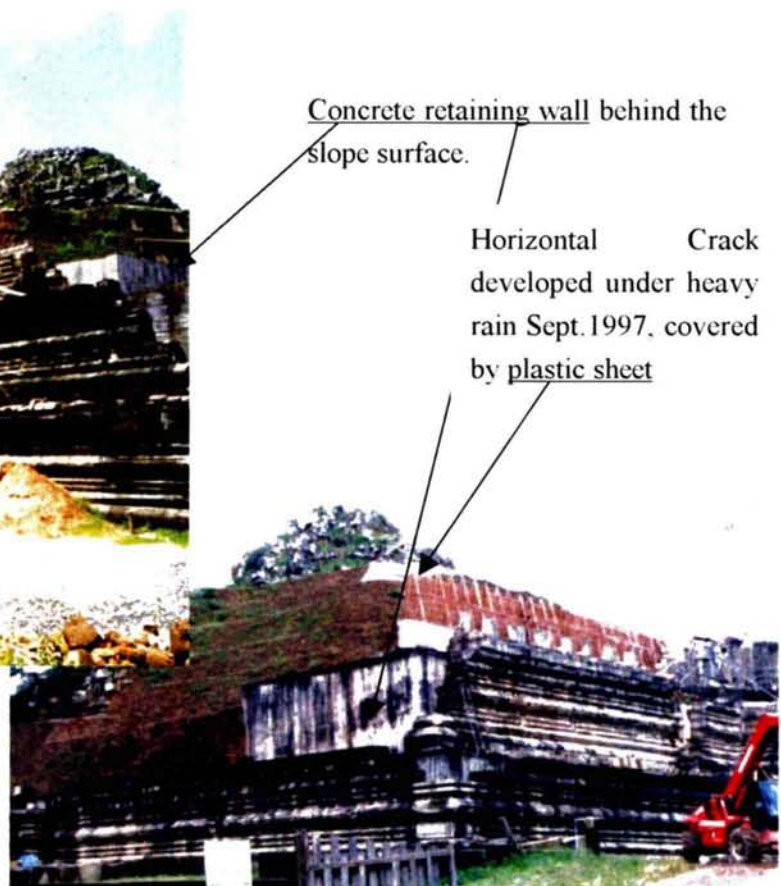
Photo 2-4 Crack appeared on top of the filling slope (photographed in October, 1997)

In September 1997, it was a heavy rain of about 200mm in one day, which caused not only a failure of embankment along the moat near the causeway to Angkor Wat but also resulted in horizontal crack of about 20m in length around top of the filling hill of Bapuhon. Fortunately, the width of the crack did not increase and the slope did not failed.

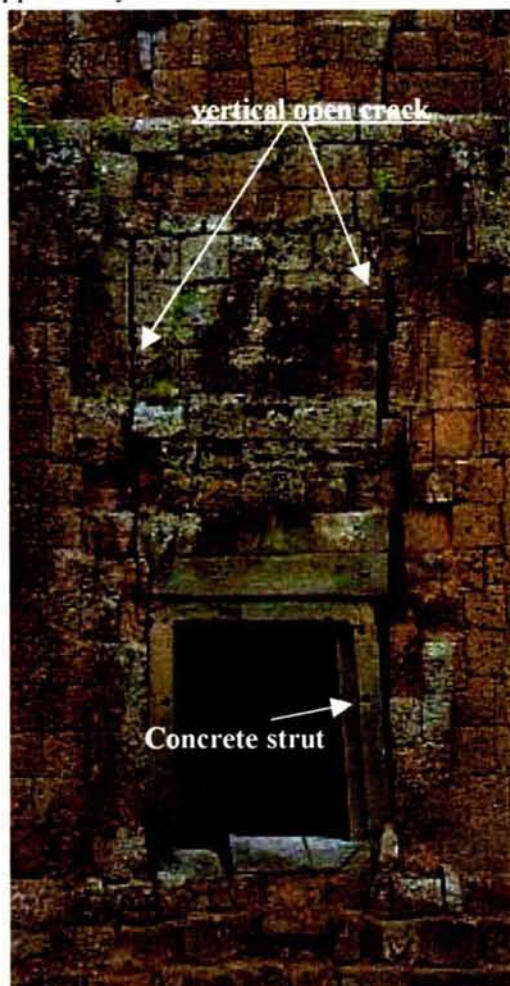
Photo 6-4 Vertical Opening above lintel

In Photo 6-4, two vertical open crack lines are extending from the each ends of lintel to the upper part of the 1<sup>st</sup> story. Whole weight of the laterite blocks between two cracks is supported by the lintel, which transmits this heavy load to the vertical columns. The both ends of the columns are further supported by horizontal bottom frame of stone beam as shown in Photo 6-4.

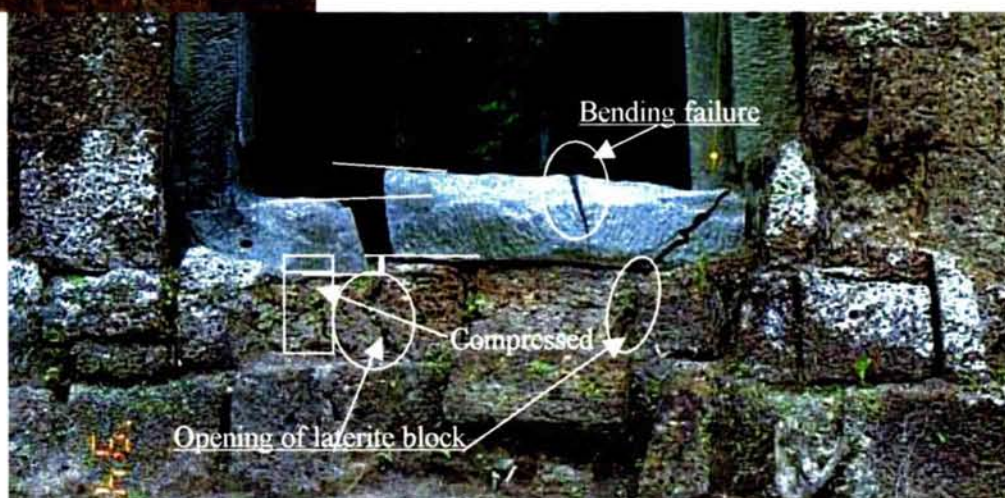
The horizontal base beam and laterite blocks beneath the beam are enlarged in Photo9-5. At the base of the wall opening, there is a horizontal stone beam, whose dimensions are 60cm in width, 30cm in thickness, and 170cm in length. The side vertical columns stand at the both end of the horizontal beam. The beam has broken at its center due to bending failure and split into four peaces and the both ends subsided against the central part. If we look the laterite blocks beneath the beam, it becomes clear that the laterite blocks have not only subsided but also compressed due to the excessive vertical load through columns. The right hand side laterite has been compressed about 4-5cm, which resulted in settlement of the column and had caused the shear failure of the horizontal base beam.

Photo 6-5 Compressed laterite block beneath horizontal beam sandstone

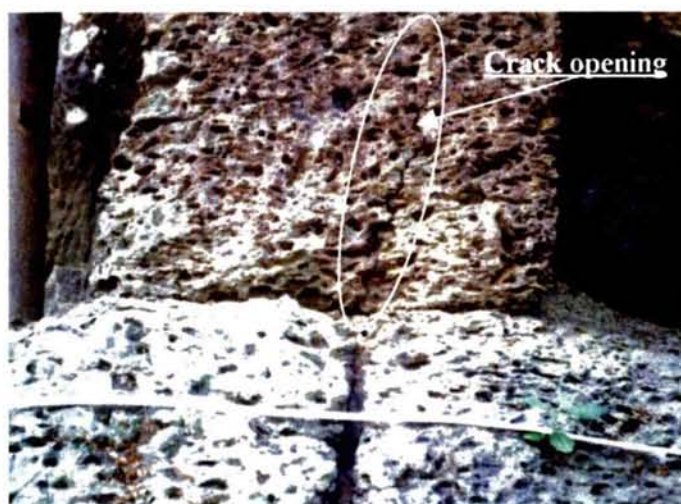
In the eastern face, there is a crack on east wall above an opening of stones in the upper level foundation. Since this crack is found rather fresh, the joint movement of the laterite blocks beneath the block might have caused the opening to begin and to continue to develop.

Photo.6-12 Fresh crack found at laterite block of East face (see Photo 6-10 white circle)

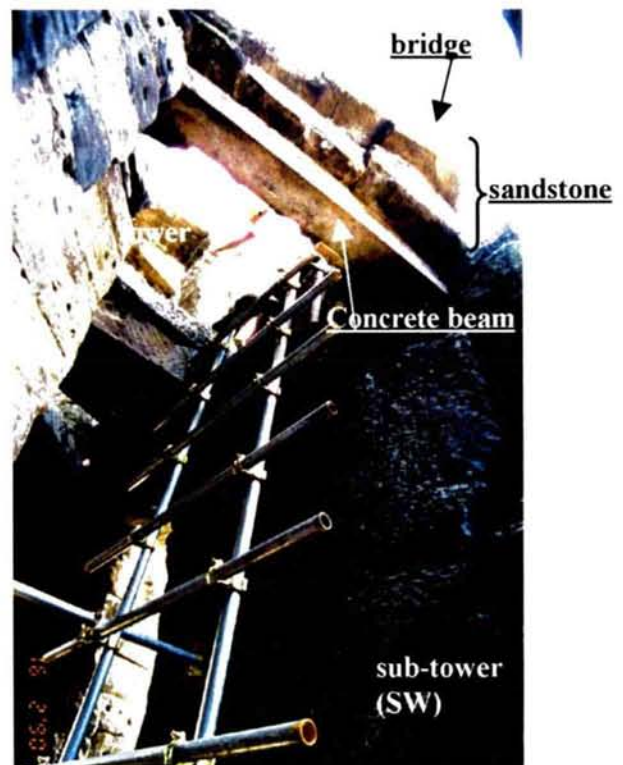
Openings are found between many neighboring stone columns and most these openings have caused large displacements of the top of the columns that caused damages of bridge elements.

Photo7-5 bridge between Central and sub Towers.

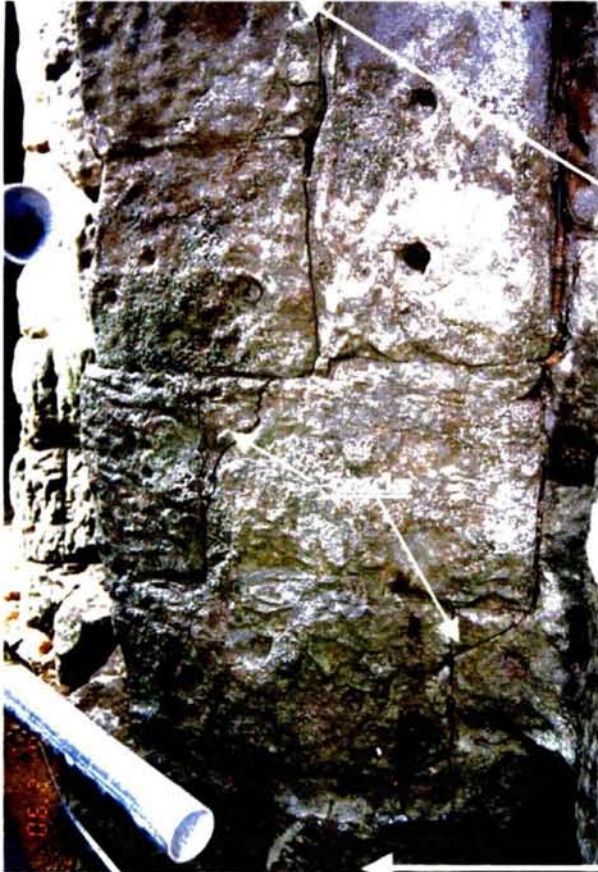
There is another example at the southwest corner of the Gallery that is shown in Photo 7-8 and 7-9. Two cracks are shown in the Photos and these cracks at the lower level in the blocks continue upwards with increasing opening width.

Photo 7-9 Enlarged bottom part

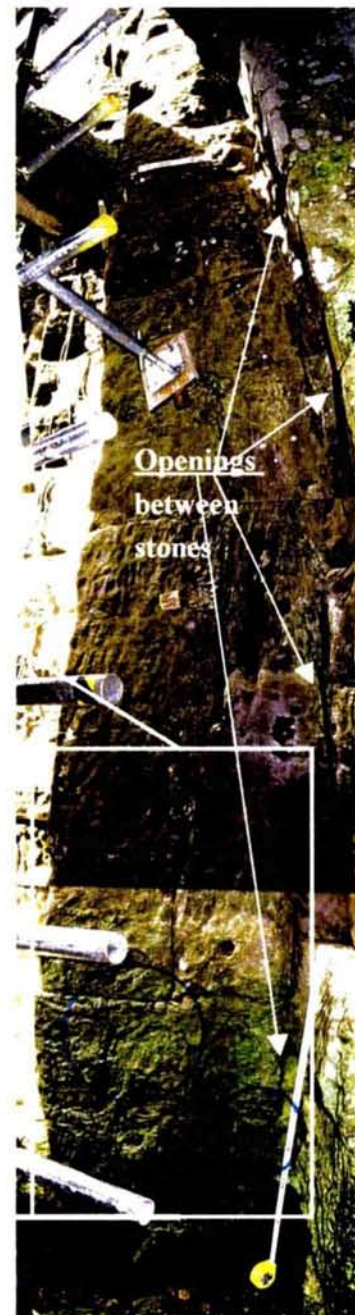
Photo 7-8 Southwest corner of the Gallery of the Central Tower

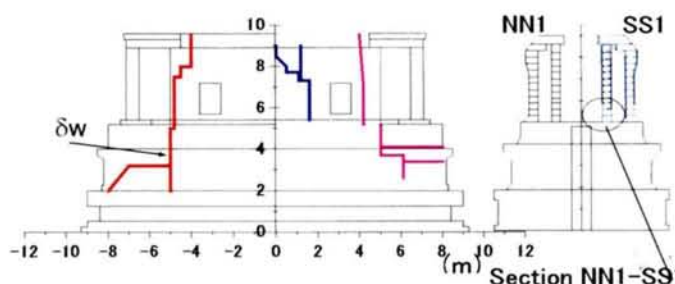
Fig. 8-5 Cracks on South Side of N. Library

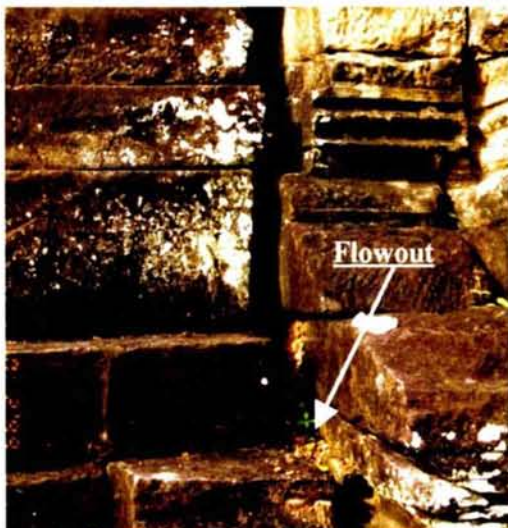
Photo 9-4  
Flow out of decomposed laterite  
(South Library, Bayon Temple)

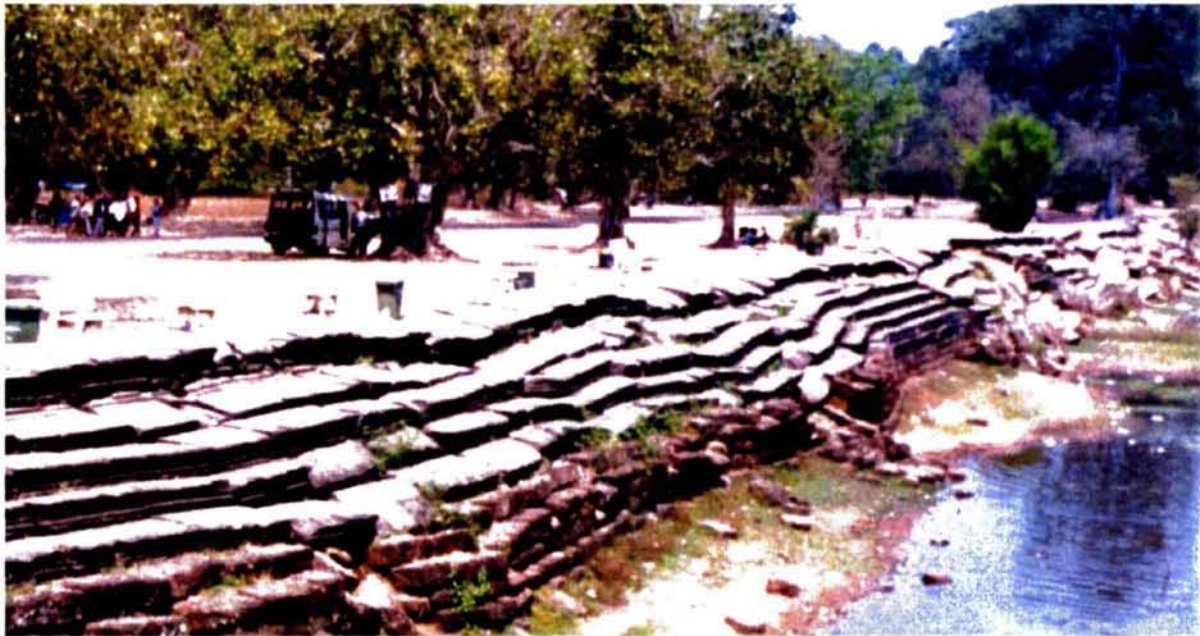
Photo 9-5 Inclination of embankment along moat of Angkor Wat
