## Creep and Failure of Palaeozoic-Rock Slope

By Yoshimasa KOBAYASHI and Akira NAKAGAWA

### Abstract

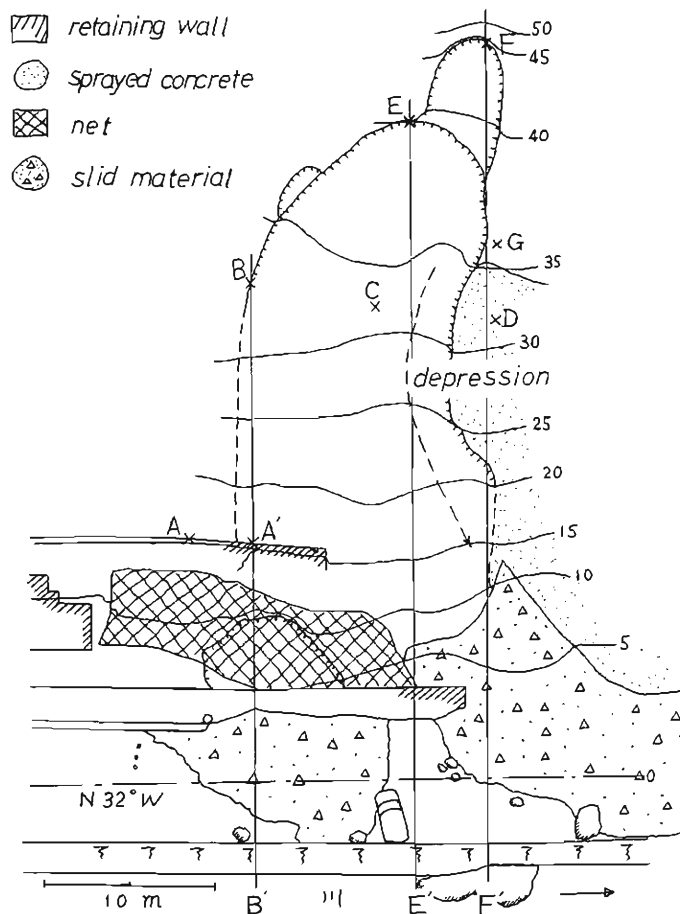
Fig. 4. Plan of the site.

The longitudinal section of the slope through the point E is shown in Fig. 7, from which the average inclination of the slope is revealed to be about 40 degrees in the upper half and 60 degrees in the lower half. On the main sliding mass there is a channel-like depression, which begins at about 35 m height and comes down curving gradually to left as shown schematically in Fig. 4. The depression seems to be the space from which the main larger slide originated.

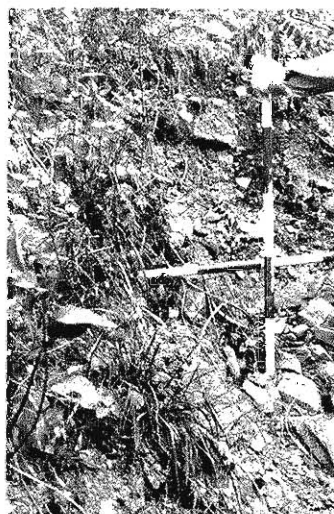
Fig. 6. A trace of slip amounting to about 25 cm.

trace of slip amounting to about 25 cm was observed along the boundary of the integrated sliding mass (Fig. 6).

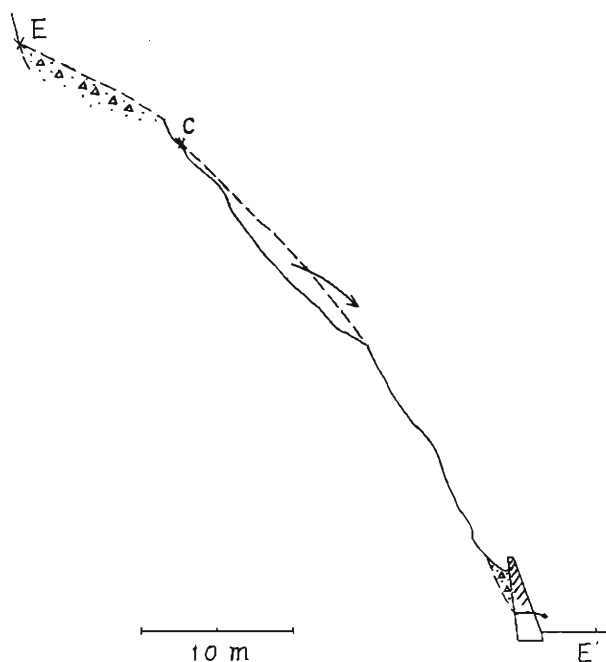
Fig. 7. Longitudinal section of the slope.

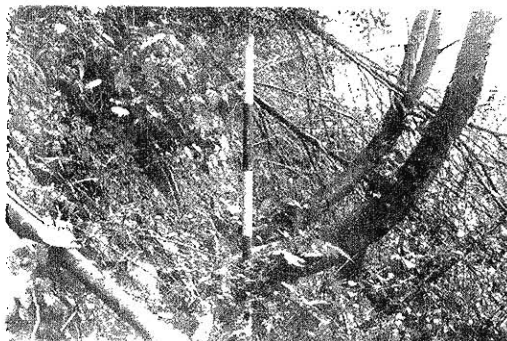
Proceeding creep can be presumed also by curving tree trunks (Fig. 8). Vines which extend from the bedrock over slide scarp to the sliding mass are in tension,

Fig. 8. Curving tree trunks.

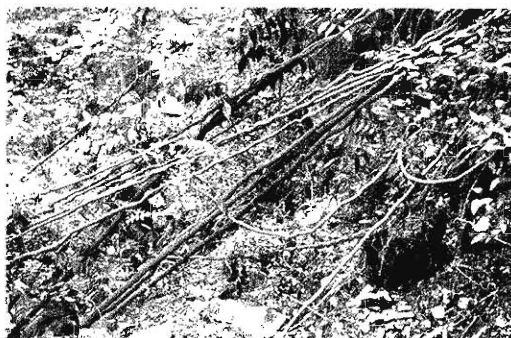
Fig. 9. Vines in tension due to differential displacement of ground.

suggesting a recent downhill displacement of the mass (Fig. 9).

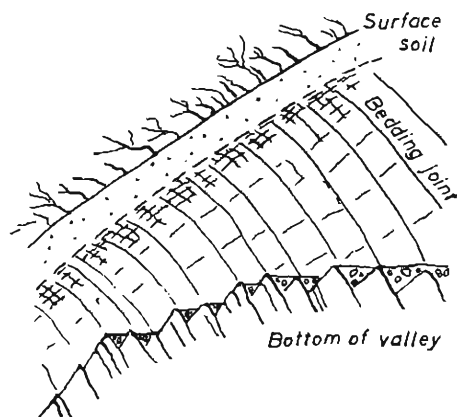
Fig. 10. Hakenwerfen or gravitational deformation of rock mass near slope surface.

A Hakenwerfen (gravitational deformation)<sup>3,4)</sup> phenomenon is observed at a valley cutting normally into the slope at some tens of meters north from the site (Fig. 10). This phenomenon also indicates a proceeding downhill creep under the effect of gravity. Warping of the discontinuity develops as deep as 5 m into the rock mass, and above this depth the rock is appreciably loose because of toppling blocks<sup>5)</sup> and

opening joints. The rock condition is similar at this point and in the slide site so the phenomenon may probably be assumed also to have existed in the slope concerned.
