## THE DAMAGE TO STRUCTURES CAUSED BY THE SECOND MIYAKOJIMA TYPHOON

by Hatsuo ISHIZAKI, Junji KATSURA and Tatsuo MUROTA

### Abstract

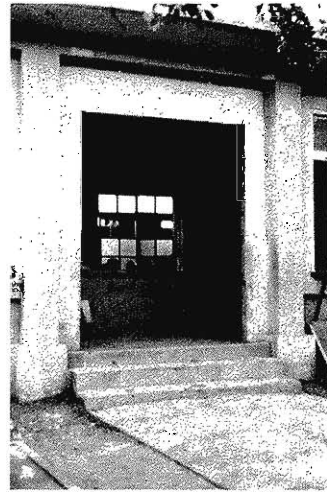
**Reinforced concrete buildings.** Reinforced concrete buildings of schools, offices, dwellings were only partly damaged; mostly broken doors and windows. (Photo. 3)

Photo. 3 Damage to reinforced concrete buildings; a broken door.

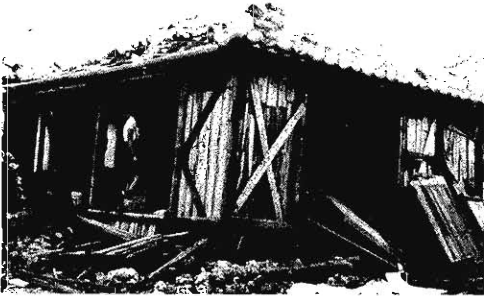
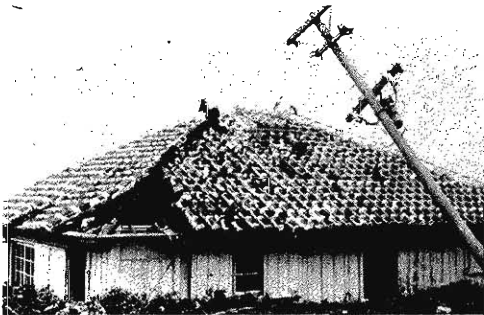
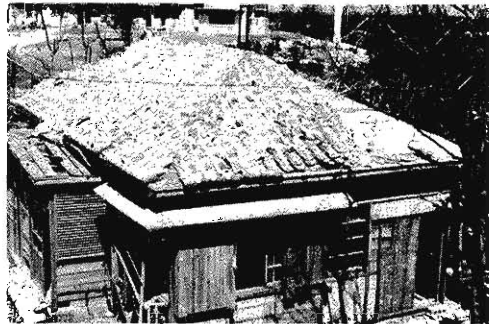
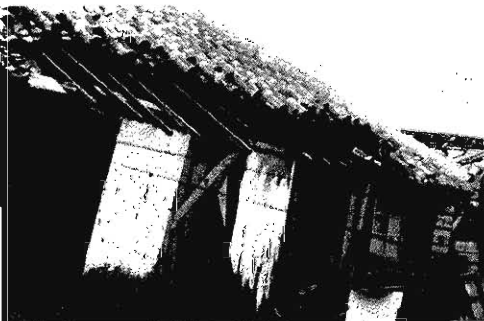
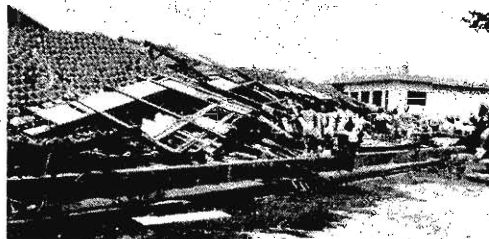
Photo. 4 Damage to wooden buildings with clay-tile roofings ;

(a) wreckage of openings, (b), (c) removal of tiles from ridges and corners, (d) removal of tiles from the eave, (e) total destruction of a school building. (by courtesy of the Miyako Bureau of Local Administration =(a), (b), Hirara City Hall= (d), and The Okinawa Times=(e)).

(1) damage to wooden buildings with clay- or cement-tile roofings with bed boards were as follows: (Photo. 4)

- i) broken doors and windows
- ii) removal of roof tiles from eaves, ridges, verges or corners
- iii) total destruction

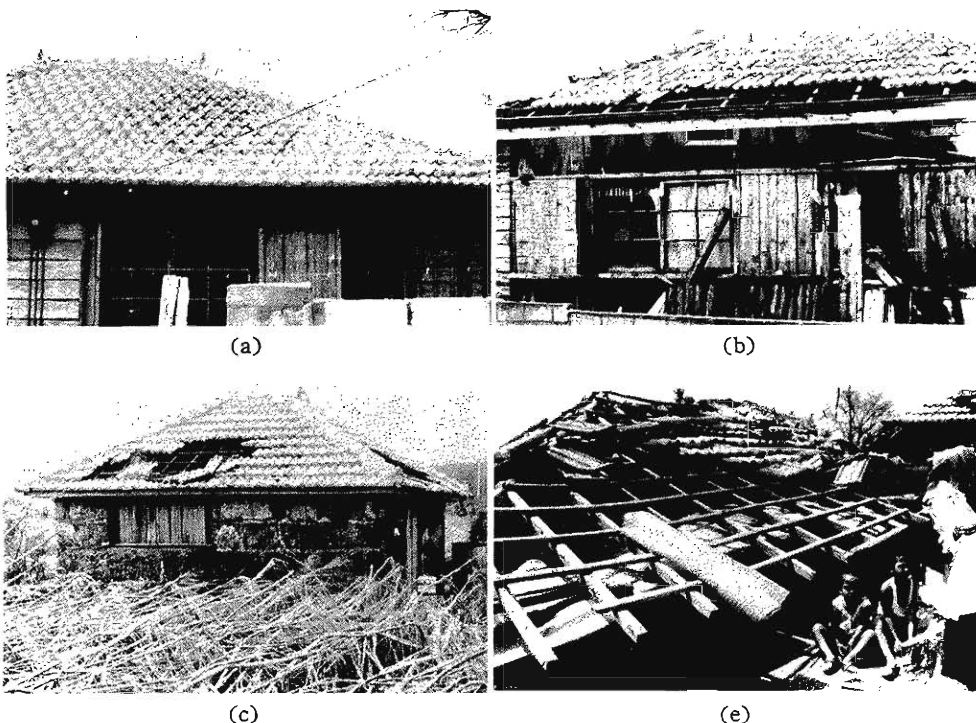
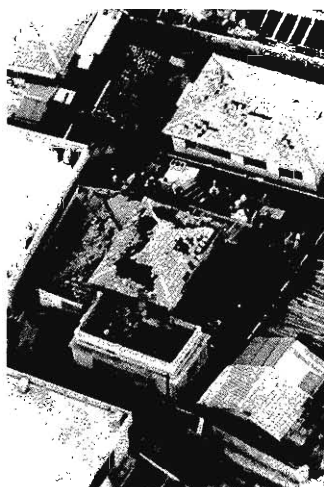
(2) damage to wooden buildings with cement-tile roofing without bed boards were as follows: (Photo. 5)

Photo. 5 Damage to wooden building with cement-tile roofing :

(a) lifting of tiles from a leeward roof, (b) removal of tiles from eave, (c) (d) removal of tiles from leeward roofs, (e) total destruction of a house. (by courtesy of Hirara City Hall=(b), the Miyako Bureau of Local Administration =(c), the U.S. Civil Administration of the Ryukyus =(d) and The Okinawa Times =(e)).

- i) broken doors and windows
- ii) lifting of tiles from leeward roofs
- iii) removal of tiles from leeward roofs, eaves or verges
- iv) total destruction

The lifting and removal of tiles are closely related with damage to openings in the walls.

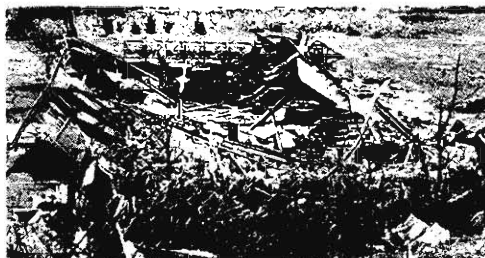
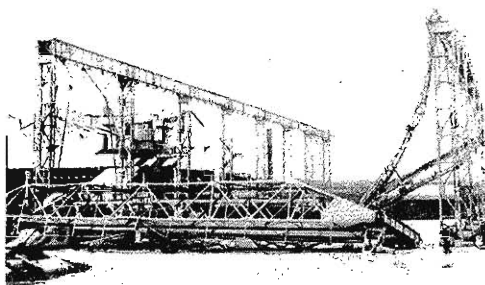
**Steel frames.** Damage to steel framed buildings occurred in sugar factories and a warehouse of the U.S. Army. The sugar factories were galvanized iron structures and many galvanized iron plates were removed from the walls or roofs. The warehouse was a gable-roofed steel frame and collapsed completely downwind. (Photo.6)

Photo. 6 Damage to steel framed structures: (a) collapse of a gable-roofed warehouse, (b) collapse of a track crane at a sugar factory (by courtesy of the U.S. Civil Administration of the Ryukyus= (a) and the Miyako Bureau of Local Administration =(b)).

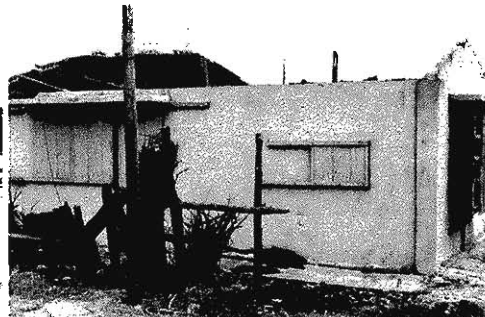
**Reinforced masonry buildings with wooden roofs.** Masonry buildings were not so much in number as wooden buildings but most of them were seriously damaged. The damage was mostly the bodily removal of wooden roofs, because of the weak connection between roofs and walls. (Photo.7)

Photo. 7 Damage to masonry buildings with wooden roofs : (a), (b) bodily removal of roofs (by courtesy of The Ryukyu Shimpō=(a)).

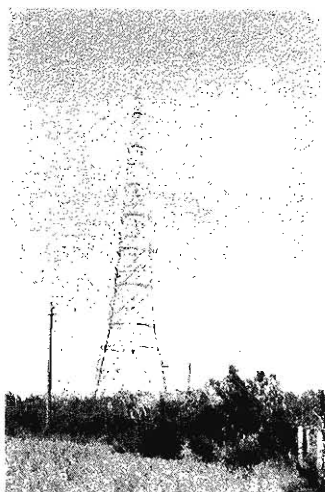
| | TYPE | SITE | DAMAGE |
|---|---|---|---|
| antenna | steel truss,<br>G. L. +35m | in flat, sugar-cane<br>field, Hirara City | separation of paint by wind<br>(Photo. 8) |

Photo. 8 Damage to a steel truss antenna : separation of paint by wind.

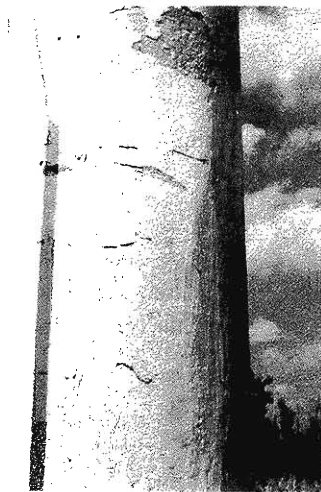
| | TYPE | SITE | DAMAGE |
|---|---|---|---|
| | guyed pile,<br>reinforced<br>concrete,<br>G. L. +12m | top of a hill,<br>Hirara City | slip-off of a guy cable,<br>cracks in the windward<br>side of the pile (Photo. 9) |

Photo. 9 Damage to a reinforced concrete antenna : cracks in the windward side.

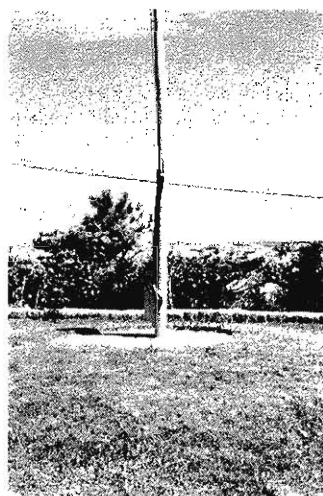
| | TYPE | SITE | DAMAGE |
|---|---|---|---|
| flag mast | steel pipe, 90 $\phi$ ,<br>G. L. +11m | top of a hill,<br>Hirara City | displacement of the top<br>about 30cm leeward;<br>estimated wind speed is<br>60.5m/sec (Photo. 11) |

Photo. 11 Damage to a flag mast : displacement of the top about 30cm leeward.
