# DAMAGE SEQUENCE AND SAFETY MARGIN ASSESSMENT OF EXPANSION JOINTS BY SHAKE TABLE TESTING

Yu Otsuki<sup>1</sup>, Masahiro Kurata<sup>2</sup>, Konstantinos A. Skalomenos<sup>2</sup>, and Yoshiki Ikeda<sup>2</sup>

## SUMMARY

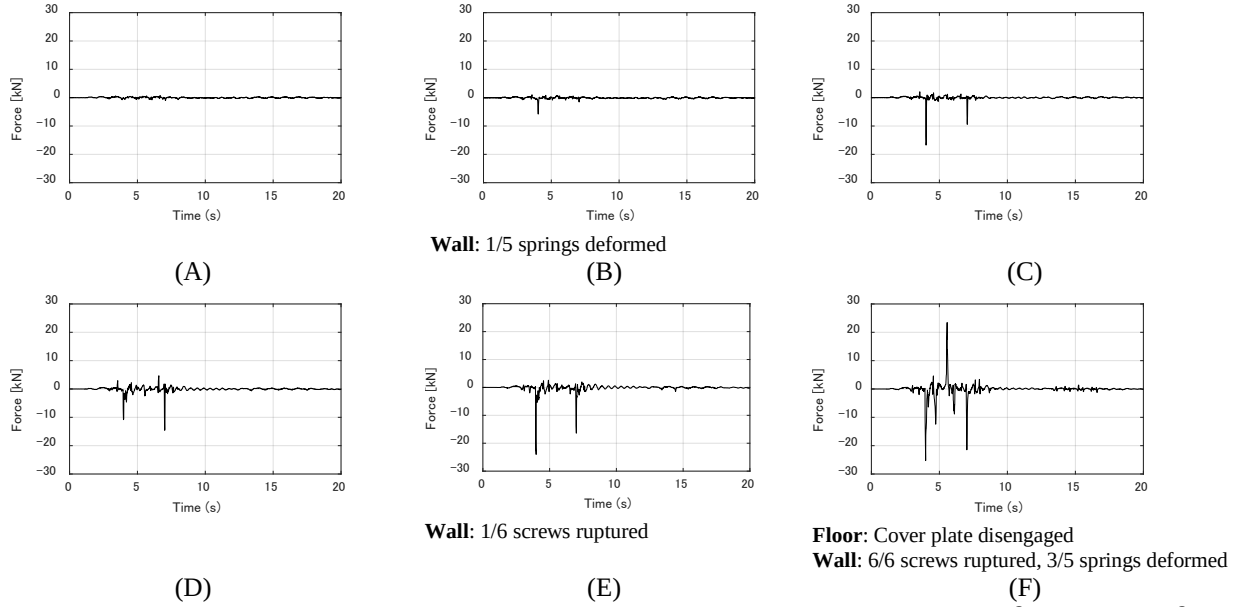
**FIGURE 10 Force applied to HP expansion joints with damage descriptions: (A) 350 cm/s<sup>2</sup>, (B) 400 cm/s<sup>2</sup>, (C) 450 cm/s<sup>2</sup>, (D) 500 cm/s<sup>2</sup>, (E) 550 cm/s<sup>2</sup>, and (F) 600 cm/s<sup>2</sup>**

The force  $F_{expj}$  applied to the HP expansion joint specimens was derived from the above procedures. Figure 10 shows the time history of  $F_{expj}$  with damage descriptions for the specimen subject to different amplitudes of sine wave 1.0 Hz. The negative value indicates that a force was applied when the two frames approached. Note that  $F_{expj}$  is the total force applied to the floor and wall expansion joint specimens. At first, during the input of the 350 cm/s<sup>2</sup> excitation, no force was observed on the expansion joints, which validated the smooth movement of the expansion joint specimen. Under 400 cm/s<sup>2</sup>, damage occurred at one of the five springs of the HP wall expansion joint specimen. This could be related to the peak force in the negative side. From 450 cm/s<sup>2</sup> and beyond, the two steel frames collided repeatedly, and the resulting force increased as the input amplitude increased. Under 550 cm/s<sup>2</sup>, approximately -25 kN was observed at the first collision, which resulted in the fracture of one of

the six screws. After 600 cm/s<sup>2</sup>, all six screws and two other springs at the HP wall expansion joint specimen were broken. The cover plate of the HP floor expansion joint specimen was also disengaged when the two frames moved away from each other.

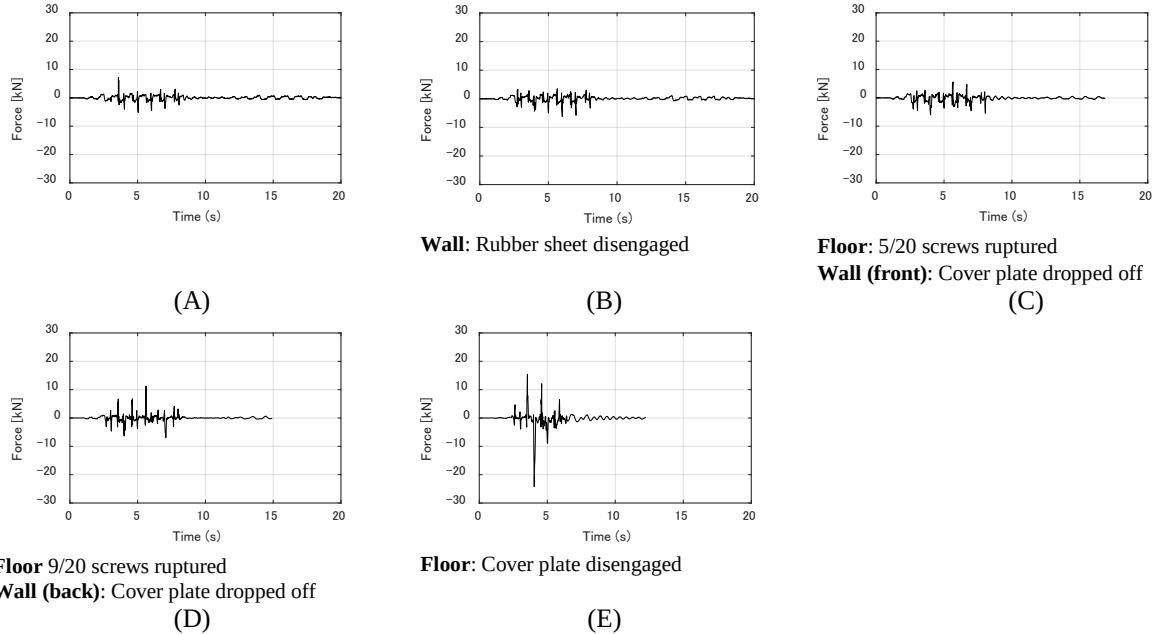
**FIGURE 11 Transition of force applied to SD expansion joints with damage descriptions: (A) 350 cm/s<sup>2</sup>, (B) 400 cm/s<sup>2</sup>, (C) 450 cm/s<sup>2</sup>, (D) 500 cm/s<sup>2</sup>, and (E) 550 cm/s<sup>2</sup>**

Figure 11 illustrates the time history of  $F_{expj}$  for the SD floor and wall expansion joints with damage descriptions. In general,  $F_{expj}$  was smaller for the SD specimens than for the HP specimens because the two frames connected with the SD expansion joint specimens did not experience a collision. Several peaks of small forces were observed due to collisions between the cover plate and the screws of the SD floor expansion joint specimens. Even though the cover plate of the SD wall expansion joint specimens fell off under the 450 cm/s<sup>2</sup> and 500 cm/s<sup>2</sup> excitations, a large force did not appear. This was because the sliders of the SD wall expansion joint specimens railed off smoothly. Under 550 cm/s<sup>2</sup>, the large negative force was observed because the cover plate of the SD floor expansion joint specimen collided with the side plates. The large positive force appeared when the cover plate of the SD floor expansion joint was disengaged.

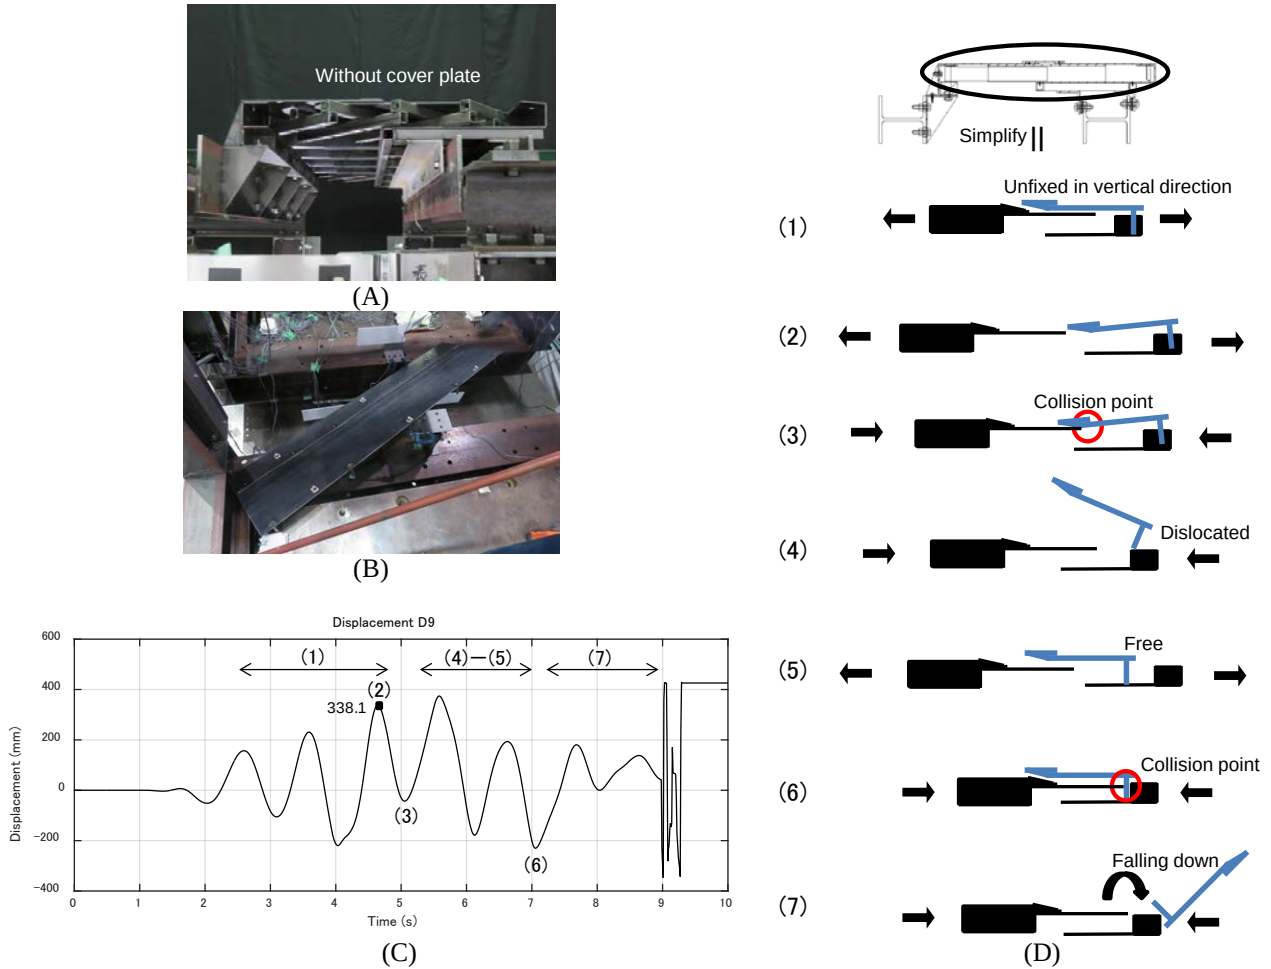
The first damage pattern observed for the HP floor expansion joint was cover plate disengagement during the input of 600 cm/s<sup>2</sup>, as shown in Figure 12(A)-(B). Figure 12(C) shows the relative displacement corresponding to each condition described in Figure 12(D). Based on Figure 12(D) and videos, the relative displacement in the tension side immediately before the collision, noted as (2), was 33.8 cm. At this deformation, the plate underneath the cover plate could no longer support the cover plate. As a result, the cover plate was inclined to the inner side, and the collision (3) occurred. After the collision (3), the cover plate was dislocated from the holes, noted as (4), and freely stood (5). Then, the two frames approached the relative displacement of 23.0 cm, and the collision (6) occurred. Finally, the cover plate fell off and disrupted the displacement sensor D9 (7). This damage was induced by the two collisions at (3) and (6) in Figure 12(D), and these collisions caused the large peak accelerations in Figure 9 as mentioned before. The second collision did not occur without the first collision, but there is also a possibility that the cover plate fell off due to the first collision. Therefore, the first collision was considered critical, and the critical relative displacement of this damage was evaluated as 33.8 cm in the tension side. This value is 193% of the design motion range of 17.5 cm, and thus the tested HP expansion joint has a sufficient safety margin beyond the design tolerance.

This expansion joint can be reused immediately after re-engaging the cover plate according to the expansion joint manufacturer. Therefore, following the definition in Table 2, this damage was defined as damage state 1. Even though this was not a failure state, loadings were finished because the displacement response of the SSBs nearly reached the maximum capacity of 40 cm.

**FIGURE 12 HP floor specimen DS1 (cover plate disengaged): (A) after cover plate disengagement, (B) dropped cover plate, (C) relative displacement during input of 600 cm/s<sup>2</sup>, and (D) descriptions of damage sequence**

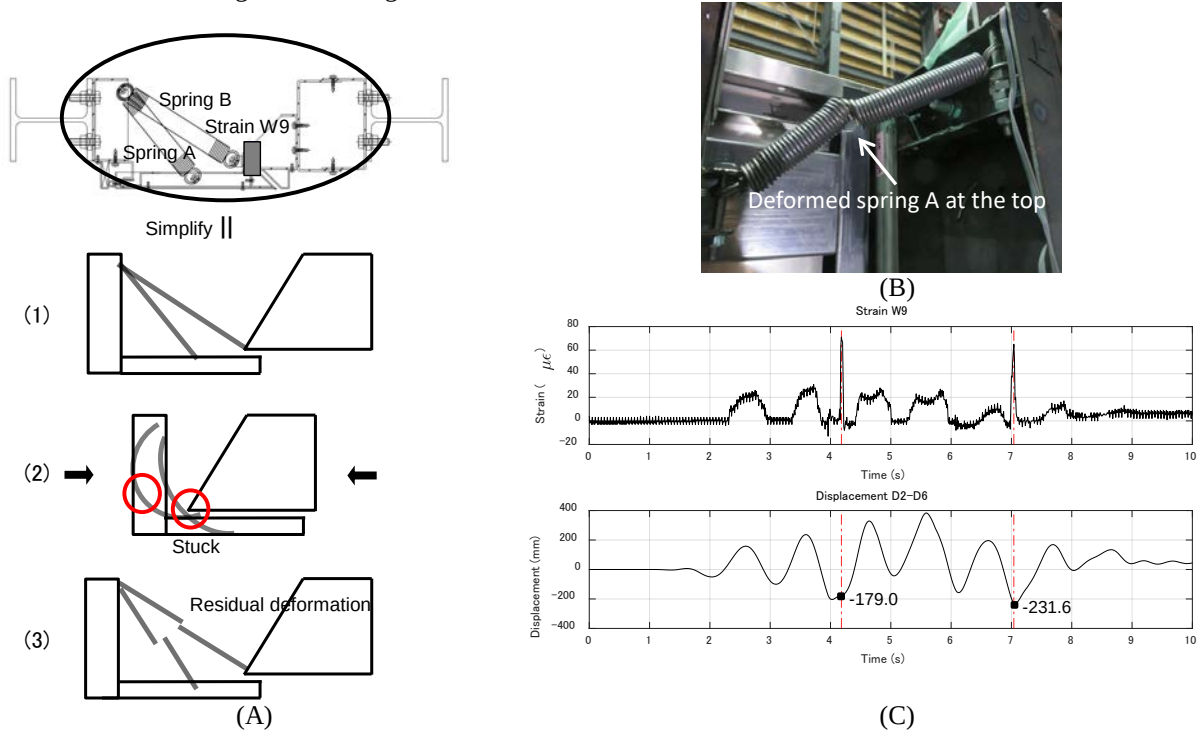
There were five springs (three of spring A and two of spring B in Figure 13(A) inside the HP wall expansion joint specimen. Their function was to pull back the cover plate from rotation. Excited by the sine wave of 400 cm/s<sup>2</sup>, one spring A at the top was caught on a surrounding member at the time of compression, and a residual deformation remained in the spring. This was confirmed by video. Because there was no residual rotation at the cover plate, this damage was classified as damage state 1.

After the input of 600 cm/s<sup>2</sup>, two spring B sustained residual deformation. Figure 13(C) shows the time history response of the strain gauge labeled W9 attached close to the base material and the relative displacement between two frames. There were two peaks in the response of strain W9, which were attributed to a collision with springs or other materials. The relative displacements at the timing of the strain peaks were 17.9 cm and 23.2 cm in the compression side. Therefore, this damage depended on the relative displacement in the compression side. The critical relative displacement of this damage was evaluated as the maximum relative displacement in the compression side, which was 23.2 cm for the input of 600 cm/s<sup>2</sup> and 19.1 cm for 400 cm/s<sup>2</sup>. These values are beyond the design motion range, and the seismic performance of this expansion joint satisfied the required performance in Table 1.

**FIGURE 13 HP wall specimen DS1-A (spring deformation): (A) damage sequence, (B) residual deformation of spring A after input of  $400 \text{ cm/s}^2$ , and (C) strain and relative displacement response during  $600 \text{ cm/s}^2$**

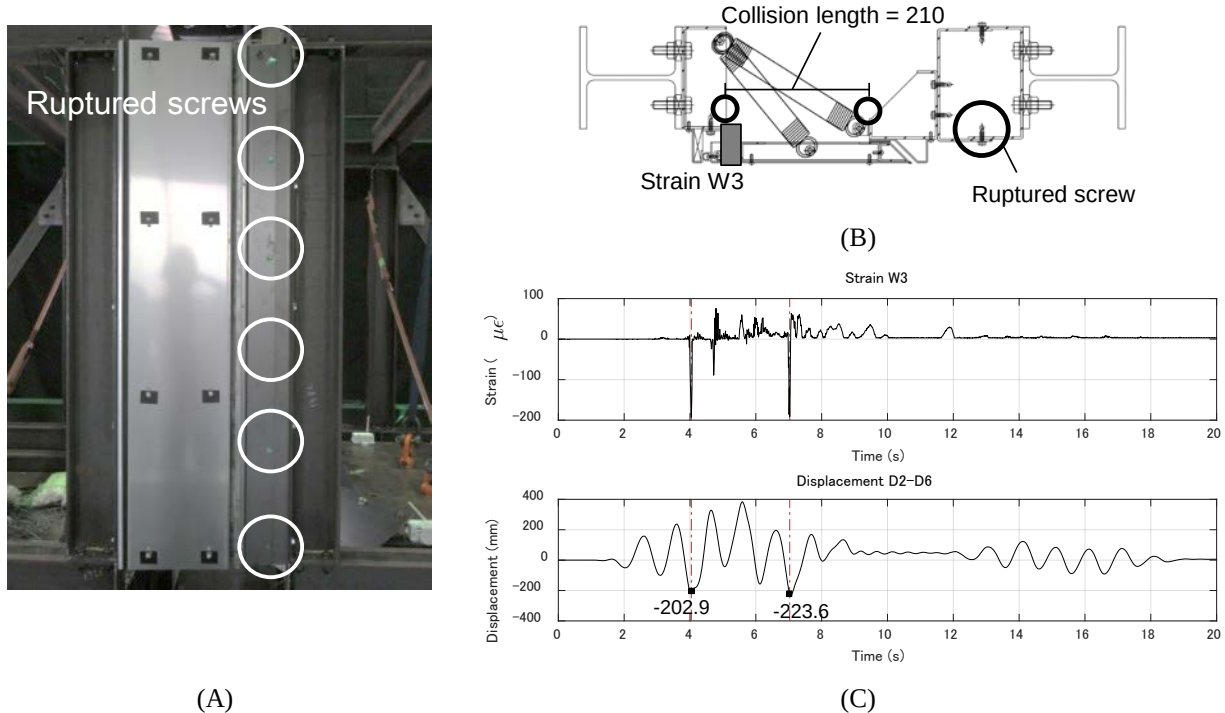
Another damage state observed for the HP wall expansion joint was the rupture of screws at the base materials as shown in Figure 14(A) and (B). The damaged screws were M6 drill screws. At the input of a sine wave of 550 cm/s<sup>2</sup>, the base materials collided twice at the collision point indicated in Figure 14(B), and one of the six screws fractured. Under the input of 600 cm/s<sup>2</sup>, the other five screws were also fractured. Even without screws, this expansion joint retained its function, and a small repair was required. Thus, this damage was defined as damaged state 1. Because “DS-1A: spring deformation” occurred at the same time, these damage states were classified as simultaneous damage.

construction errors. All screws were nearly fractured at the first collision, and thus a larger relative displacement of 22.4 cm was required at the second collision because the surrounding materials moved due to the loss of the screws.

Based on the above analysis, this damage state clearly depends on the relative displacement and the collision length. In summary, two patterns of damage state 1 were observed when the relative displacement was nearly equal to 110 and 130% of the design motion range. Although the experiment ended without observing the failure state, the margin of failure should be larger than 130% of the design motion range.

**FIGURE 14 HP wall specimen DS1-B (screw rupture) (unit: mm): (A) damage location; (B) damage descriptions in the drawing, and (C) strain and relative displacement during the excitation under  $600 \text{ cm/s}^2$**

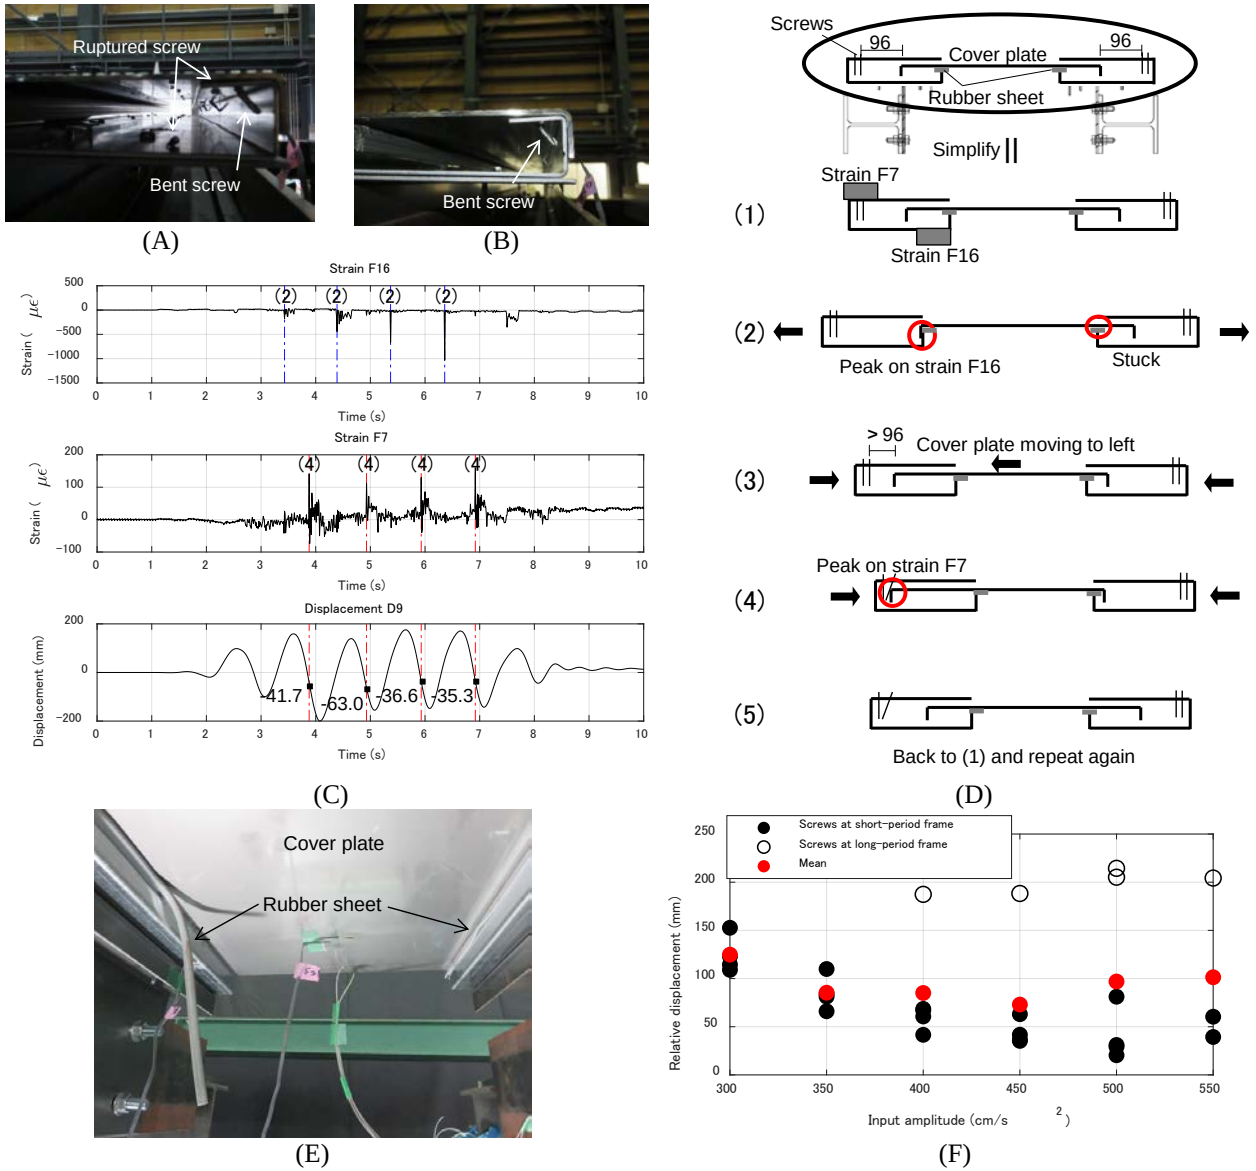
**FIGURE 15 SD floor specimen DS1 (screw rupture) (unit: mm): (A) bending and fracture of screws, (B) bent screw, (C) strain and relative displacement during the input of 450 cm/s<sup>2</sup>, (D) damage sequence, (E) disengagement of rubber sheets, and (F) relative displacement at the moment of collision for each input**

In the SD floor expansion joint specimen, the first observed damage was the fracture of several drill screws, as shown in Figure 15(A)-(B). In the design drawing in Figure 15(D), the distance between the edge of the cover plate and the screws is 9.6 cm. Under the input of 300 cm/s<sup>2</sup> or larger, the cover plate hit the screws, resulting in bending and fracture of the screws. Under the input of 450 cm/s<sup>2</sup>, five of twenty screws were shear fractured. Four more screws were shear fractured under the input of 500 cm/s<sup>2</sup>. Damaged screws can be easily replaced from above the cover plate and thus this damage was considered damage state 1.

The sequence of the damage during the input of 450 cm/s<sup>2</sup> is described in Figure 15(D). Ideally, a collision between the cover plate and screws should occur at a relative displacement of  $9.6 \times 2 = 19.2$  cm. However, in the experiment, the cover plate moved toward one side due to the imbalanced friction force between the cover plate and the two rubber sheets, and the collision occurred at less than 19.2 cm. For example, under the 450 cm/s<sup>2</sup>, the cover plate collided with the screws on the short-period frame side only. The collisions at (2) in Figure 15(D) represent peaks at strain gauge F16 in Figure 15(C). Assuming that the timing of the collisions at (4) in Figure 15(D) correspond to peaks at strain gauge F7 attached close to the screws, there were four collisions (double-checked by videos). From Figure 15(C), the relative displacements at the moment of these collisions were measured as 4.2 cm, 6.3 cm, 3.7 cm and 3.5 cm in the compression side. Due to the repetition of those collisions, the screws ultimately fractured. After repeated loadings, the rubber sheet was also disengaged as shown in Figure 15(E), and the friction force between the cover plate and rubber sheet differed between the short-period and long-period frame sides.

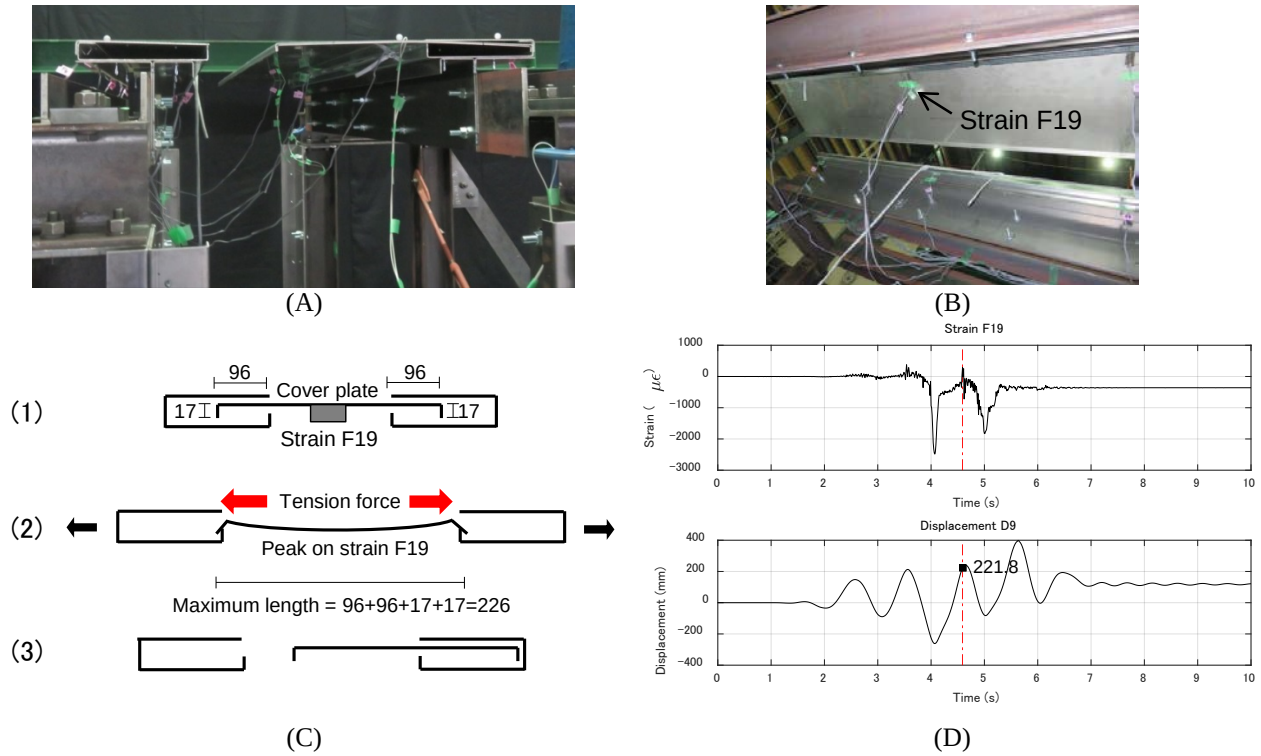
Figure 16(A)-(B) illustrates the failure mode of the SD floor expansion joint specimen. During the input of  $550 \text{ cm/s}^2$ , the cover plate was disengaged from the side plate, creating a gap between floors. Since the cover plate could no longer sustain human weight, its function was lost. Therefore, this damage state was classified as failure. The relative displacement at the timing of failure can be estimated by the response of the strain gauge attached to the cover plate. A large tension force was applied to the cover plate at the moment of failure, as shown in Figure 16(C). From the response of strain gauge F19 attached to the center of the cover plate, this moment was identified as 4.59 s, as shown in Figure 16(D). Note that large peaks in the compression side were observed at F19 due to the cover plate collision with the side plate. From the relative displacement obtained by the D9 transducer, the critical value was calculated as 22.2 cm (127% of the design motion range 17.5 cm). This value is similar to the maximum affordable length of 22.6 cm calculated from the dimension of the cover plate, as shown in Figure 16(C). Therefore, this damage depends on the dimension of the cover plate and is displacement sensitive. In summary, damage state 1 was observed when the relative displacement reached nearly one half of the design tolerance, and the failure occurred at approximately 130% of the design tolerance. Compared to the HP floor expansion joint specimen, which exhibited damage state 1 at 193% of the design tolerance, the margin of safety of the SD floor expansion joint is significantly smaller.

**FIGURE 16 SD floor specimen failure (cover plate disengaged) (unit: mm): (A) front view, (B) inside view, (C) damage sequence, and (D) strain and relative displacement response during the excitation of  $550 \text{ cm/s}^2$**

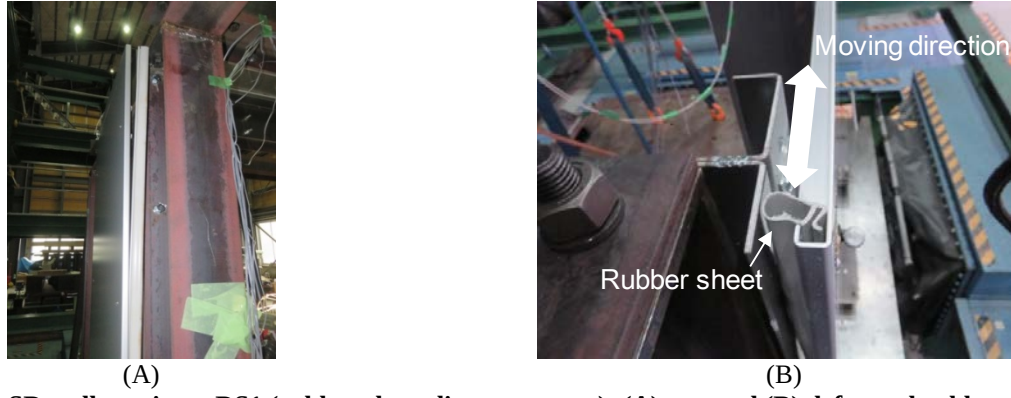
Damage state 1 for the SD wall expansion joint specimen was rubber sheet disengagement, as shown in Figure 17. The gap indicated in Figure 17(A) led to concern about air and water leakage. This damage was first observed after the input of  $400 \text{ cm/s}^2$ . For each wall expansion joint, two rubber sheets at the edges were attached as a sealing material. During excitations, a rubber sheet on one side moved along with the cover plate and was rubbed by the surrounding materials as shown in Figure 17(B). Under  $400 \text{ cm/s}^2$ , the rubber sheet on the back wall was largely detached, and a gap of approximately 5 cm was created. This damage resulted from repeated loading during shakings, and therefore it is difficult to identify the critical demand value that initiates this damage. This damage can be repaired by an adjustment and thus was classified as damage state 1.

FIGURE 17 SD wall specimen DS1 (rubber sheet disengagement): (A) gap and (B) deformed rubber sheet

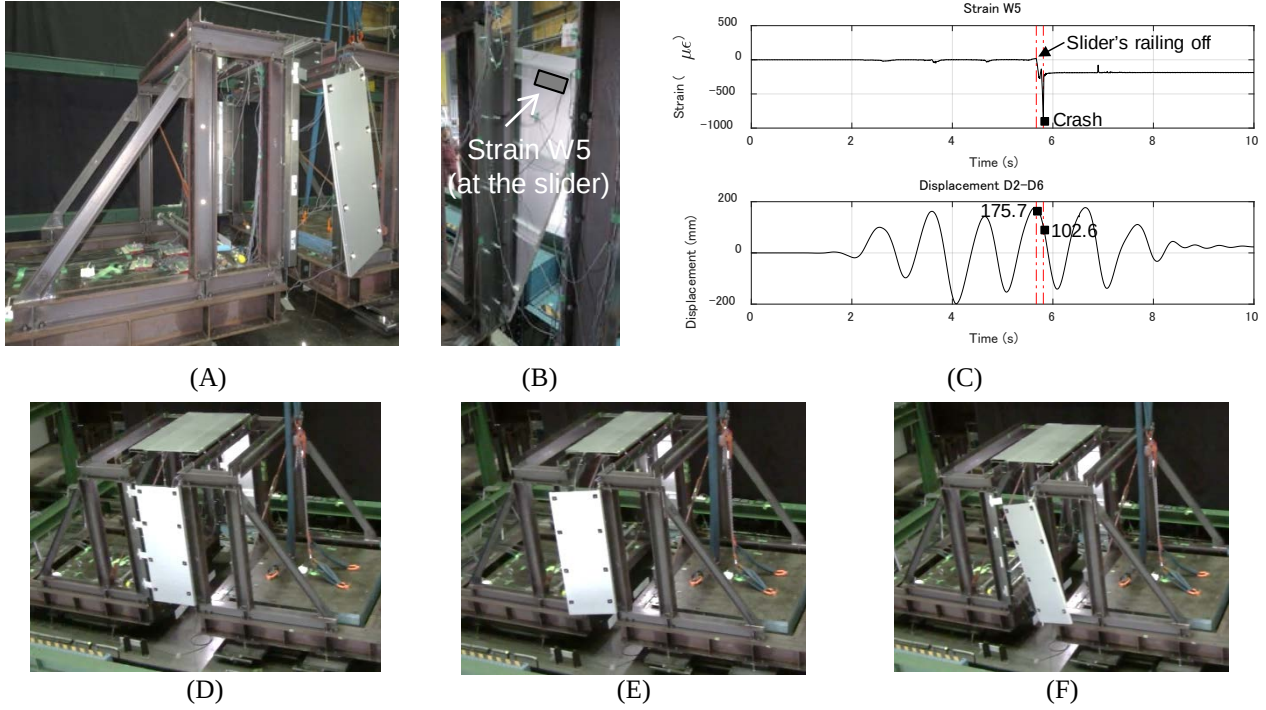
FIGURE 18 SD wall specimen failure (cover plate dropped off) (unit: mm): (A) front view, (B) inside view, (C) strain and relative displacement response during the input of  $450 \text{ cm/s}^2$ , (D) at the moment when the relative displacement equaled 17.5 cm, (E) at the moment of crash, and (F) immediately after the crash

Figures 18(A)-(B) show the failure of the SD wall expansion joint specimen. During the input of  $450 \text{ cm/s}^2$ , the cover plate of the front wall fell off because its sliders railed off. Immediately after the sliders dropped off, the short-period frame crashed into the cover plate (Figure 18(D)-(F)). This damage sequence can be explained from the strain responses. As shown in Figure 18(C), the response of the strain gauge W5 attached to the slider had a large peak in the compression side. The large compression force was applied when the cover plate was crashed by the short-period frame, and thus the moment at which the sliders railed off should be at the peak in the tension side immediately before the crash. Therefore, the relative displacement at the time of falling was evaluated as 17.6 cm. This result corresponds well with the design motion range, which was defined as a slider length of 17.5 cm. Thus, this damage state was displacement sensitive. Note that under the excitation of  $450 \text{ cm/s}^2$ , only the cover plate of the front wall dropped off because the relative displacement at the back wall was smaller than that at the front wall due to the rotational movement of the long-period frame.
