Existing Performance and Effect of
Retrofit of High-Rise Steel Buildings
Subjected to Long-Period Ground
Motions

March 2010

Yulin CHUNG

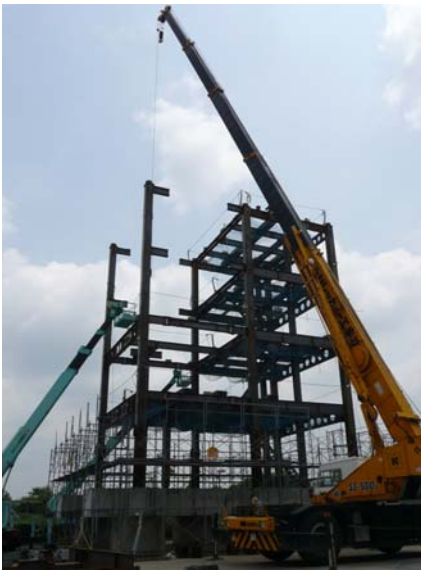
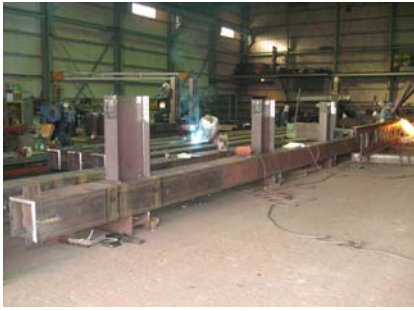
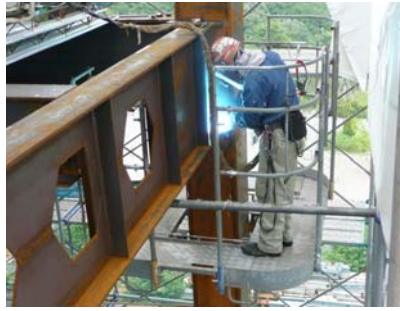
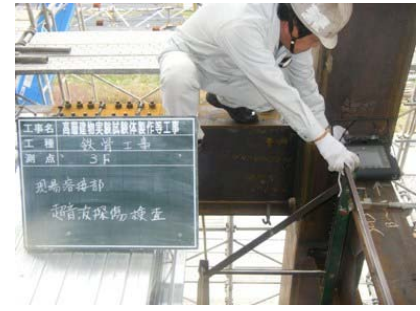
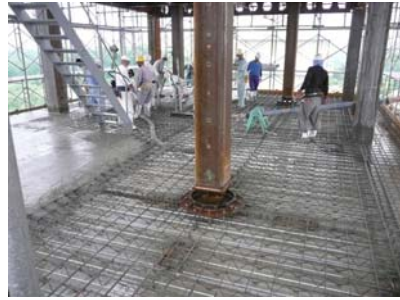
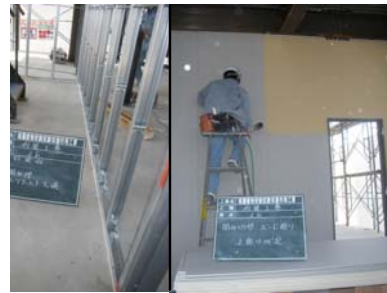
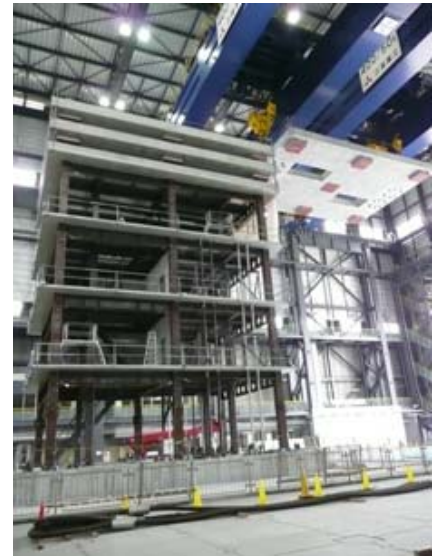
A few construction stages are shown in Figure 2.13. Construction of the specimen and welds of the connections followed as closely as possible the actual situation in the construction field. The box section column with inner-diaphragms was shop welded with the bracket beam in the shop. In the construction field, this column was bolted with the first story column which was embedded in the RC foundation beam in the first. Then the bracket beams were bolted with the central part of the beams in the longitudinal directions of the test specimen. Beams in the transverse direction of test specimen were connected with the column using the field weld detail of welded unreinforced flanges and bolted web. Welders had to work on unstable scaffolds in a high altitude, about 15m height in the E-Defense specimen. Due to presence of the beam web, weld at the bottom flange had to be interrupted at the web. The welder had to move to the other side of beam to weld the next pass after he finishes every pass in front of him. All welders were certified, and all groove welds were ultrasonically tested and qualified by an independent welding-inspection firm and all satisfied the demands of UT test criteria (AIJ 2008). Nonstructural components included the dry wall partitions and ALC (Autoclaved Lightweight Concrete) partitions were installed at the second and third story. The construction of the test frame was completed outside. Then the test frame was moved in the test building, and the foundation beams were connected with the shaking table. Finally the concrete slabs, rubber bearings, and dampers were installed in the order of the sixth, seventh, and roof floors.

Figure 2.13 Construction process: (a) Test frame; (b) Shop welding; (c) Field welding; (d) Ultrasonic test; (e) RC floor slab placing; (f) Drywall partitions; (g) Install of the substitute layers

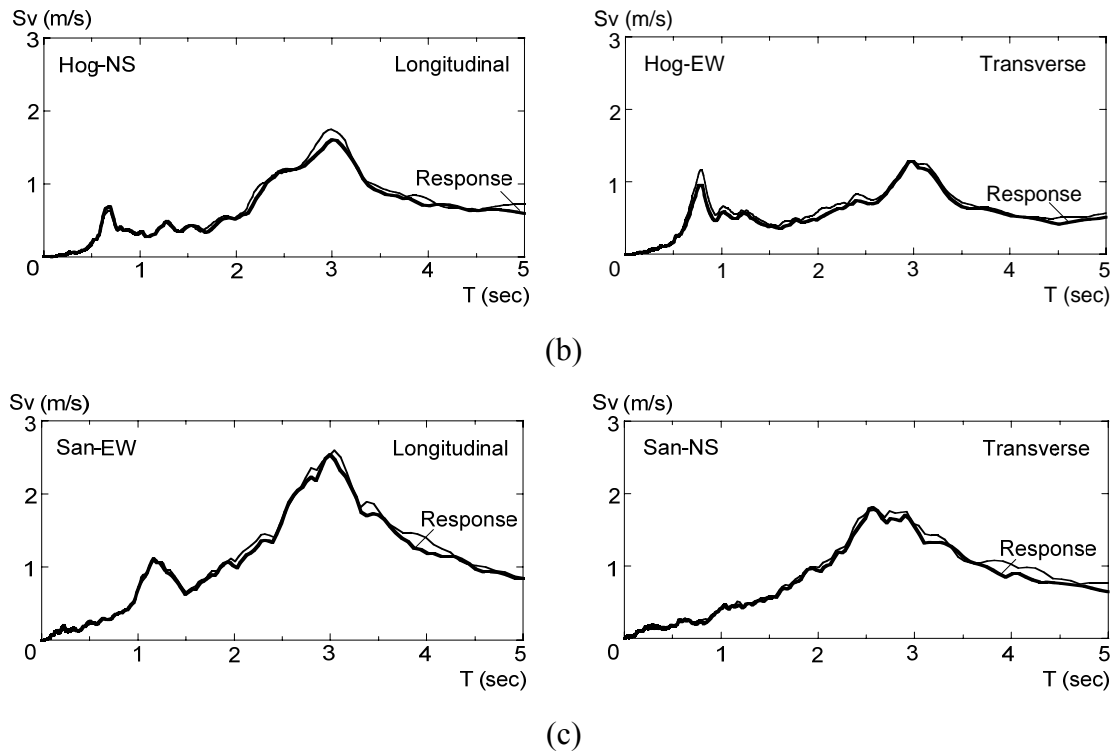
Figure 2.17 shows the velocity spectrum of the input waves and the response from the RC beam foundations of the test specimen. The shaking table shows notable representation on these waves.

Figure 2.17 Pseudo velocity response spectra of input waves and response of foundation beams :
 (a) Response of El Centro wave; (b) Response of Hog wave; (c) Response of San wave

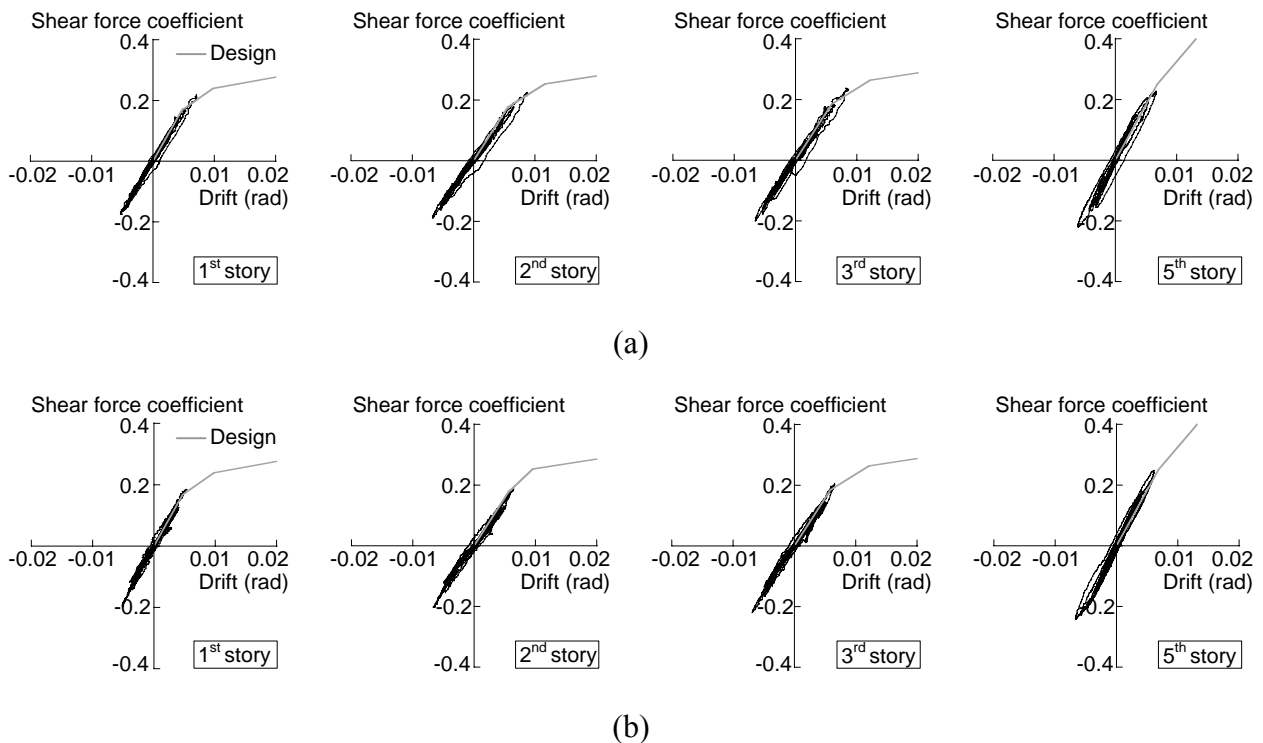
Figure 3.5 Story shear force and drift angle subjected to El Centro Level 2 loading:
(a) Longitudinal direction; (b) Transverse direction

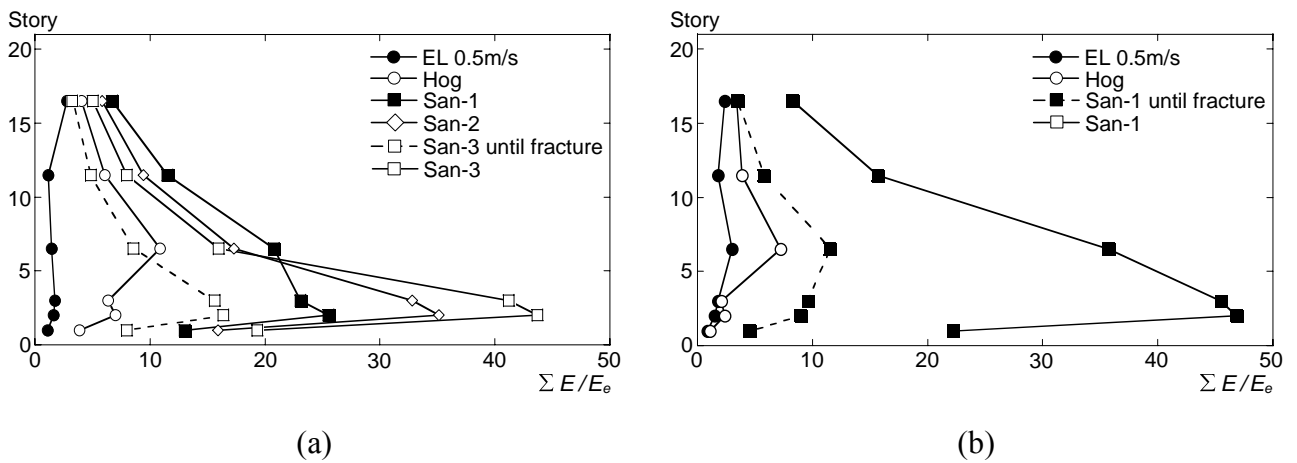
Figure 3.13 shows the distribution of cumulative ductility ratios with the height of the test specimen. The dotted lines represent the cumulative values measured until the first fracture. This figure showed similar results with the maximum inter-story drift angle distribution (Figure 3.1). Each story of the test specimen sustained similar cumulative ductility ratios when subjected to the level 2 El Centro wave loading. The cumulative ductility ratios started to concentrate on the test frame after this loading. The San-1, San-2 and San-3 waves exhibited significant cumulative ductility ratios at the second and third stories, which were about 15, 20 and 25 times larger than that of the design wave. The large cumulative ductility concentrations in these two stories made most fractures occurred at these two stories (Figure 3.4) and caused the cumulative ductility in the substitute layers reduced after each San wave loading.

Figure 3.13 Distribution of inter-story cumulative ductility ratios: (a) Longitudinal direction; (b) Transverse direction

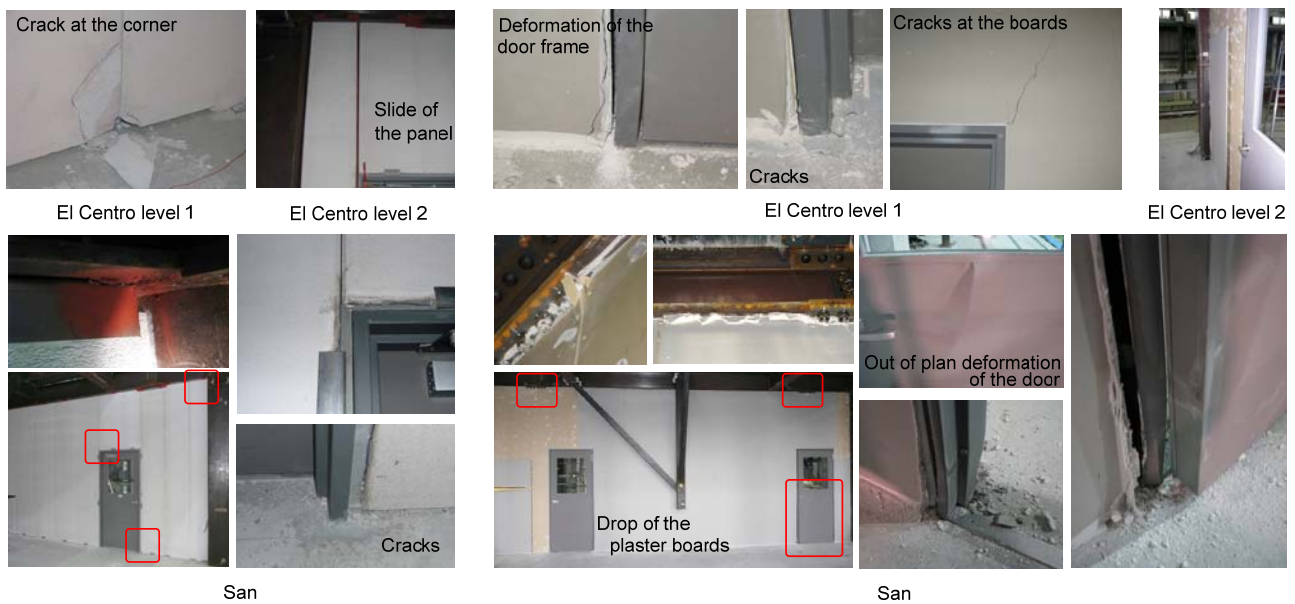
Figure 3.15 Damage to various nonstructural components

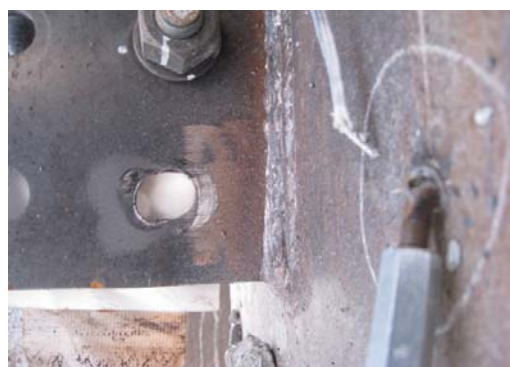
Figure 4.8 Deformation of bolt hole

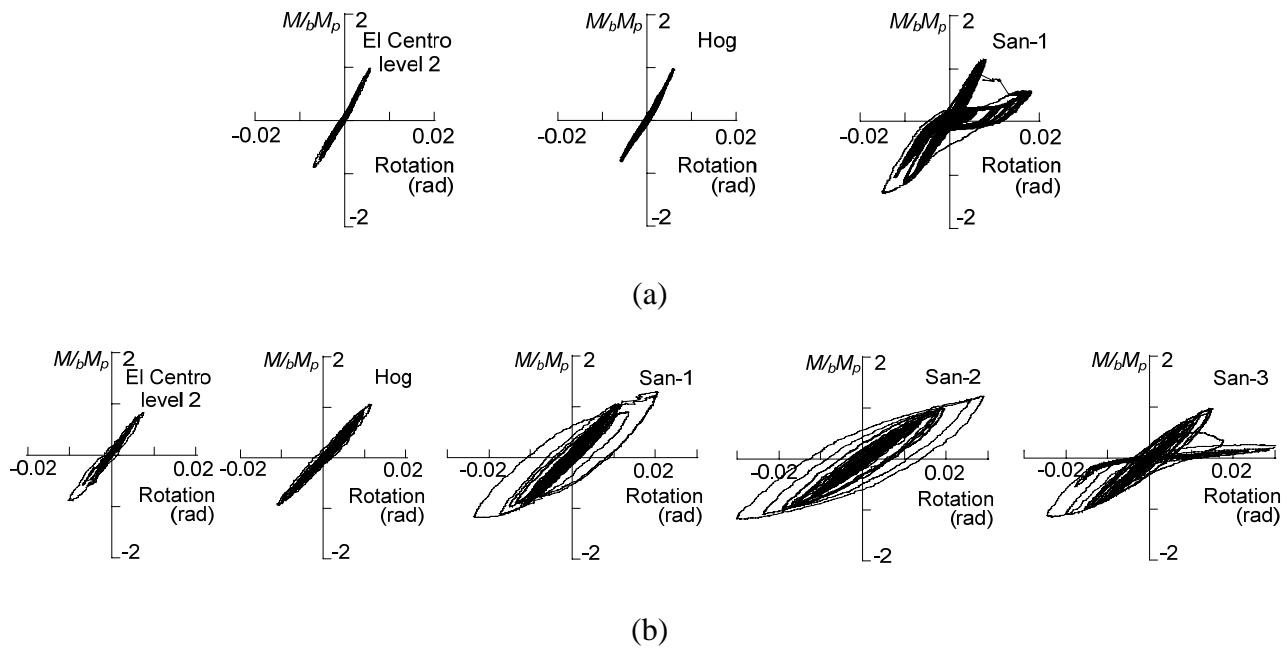
Shop weld connection sustained larger deformation than that of field weld connection under the three loadings. Maximum rotation of shop weld connection was 0.008 rad under the level 2 El Centro wave loading while the maximum inter-story drift angle was 0.9%. The fractured shop weld connection was able to sustain the maximum resistance of $1.3 \ bM_p$ in the positive bending and rotation of 0.022 rad under the second San wave loading. Connection showed stable hysteretic loops before the fracture and experienced notable plastic cycles than that of field weld connection.

Figure 4.10 Hysteretic behavior of fractured connections: (a) Field weld connection (the third floor, EL); (b) Shop weld connection (the third floor, NR)

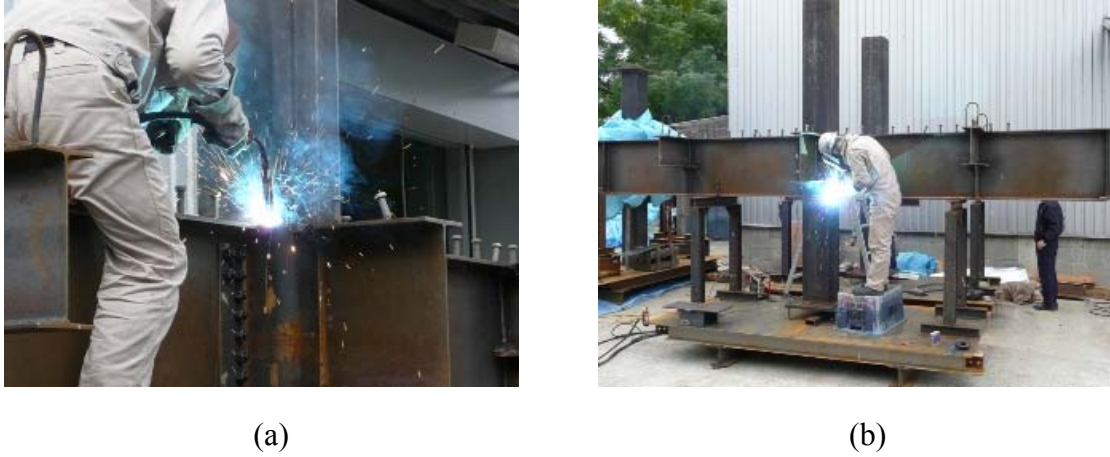
Figure 5.3 Field weld situation: (a) Top flange; (b) Bottom flange

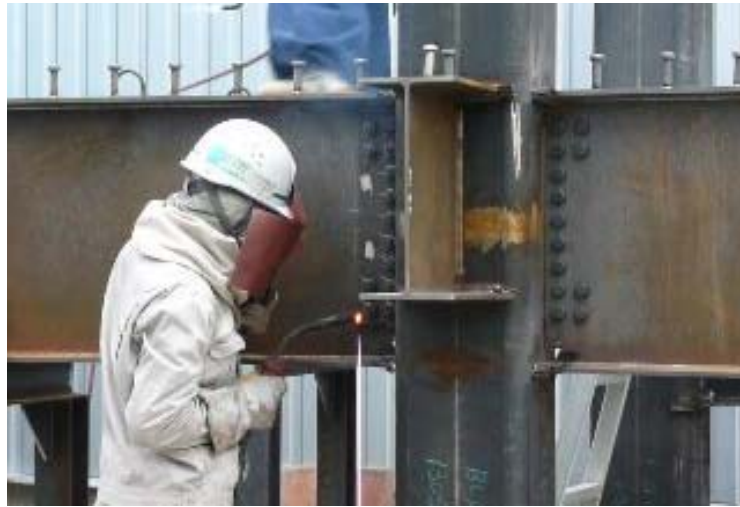
F_{wy} is the yield strength of web; s is the size of the fillet weld (7 mm); a is the throat of the fillet weld; l_h is the length of the horizontal weld; D_s is the height of the shear plate; and l_v' is the distance of the clearance in the middle of the vertical welding. Figure 5.4 shows the vertical welding applied

Figure 5.4 Vertical welding in web

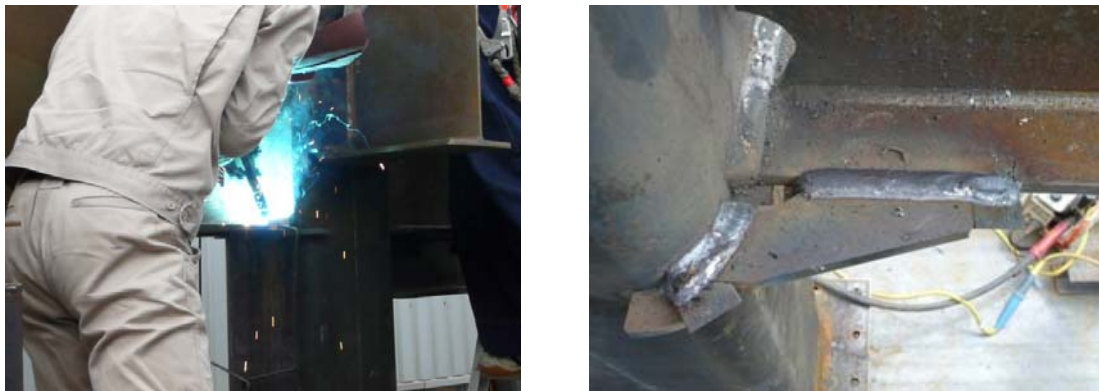
w_e is the effect width of the wing plates (totally 100 mm); t_f is the plate thickness of the flange; d_b is the distance between the centers of the two flanges; and F_{fu} is the maximum tensile force of the flange metal. According to the calculation, the connection strength ratio ${}_jM_u / {}_bM_p$ of the wing plate connection was 1.39. Figure 5.6 shows the welding situation and the detail of the wing plate.

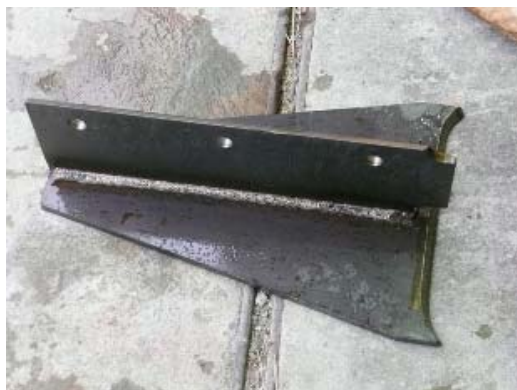
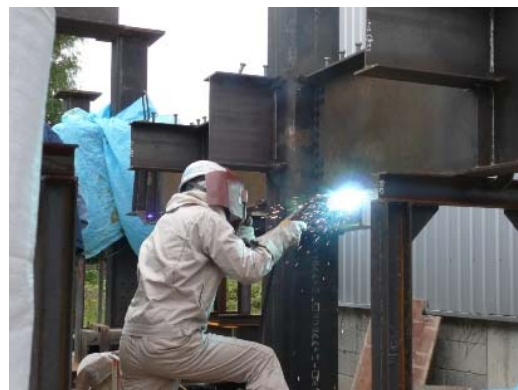
In the fabrication work, the haunch was first bolted to the shear tab, which was pre-welded to the bottom flange of the beam. The shear tab also worked as a backup plate when the penetration weld was applied between the haunch web and bottom flange of beam. Then, the welder applied the horizontal, vertical and downward welding at the web and flange of the haunch (Figure 5.8).

Figure 5.8 Field weld situation of Haunch: (a) Haunch; (b) Welding situation

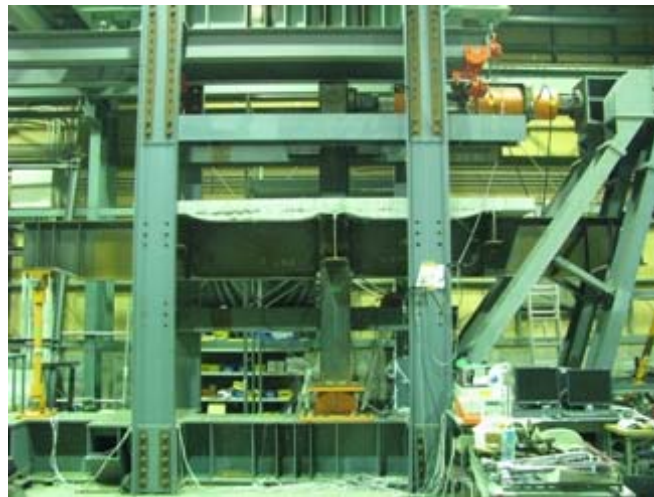
The test setup and test specimen are shown in Figures 5.9 and 5.10. The specimen consists in one column and two beams with respective beam-to-column connections. In one of the specimens, one side of the beam was arranged with the original connection. On the other side of the beam, the connection was modified slightly, and the shear tab was welded to the beam web as a possible retrofit. In the other specimen, the wing plates and haunch connections were arranged on each side of the beams. The top and bottom of the column and the two ends of the beams were pin supported. The horizontal load was applied at the top of the column by the 1,500kN oil jack. A RC floor slab with the thickness of 120 mm was placed on top of the beams. The dimension of the RC slab was limited to 1 m in width and 1.9 m in length on each side. The left and right beams were loaded independently by releasing the pin at the other beam. The column was 3 m long from the jack to the pin support. The beam was 3 m from the center of the column to the pin support. The entire specimen was 3 m in height and 6 m in width, which was three quarters of the E-Defense test frame in the transverse direction.

Figure 5.9 Member test specimen and setup

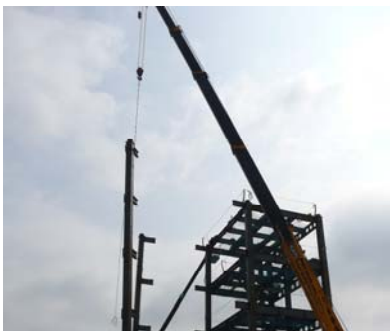
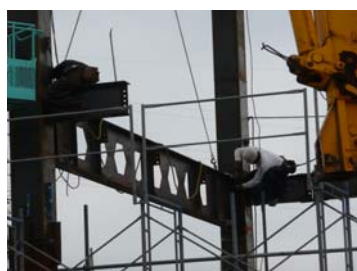
Figure 6.2 Construction of test specimen: (a), (b) Construction of test frame; (c) Scaffolds for filed weld; (d), (e) Field weld; (f) Ultrasonic test; (g), (h) Ultrasonic test for retrofit welding

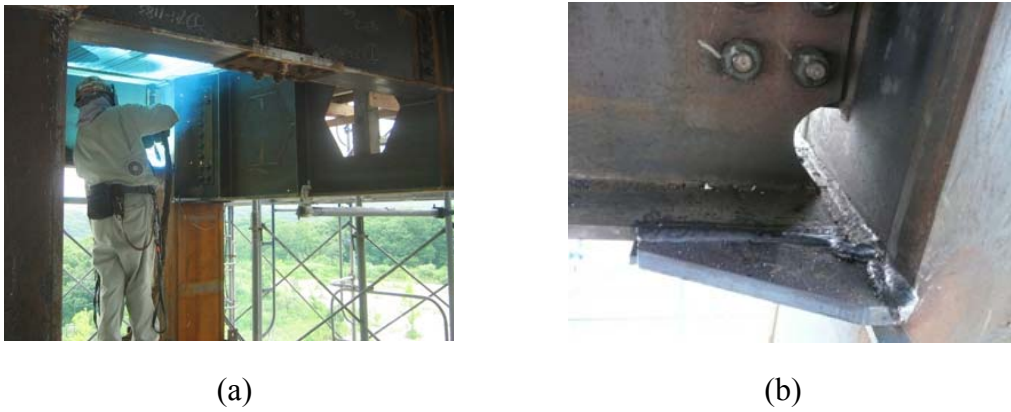
Figure 6.8 Wing plate connection: (a) Welding situation; (b) Close-up view

Figure 6.7 shows the details of the wing plate connection adopted on the 600 and 800 mm deep beams. The thicknesses of the plates were 15 and 19 mm, which was identical with the bottom flanges. The plate width was enlarged to the width of the box section column, i.e., 400 mm. Figure 6.8 shows the welding situation and a close-up view of the connections. Following the strength equations proposed in Chapter 5 (Equation 5-4), the design strength (jM_u / bM_p) of the connection was 1.42 and 1.43 for the 600 and 800 mm beams. These values were slightly higher than 1.39 designed for the member specimen.

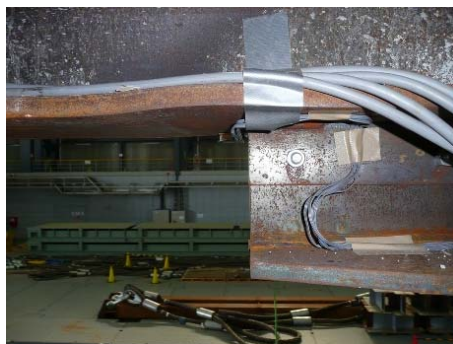
Figure 6.19 Fracture situation of connections (SL)

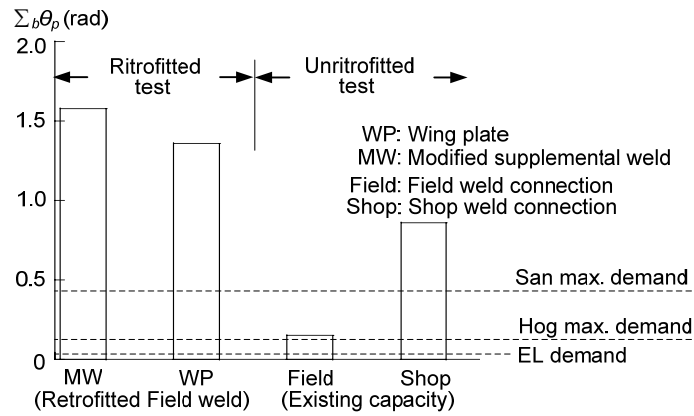
Figure 6.23. Comparison of minimum capacity and maximum demand
