The Application of Monitoring and Early Warning System of Rainfall-Triggered Debris Flow at Merapi Volcano, Central Java, Indonesia

Teuku Faisal Fathani and Djoko Legono

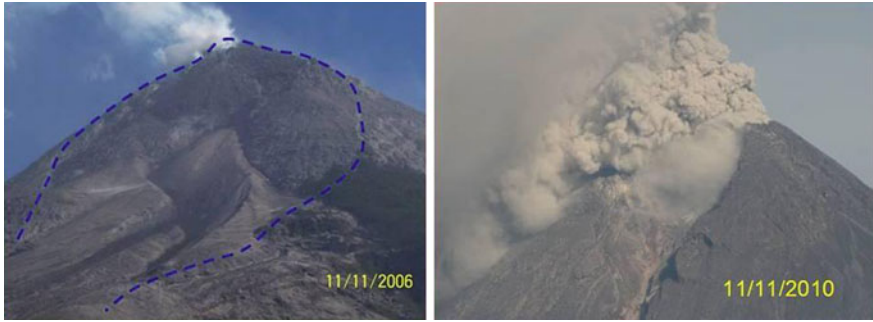
Fig. 1 Merapi volcano before the 2010 eruption

It was reported that the 2006 Mt. Merapi eruption (from April through October 2006) had produced approximately 8 million m³ of sediment, which has high potential to move downstream towards the southern part of the mountain (Legono et al. 2008). Meanwhile, the 2010 Mt. Merapi eruption (from 25 October through 2 December 2010) produced approximately 140 million m³ of pyroclastic deposit toward the southern and western part of the mountain (Legono et al. 2011a). Since then, the volcanic debris flow has caused severe damage to the inhabitants and residents living on the foot slopes. Figure 1 shows the Merapi volcano before and after 2010 eruption.

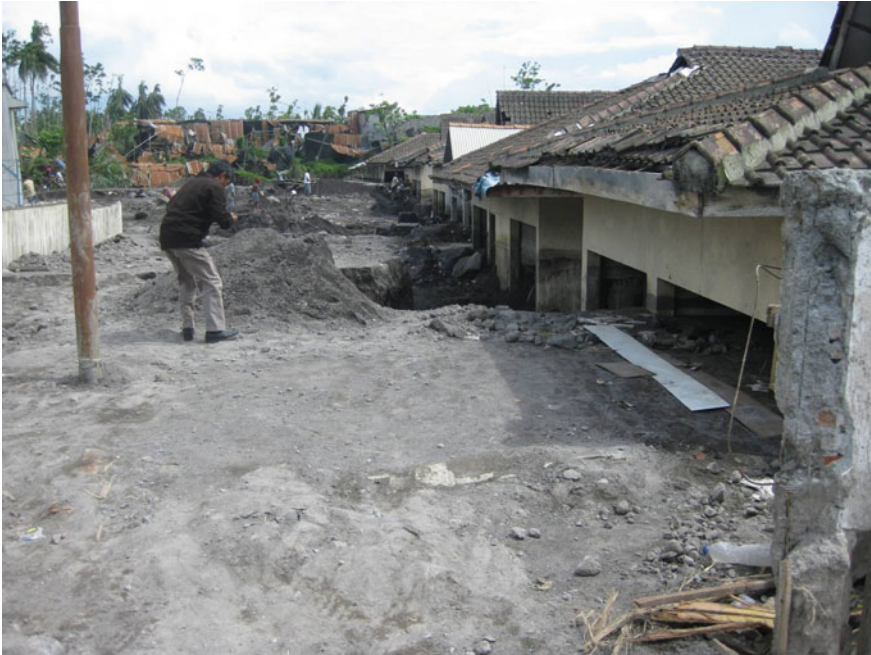
Fig. 3 Damage on houses near the volcanic river

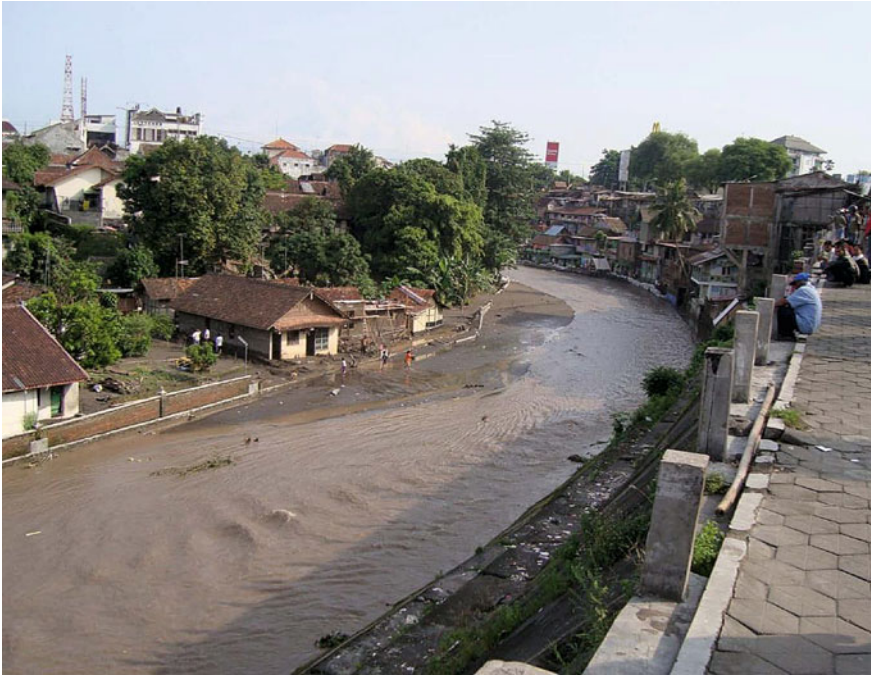
Fig. 6 Downstream condition of Code River: Jogoyudan area in the Yogyakarta City on 30 November 2010

Apparently, during the days after 29 November 2010, increase in rainfall intensity occurred, triggering a more intensive debris flow that caused significant damages in several infrastructures at some rivers (Pabelan River and Putih River). Fortunately, no casualty was reported. However, the damage of important infrastructures such as roads, bridges, paddy fields, and settlements was very significant. A hyper-concentrated flow in Boyong/Code River occurred several times that made the local people evacuate themselves (Fig. 6).

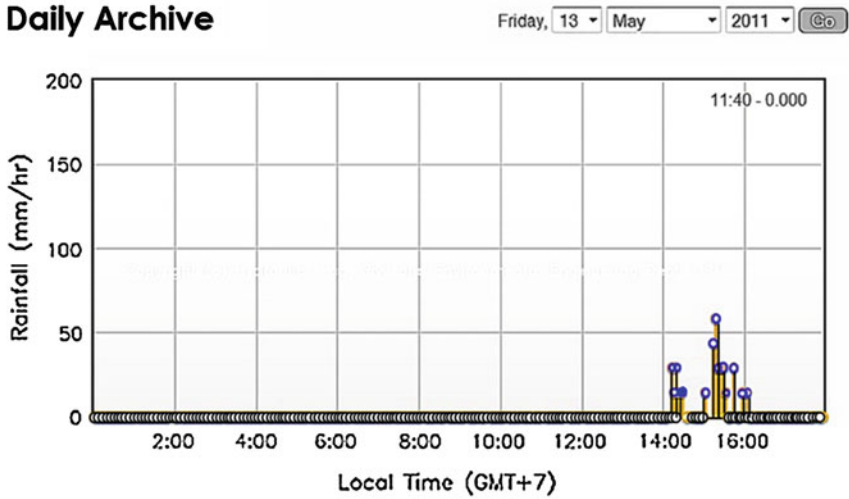
Automatic Rainfall Recorder (ARR) in Turgo recorded rainfall intensity every 6 min in the logger and then sent the data to the central station by radio telemetry. Rainfall intensity over 50 mm/h occurring between 14:00 and 16:00 PM on 13 May 2011 can be monitored from the website (Fig. 10). With this information, focal points should increase their awareness on the possibility of debris flow occurrence in the downstream.

Fig. 10 Example of online reading obtained from Turgo ARR monitoring system

Due to the insufficient budget, only the Automatic Rainfall Recorder (ARR) in Turgo and the Automatic Water Level Recorder (AWLR) in Rejodani were then established in the beginning of 2011. Figures 10 and 11 show some readings obtained from the installed ARR in Turgo and AWLR in Rejodani, respectively.

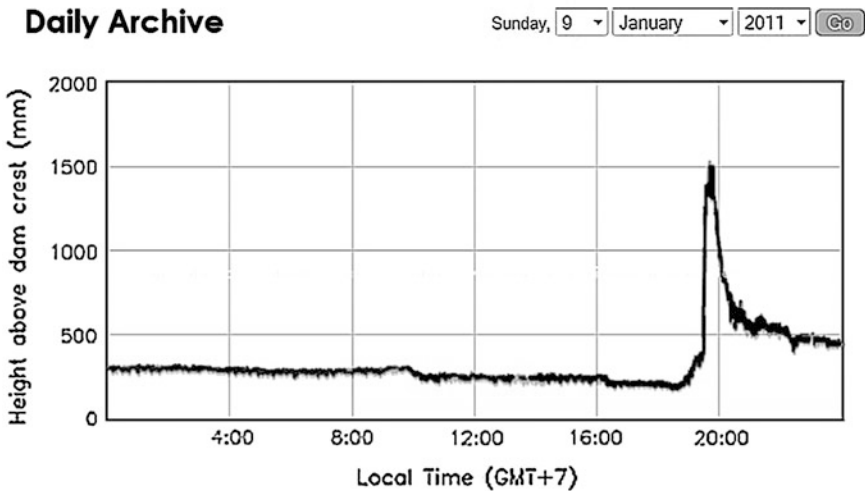
Fig. 11 Example of online reading obtained from Rejodani AWLR monitoring system

In Fig. 11, the rising of the flow monitored by the ultrasonic equipment every 15 s is shown real-time on the website. On 9 January 2011, the water elevation to dam crest rose from 39 to 130 cm in only 20 s. Further study should be carried out to determine the time needed for the debris to reach Yogyakarta City and the elevation of the flow in the downstream.

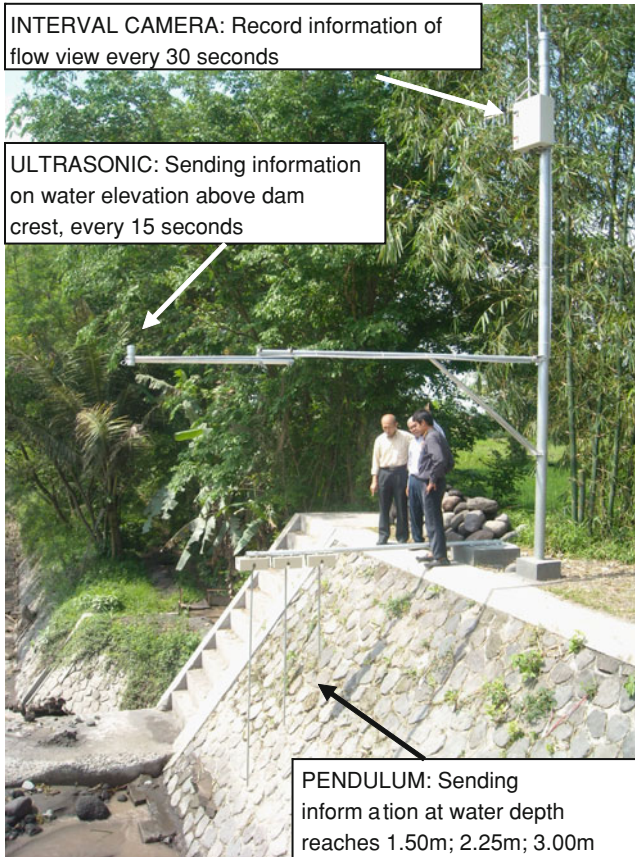
Figure 12 shows the cross-sectional monitoring system at Rejodani. Ultrasonic monitoring equipment, interval camera, and three different levels of pendulum are

Fig. 12 Cross-sectional monitoring system at Rejodani

placed in one river cross-section. This system transfers the monitoring results regularly to the central station. The whole system was built by prioritizing most adaptive and least cost technology. Through this system, a debris flow monitoring system of Boyong/Code River for community at Yogyakarta City is implemented. This monitoring system is easy to replicate for rivers threatened by debris flow disaster at the surrounding of Mt. Merapi area.
