6th Asia Pacific Workshop on Structural Health Monitoring, 6th APWSHM

## A Feasibility Study on Crack Identification Utilizing Images Taken from Camera Mounted on a Mobile Robot

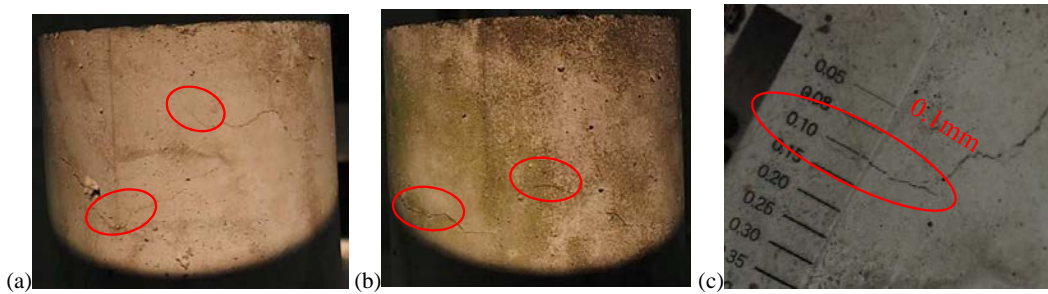
Fig. 3. Target cracks: (a) clean target surface; (b) dirty target surface; (c) closer look with a width gauge. (red circles mark the location of 0.1-mm cracks)

Two concrete blocks, serving as inspection targets, were placed at a certain distance away from the sensing system (see Fig. 1); both blocks were covered with surface cracks but one was clean and the other was dirty on surface, as shown in Figs. 3(a) and (b). The target width was 0.1 mm, as mentioned above. Those target surface cracks are also marked in Figs. 3(a) and (b), while a closer look of one crack along with a crack gauge is presented in Fig. 3(c).
