## Historical Development and Some Experiences of Energy Dissipator at Multiple-Purpose Projects in Japan

By Yoshiaki IWASA and Hiroji NAKAGAWA

### Synopsis

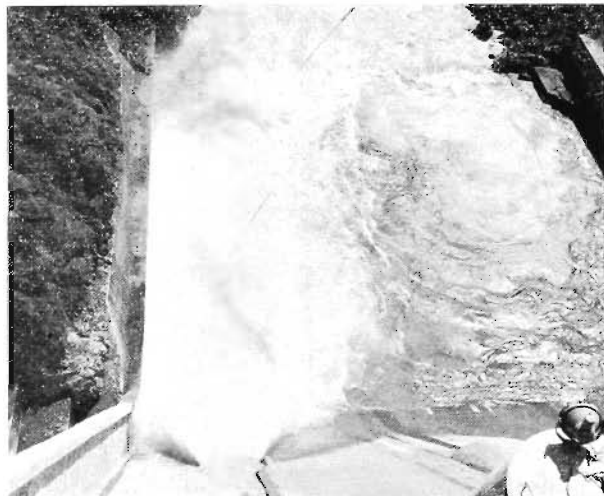
Fig. 14. Laterally back current at Tase Dam during one outlet operation.

Moreover, the cofferdam left just downstream of the apron checked the development of the bed

roller and promoted occurrences of bed scour and lateral eddy.

(2) Design and operation of spillway or outlet should be conducted to make the released flow symmetric to the center line of the basin, and not to cause the laterally back roller which might draw the eroded debris into the basin.

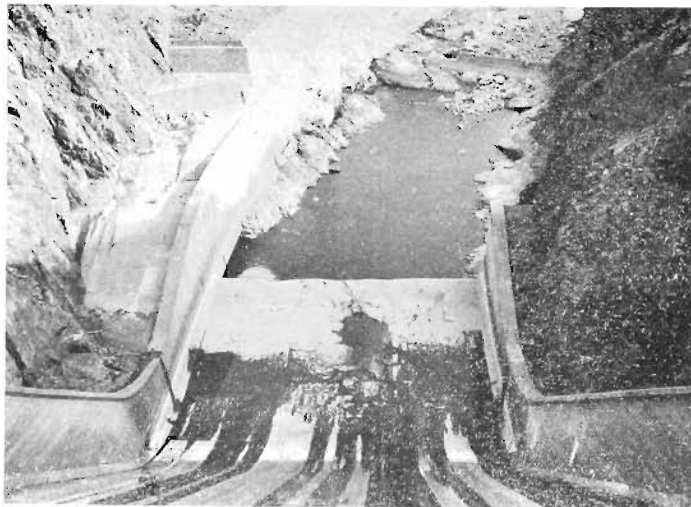
Fig. 15. Erosion at Nagayasuguchi Dam.

The first operation of the spillway was made during the flood in September, 1956, after completion of the project in 1955. Six floods of which the maximum released discharges ranged from 1,000 m<sup>3</sup>/sec. and the average period of operation was 300 hours passed over the spillway during the year of 1956 to 1957. An extensive damage was noticed at the central part of the apron and on the top of the end sill, when the basin was dewatered for inspection in January, 1958, as shown in Fig. 15. The maximum depth of erosion on the concrete floor was about 2 m and the face of guide wall on the left side was roughened by abrasion. The severe erosion on the top of the end sill would result from the cavitation, where the reinforcing steel was bent toward upstream by bed rollers.

The subsequent investigation made in 1960 after 10 flood releases with the maximum rates of 300 m<sup>3</sup>/sec. to 2,000 m<sup>3</sup>/sec. did not find the further erosion of the basin while the scour of the foundation just upstream of the cofferdam was considerably progressed. During the flood in September 1960, 4 spillway gates except 2 on both sides were operated to release water of 4,500 m<sup>3</sup>/sec., with results of failure of the part of the cofferdam and the protection wall of the downstream channel.

Causes of erosion and failure were thought to be the following: In design, though the front of jump is secured in the basin for discharges less than 1,500 m<sup>3</sup>/sec., the length of the apron is so short the bed erosion between the apron and the cofferdam is severe, and that the lateral eddy current which occurs due to the uneven distribution of the incoming flow and curvature of the exit channel draws the scoured debris into the basin, with results of severe abrasion of the concrete floor. For discharges over than 1,500 m<sup>3</sup>/sec., the tailwater depth held by the cofferdam is so insufficient to form a hydraulic jump that the flow deflected by the end sill causes a deep erosion of the channel bank. As to construction, the erosion patterns of the apron which are different between three blocks may be verified by the fact that the placing period, the quality and strength of concrete were varied each other. Cavitation damages on the sill may be accelerated by a rough concrete surface placed at the curved section. As to actual operation, when all spillway gates are operated at uniform opening, the flow concentrating to the central part of the basin will occur and result in reduction of the stilling action. For the topographical condition, the abrupt bend of the exit channel will cause a lateral back roller at the upstream portion of the cofferdam.

In 1962, the eroded parts of the apron and protection-wall were repaired by replacing the concrete, and the damaged river bank was protected by derrick stones, which have indicated a satisfactory performance against flood releases thereafter.
