On the Ground Deformation and Phenomena Forerunning Natural Disasters (Earthquake, Rock-falling and Landslide)

By Michio TAKADA

Abstract

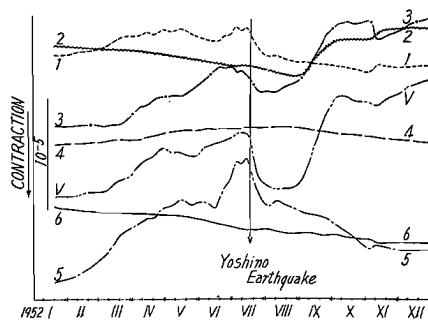
Fig. 3. Variations of linear strains and volume dilatation of which eliminated annual variations and variations caused by rainfall at Ide.
 1 : -Vertical, 2 : -Horizontal ·N88°E, 3 :
 -Horizontal ·N2°W, 4 : -Dip 50° ·N88°E,
 5 : -Dip 66° ·N2°W, 6 : -Horizontal ·N77°W,
 V : -Volume dilatation (1+2+3)

the Ide Observatory are shown as in Fig. 3. As this figure shows, peculiar variations were found several months before and after the earthquake-occurrence. Especially, the peculiar change is shown in the variation of extensometer-5 set up toward hypo-centre. The ground-strain gradually became large about March and it suddenly increased from the middle of June. Soon after, on July 13, just 5 days before the earthquake-occurrence, the direction of variation turned to the contrary direction, and the earthquake occurred on July 18. After that the variation of strain continued in the same direction for several months and the ground-strain recovered to some extent. The same remarkable variations of ground-strain were observed by extensometers 1 and 3 (set up nearly toward hypocentre) and shown in volume dilatation-V calculated from the record observed by extensometers 1, 2 and 3 (which were set up rectangular co-ordinate axis). The peculiar changes were not shown clearly in the other components orthogonal in the direction of hypo-centre. On the other hand, the peculiar change of ground-strain before and after the Yoshino Earthquake was also observed by Prof. I. Ozawa at the Osakayama Observatory about 20 km distance from the Ide Observatory.

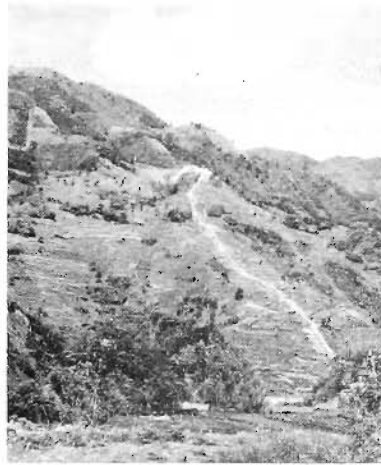
Photo. 1. Distant view of the neighbourhood of the penstock.

The geological structure in this area consists of a shale zone and the alternation zone of sandstone and shale. In the higher part of the penstock is a sandy shale zone, in the center part is an alternation zone of sandstone and shale, and in the lower part is a shale zone.

the neighbourhood of the penstock at an unfinished water power plant in Kochi Prefecture. The purpose of this investigation was surveillance, realizing that it will not serve directly for landslide because a landslide had once occurred in this area and might occur there again. (See Photo. 1.)

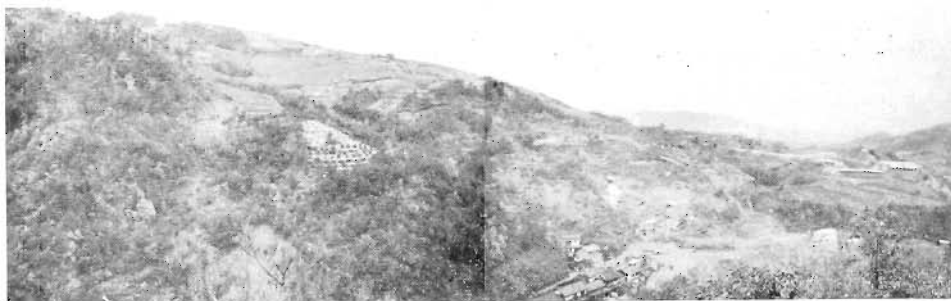
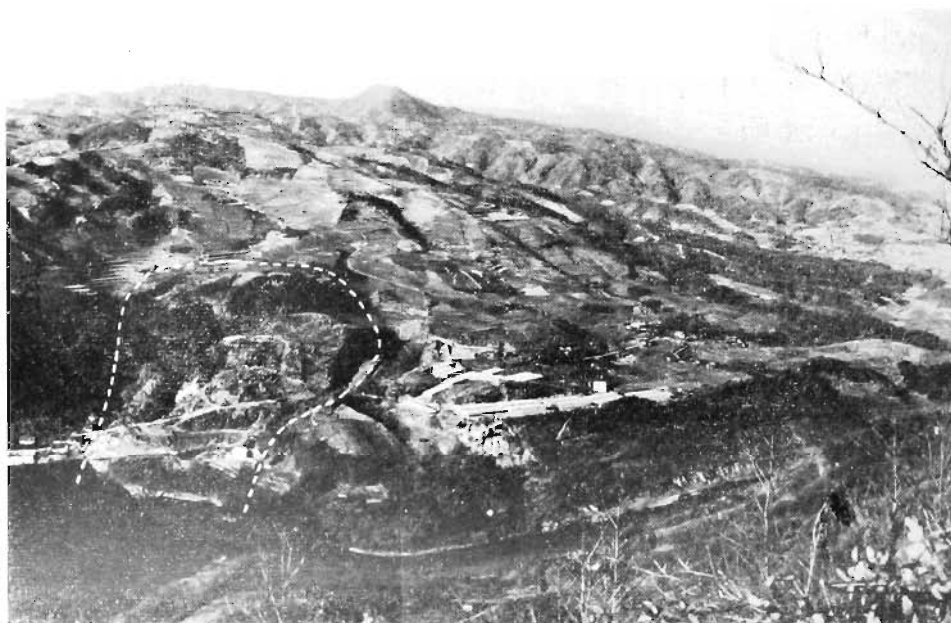
Photo. 3. (a)

The geological structure in this area is complicated. The upper most zone is covered by the Ōsaka Group consisting of clay and pebbles, the next zone is formed by the Nijo Groups consisting of two-pyroxene andesite,

Photo. 3. Distant views of Kamenose Landslide area.

The vicinity where the Yamato runs westward gathering many streams in the Nara basin and flows into the plains of Ōsaka acrossing the Ikoma range is generally called "Kamenose" and forms a ravine. The left bank of the Yamato is Ōji-cho, Kitakatsuragi-gun, Nara Prefecture and is a mountainous area having Mt. Myojin and Mt. Nijo. At the base of this area, the important routes of communication and transportation of the Kansai district such as the National Railway Kansai-Line and National Road Route 25 concentrate. The right bank is Toge, Kashiwara City, Ōsaka Prefecture and is a hill zone commanding a distant view of the mountains of Shigi and Ikoma in the North. Here owing to the fertile soil and sunniness from the south, this hill is well suited to the cultivation of fruit-trees and has for long been famous for the production of grapes, peaches and oranges. (See Photo. 3.)

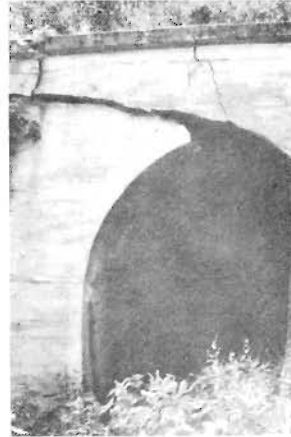
In the upper stream area, houses and fields near the bank were flooded by the rise in water level of about 4 m. The Kamenose Tunnel (about 500 m in length) of the Kansai Line was especially destroyed and the traffic was entirely interrupted. As a result the railroad of the Kansai Line was forced to move to the opposite bank because it was too difficult to repair. The remains of the eastward mouth of old Kamenose Tunnel are shown in Photo. 4. After the rainy season in 1932, such great landsliding was gradually ending. The displacement caused by this landslide was about 33 m at the maximum sliding point.

Photo. 4. Eastward mouth of the old Kamenose Tunnel.

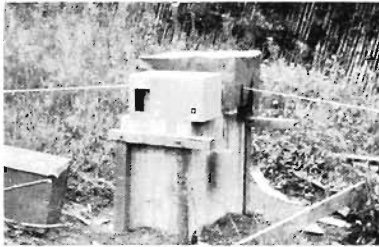
Photo. 5. Extensometer.

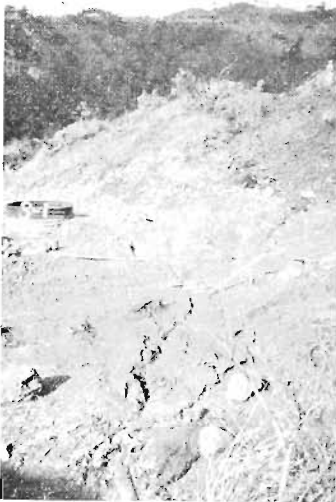
Photo. 7. Cracks occurred in the neighbourhood of Shaft No. 1.

The removal works near extensometers 3 and 4 were finished in the beginning of November. During this period cracks occurred along the crashed zone in the south-east of shaft No. 1. (See Photo. 7.) But it was nothing to worry about. After that, a project to dig down the shaft No. 1 (30 m in the depth) 15 m deeper was begun on December 15 and work progressed without incident the first day. The next day, in the midst of digging operation an unpleasant rumbling of the earth was heard in the bottom of the shaft and there was a feeling that a landslide might occur, so the project was stopped. Everything was in good order on the surface. On December 17, on the boundary between the compressive zone and tensile zone the extensometer 5, many cracks were found along the crashed zone, (See Photo. 8 and Fig. 24.) soon the posts 1 and 2, 3 and 4 were set up, facing

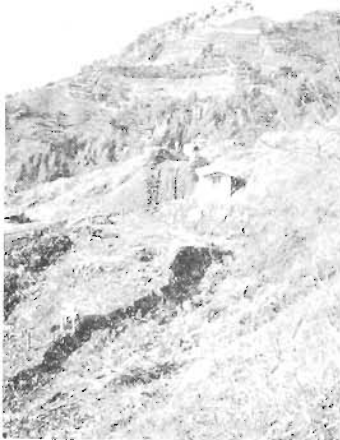
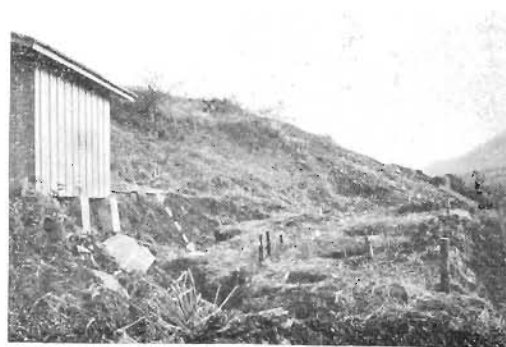
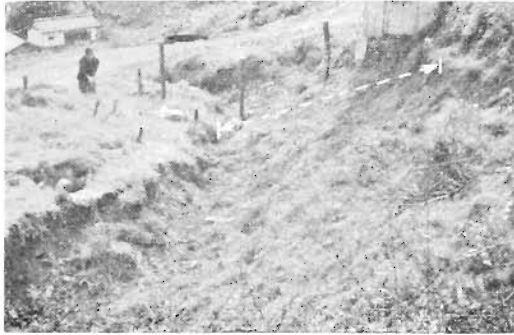
Photo. 8. Cracks occurred in the neighbourhood of extensometers 5 and 6 (On the boundary between the compressive zone and tensile zone.)
