Studies of the Third Miyakojima Typhoon

-Its Characteristics and the Damage to Structures-

By Hatsuo ISHIZAKI, Ryozauro YAMAMOTO, Yasushi MITSUTA,
Tatsuo MUROTA and Toshihiko MAITANI

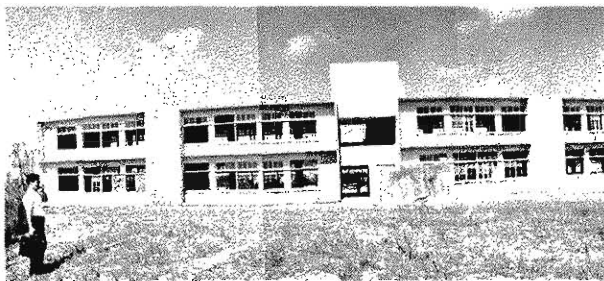
Photo. 4 Damage to a wooden school building :
removal of wooden sashes from windows.

Photo. 4 shows the damage to a wooden school building. Wooden window sashes were completely removed from the windward side of the reinforced concrete wall. This is because of the weak connection between the sashes and the

walls. Similar damage was often seen to have occurred to reinforced masonry houses as shown in Photo. 5. This damage can be prevented by careful construction work.

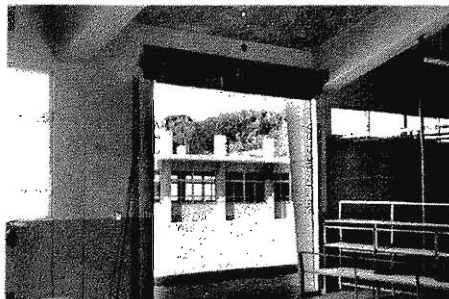
Photo. 6 Damage to light-gauge steel shutter : complete removal of shutter from the opening.

Photo. 6 shows the damage to an opening of a school building. This damage was inspected in detail by the Construction Section of the Government of the Ryukyus.

According to the inspection, the causes of damage were found to be as follows:—

- i) Lack of adequate connection between walls or beams and shutters
- ii) Deficiency in the strength of several parts of the shutter against wind.

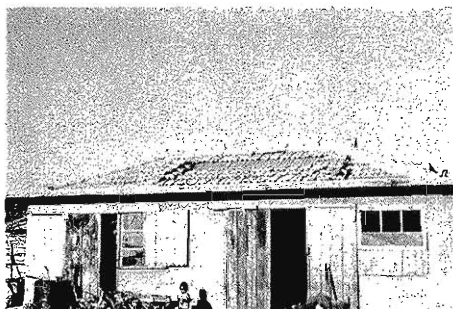
Photo. 8 Damage to a cement-tile roofing : tiles were removed extensively from the roof (damaged part are repaired by sheet-zincs).

The features of the roof damage to wooden houses appeared to differ seriously according to the type of roofings. In the case of clay-tile roofings which generally have bed boards, the removal of roof tiles from eaves, ridges verges or corners is observed, but it is not so crucial for the total collapse of the houses. On the other hand, in the case of cement-tile roofings without bed boards the damage is extensive over the roof and often it leads the houses to total collapse (Photo. 8).
