Disasters Caused by Severe Local Storms in Japan

By HATSUO ISHIZAKI, YASUSHI MITSUTA, TATSUO MUROTA,
YUZO YOSHIKAWA and IN WHAN SUNG

Abstract

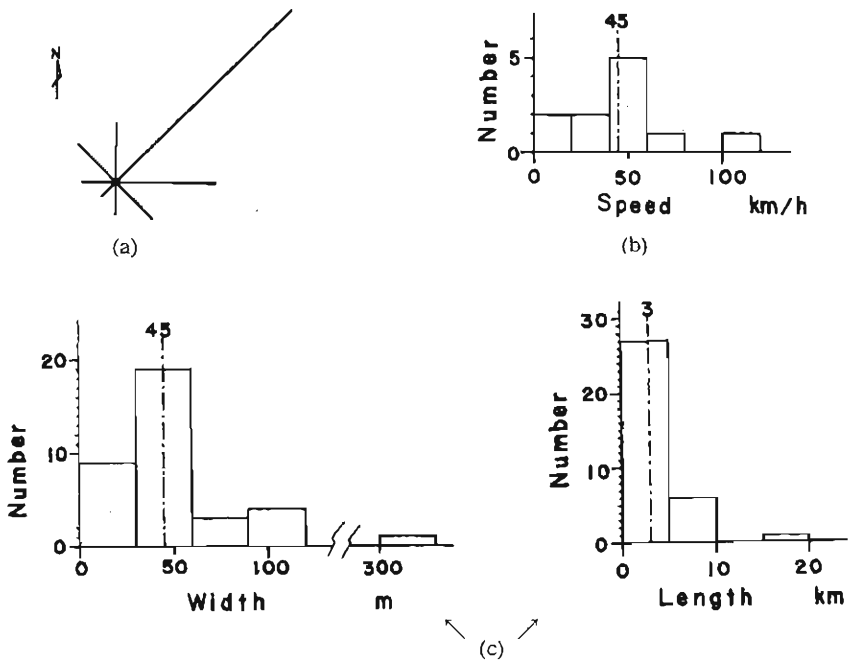
Fig. 1. The characteristics of Tatsumakis in Japan.

- a) Direction of forward motion
- b) Speed of forward motion
- c) Width and length of area damaged by Tatsumakis

"Tatsumaki" is a Japanese term for tornado, "a violently rotating column of air, pendent from a cumulonimbus cloud and nearly always observable as a funnel cloud", which is seen almost all over the world. There have been several studies on Tatsumaki climatology (e.g. Ibaraki and Tanaka⁵, Shimada⁶ and Mitsuta⁴). According to these studies most Tatsumakis occur near the sea coast, especially on the southern part of the ocean coast. The occurrence of Tatsumakis on land is about 7 per year and in an average year one person is killed, sixteen are wounded and 62 houses are damaged (Mitsuta⁴). The averaged characteristics and damages are shown in Fig. 1 and Table 1; they show that the amount of damage caused by Tatsumakis is not

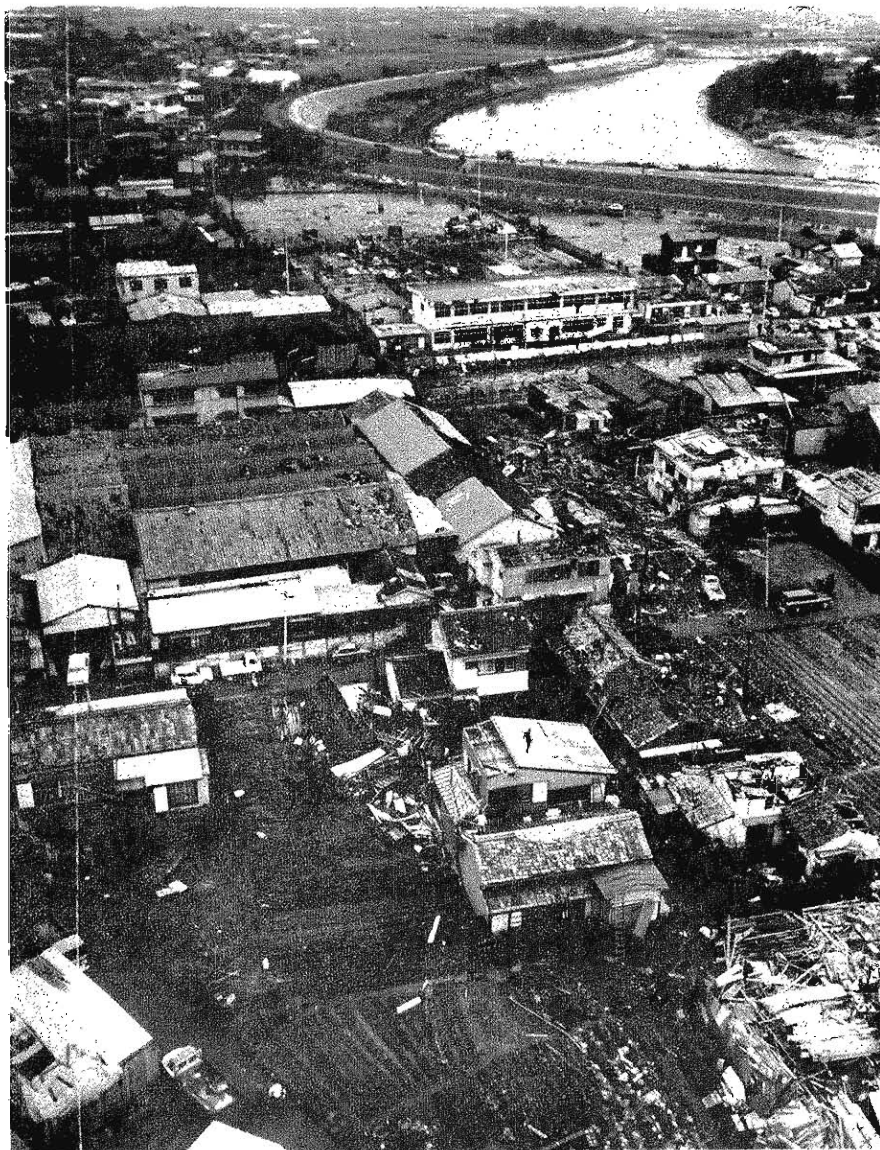
Photo. 1. Aerial view of the damage in the Shimoji-cho area after the Tatsumaki.
(by courtesy of the Chunichi Newspapers)

In Area (C), more than 80 buildings were totally destroyed or badly damaged. There, the width of the damaged area became about 200 m at maximum. The aerial view of this area after the Tatsumaki is shown in Photo. 1.

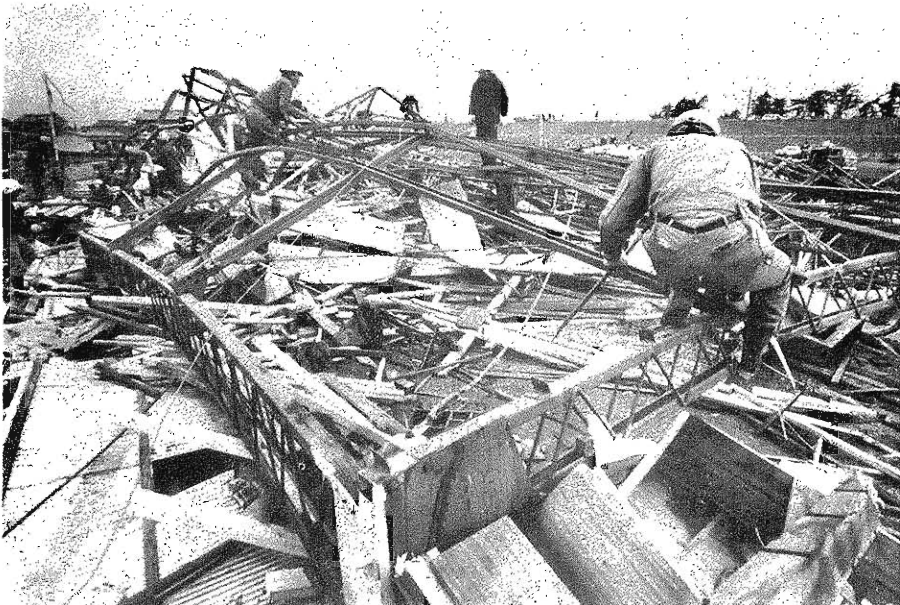
Photo. 3. Wreckage of a light-gauge-steel structure. Bodily removal of the structure from its foundations. (by courtesy of the Mainichi Newspapers)

Wooden or steel structures were more seriously damaged (Photos 2, 3 and 4). Reinforced-concrete buildings suffered damage only at openings. The general features of the damage were similar to those caused by the strong winds of typhoons, but severe local damage caused by heavy debris, as shown in Photo. 5 was often observed.

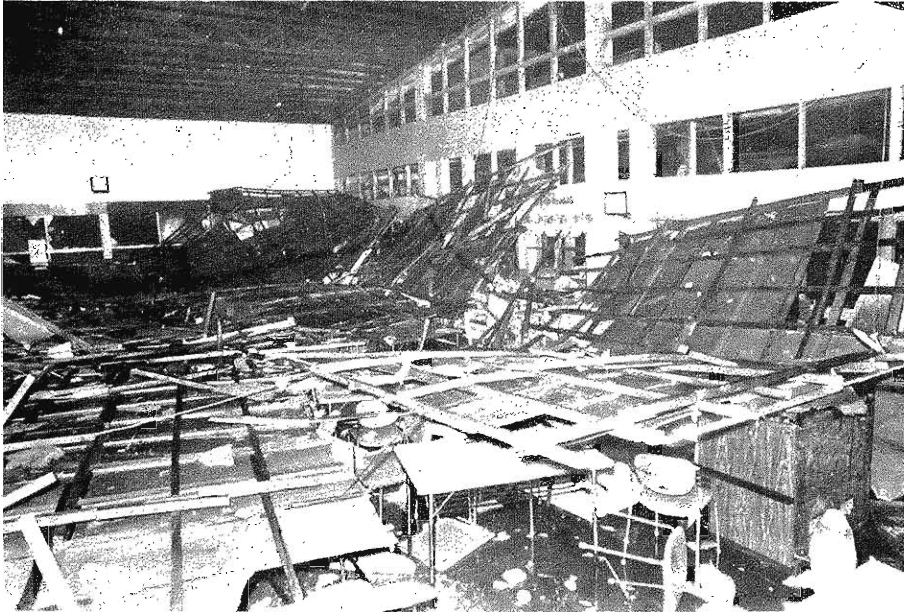
Photo. 4. Damage to a steel structure. Complete removal of the roof and collapse of the ceiling. (by courtesy of the Chunichi Newspapers)

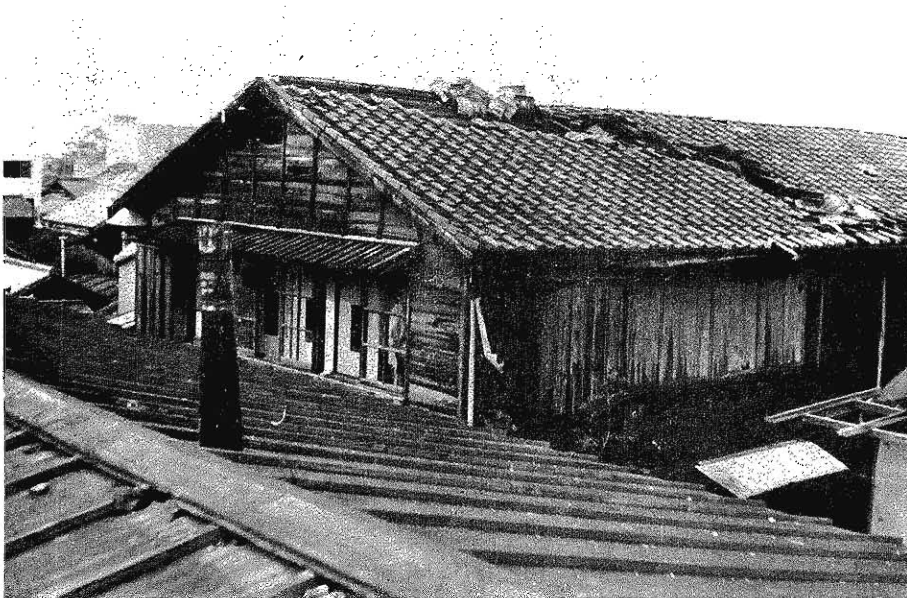
Photo. 5. Local damage to a tiled roof caused by heavy debris. (by courtesy of Mr. K. Chikada)

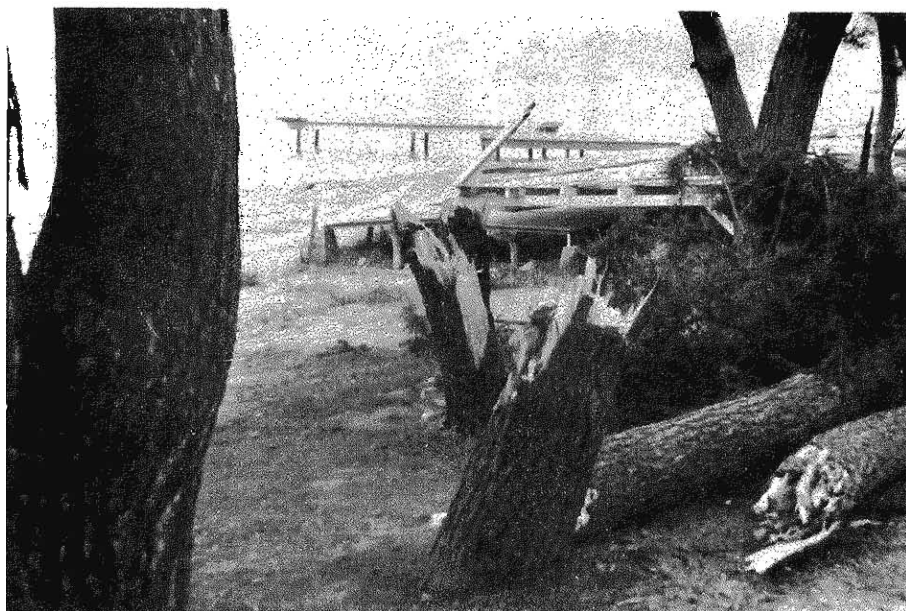
Photo. 7. 30 cm diameter pine trees broken off at the roots.

The damage caused by this storm was surveyed by the present authors just after the disaster and the detailed description of the meteorological situation and the damage is reported in another paper (Ishizaki et al.¹¹). The distribution of the damage is summarized in the map shown in Fig. 5. The shaded area is the severely damaged area, but fortunately there were only a small number of houses in it. Some of the pictures of the damage are shown in Photos 6 and 7.
