## Structural Damages Caused by Tatsumaki

By Hatsuo ISHIZAKI and Yoshihito TANIKE

### Abstract

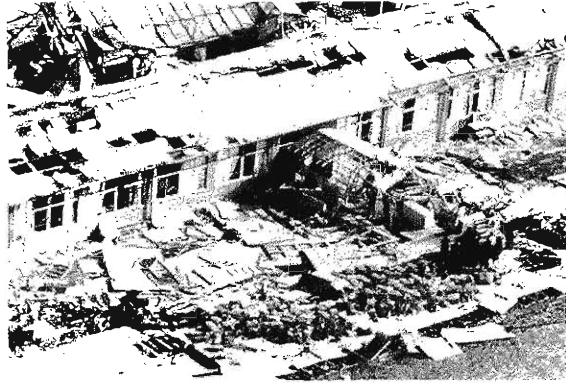
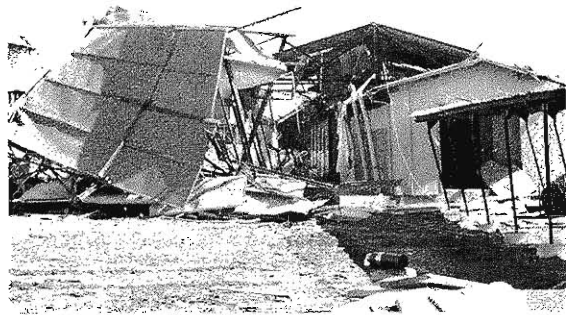
Photo. 3. The damage to a prefabricated school building.

A prefabricated one-story school building situated the north of Ichikawa City was lifted up approximately 5 m, flown over and crashed down on the other side of

a neighbouring building which was 4.8 m in height (see **Photo. 3** and **Fig. 5**). The school building had 7 rooms and a floor area of  $9.1 \text{ m} \times 59.2 \text{ m}$ . The distance between the two buildings was 37 m. The floor boards of the school building remained intact and the desks in the rooms also remained as they were. The weight of the uplifted building including the side walls and roofs was about  $82 \text{ kg} \cdot \text{w}/\text{m}^2$ . It was found that the side walls were not sufficiently fixed to the floor boards or to the foundation of the building, therefore the building could be lifted up only by an up-lift force equivalent to the weight of the building.
