Mechanism of Landslides Triggered by the 1990 Iran Earthquake

By Zieaoddin SHOAEI and Kyoji SASSA

Abstract

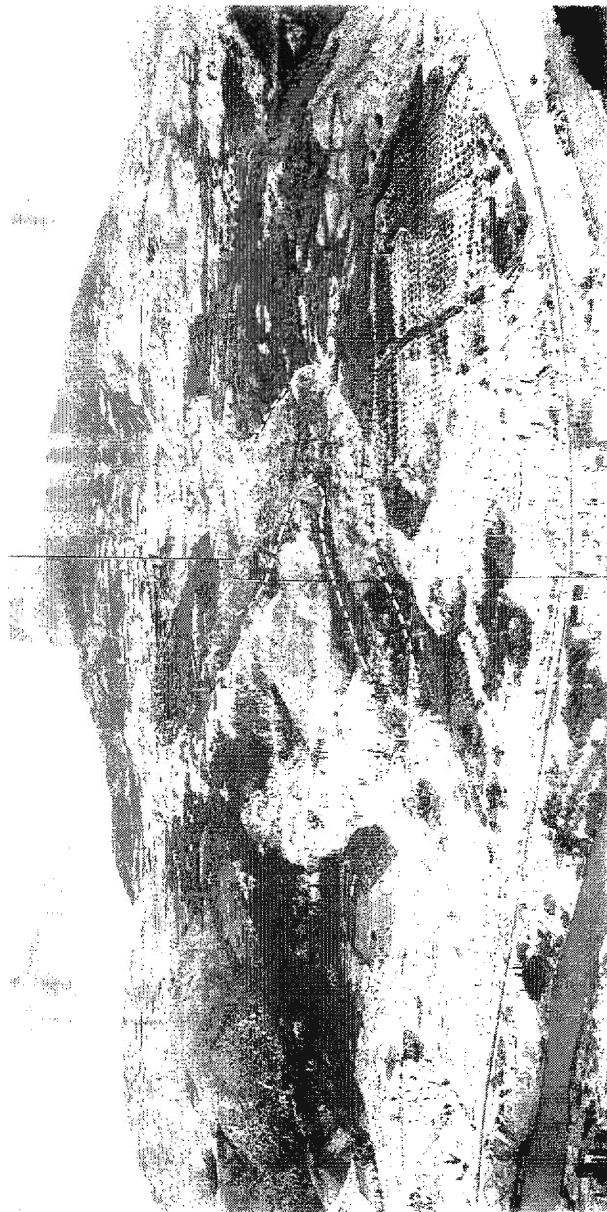
Photo. 1 Bird's-eye view of the Galdian landslide (taken on July 1991), dashed line indicates the border of the new landslide.

The biggest landslide in scale at the time of the Manjil earthquake was the Galdian landslide that occurred at the eastern flank of Sefidrood valley and near the city of Roodbar as indicated in Fig. 2. This landslide started from the slopes near the Galdian village and its direction extended along the wide U-shaped valley and then veered at the middle part of the sliding area. Fig. 2 is a contour map of the Galdian landslide. Photo. 1 is a bird's-eye view of

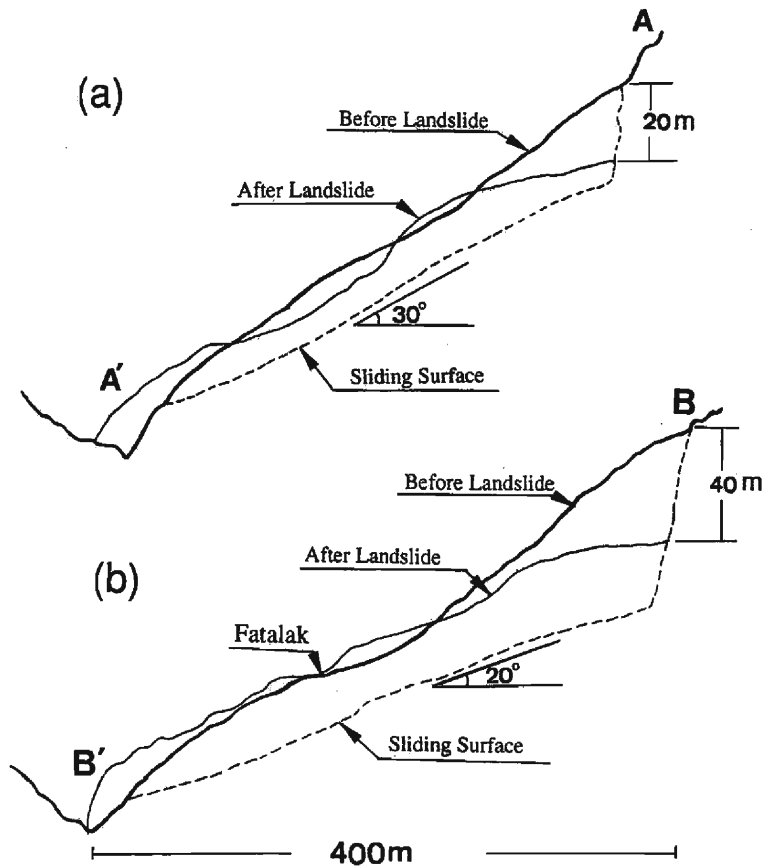
Fig. 4 Approximate longitudinal sections of the two directions of the Fatalak landslide (directions are shown in Photo. 4).

The landslide encompassed an area 400m long and 300m wide. The depth of sliding surface was about 20m on the average²⁾. The volume of moved soil was about 2 million m³. A frontal view of the Fatalak landslide is shown in Photo. 4, and Photo. 5 is a close-up view of the headscarp. Apparently the Fatalak landslide consisted of two parts: a smaller headscarp (about 20m) with steep slope (Fig. 4-a), and a higher headscarp (about 40m) with relatively

gentle slope (Fig. 4-b). The directions of sections are indicated in Photo. 4. The headscarp of landslide was composed of hard conglomerate with well-defined deep fractures that could be responsible for its weakness during the failure. The moved material at the middle and lower parts was composed of weathered soils with various sizes of boulders included. The source of the weathered material was limestone, siltstone and shale of the Triassic and Jurassic formations. Samples were collected from the fine grained soil at the bottom of scarps at the top and middle parts of landslide area.

b) **Parameters of the landslides** : For applying the tests results, the slope angle (θ) (approximated to be the same as the inclination of the sliding surface) on the studied landslides are considered as 20° in the upper slope (initial landslide meshed in Fig. 3) and 12° in the lower part (reactivating landslide, Fig. 3) of the Galdian landslide, and 20° for the Fatalak landslide (BB' section in Fig. 4).

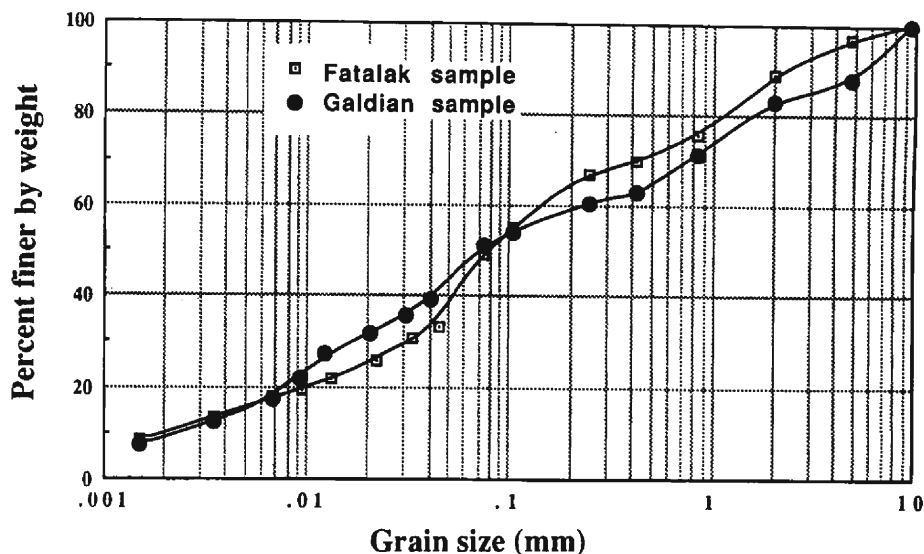
Fig. 7 Grain-size distribution curves of the Fatalak and the Galdian landslides samples.

Some properties of the samples in the field and during the tests are listed in **Table 1**. Grain size distribution curves of the samples used from the Fatalak and the Galdian landslides are shown in **Fig. 7**, and **Fig. 8** is the X-ray diffraction analysis of these samples. The peak intensities of clay minerals (montmorillonite, kaolinite, illite as found at 6–13 degrees) in the sample from the Galdian landslide are higher than that from the Fatalak landslide, which confirmed that the clay minerals in the Galdian sample were more abundant than in the Fatalak sample. For sample preparation, the samples were mixed with water and stirred for a few hours and left for one day for dispersion of soil aggregates, then were stirred again to obtain a slurry sample. The buckets of samples were shaken to release the entrapped air bubbles inside the pores and then the samples were put in the shear box that had been half-filled with water in order to avoid air entrapment. At the first stage of each test, the sample was consolidated under a normal stress corresponding to its initial normal stress in the field. After completion of consolidation, the sample was slowly subjected to shear stress corresponding to its initial shear stress in the field. In the second stage, cyclic shear loading was performed while the total normal stress was kept almost constant by using the servo-amplifier. Twenty cycles of shear loading at a frequency of 0.1 Hz was carried out. A monotonic loading test under constant normal stress and constant shearing speed was also performed to get the residual state of

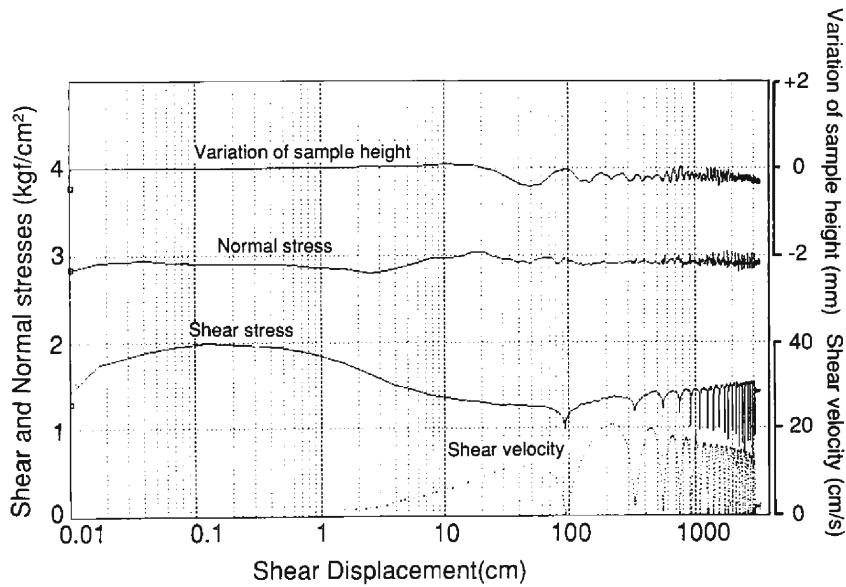
Fig. 10 Shear displacement (Log L) versus variation of sample height, normal stress, shear resistance and shear velocity in the cyclic shear stress loading test of the Fatalak sample at the peak strength state (test No. 1-3).

After consolidation (test No. 1-2) and initial shear stress loading, the cyclic shear test was carried out. The variation of normal stress was kept less than 0.2 kgf/cm^2 during the test. Fig. 9 (test No. 1-3) shows the stress path of the 1st, 2nd and final (20th) cycles. Failure occurred in the first cycle. The shear displacement after failure was about 30m during the 20 cycles. Logarithm of shear displacement is used in Fig. 10 (test No. 1-3) to present the variation of sample height, normal stress, shear stress and shear velocity. Time series data of the variation of sample height, normal and shear stresses, shear displacement and shear velocity are presented in Fig. 11 (test No. 1-3). As mentioned above, failure took place in the first cycle and the shearing velocity changed in the range of 0 to 23 cm/sec in proportion to the value of cyclic loaded shear stress.

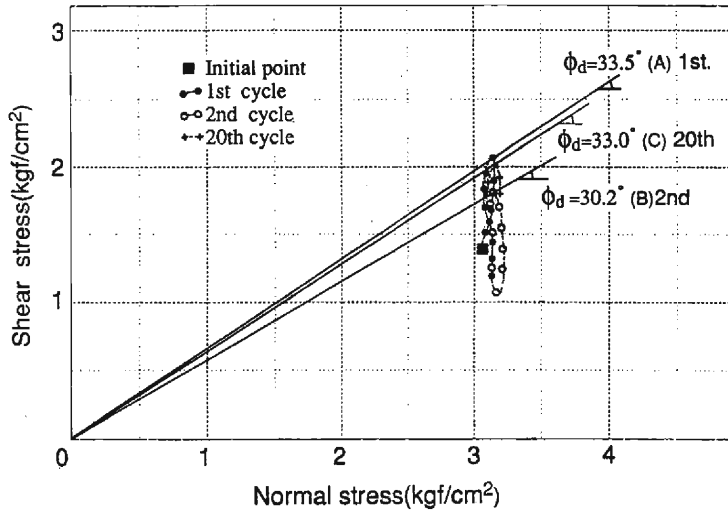
Fig. 12 Stress path of the 1st, 2nd and 20th cycles in the cyclic shear test of the Galdian sample at the peak strength state (test No. 2-3).

After completion of consolidation (test No. 2-2) and initial shear stress loading, the cyclic shear loading test was performed. Failure took place in the first cycle. The variation of normal stress during cyclic shear loading was kept less than 0.2 kgf/cm^2 during the test. Fig. 12 (test No. 2-3) shows the stress path of the 1st, 2nd and 20th cycles of this test. Logarithm of shear displacement is used in Fig. 13 (test No. 2-3) to present the variation of sample

Initial landslide in the upper steep slope : In Fig. 12 (test No. 2-3) the dynamic friction angle in the first cycle reached 33.5° and in the second cycle dropped to 30.2° , and then gradually recovered to 33.0° in the 20th cycle. This recovery of the dynamic friction angle could be due to grain crushing during shearing, as in the Fatalak sample. In the first cycle, (point (A) in Fig. 14) the seismic coefficient (k_p) necessary to cause failure was 0.174. This value was measured under the condition of pore pressure ratio (r_u) of 0.166 that corresponds to the ground water levels of 7.7m and 9.6m for the depth of the sliding surfaces of 20m and 25m respectively. In the second cycle a decrease in the soil strength was observed, and the seismic coefficient (k_p) necessary to cause failure in the second cycle (point (B) in Fig. 14) was 0.113, but shear strength gradually increased in the following cycles of test (Figs. 13, 14) and reached the maximum of $\tau_{max} = 2.04 \text{ kgf/cm}^2$ in the 20th cycle which corresponds to the k_f of 0.165. The peak ground acceleration that reached the Galdian landslide was estimated as 539 gal, ($k=0.550$)¹⁾. It was far greater than the critical value ($k_f=0.174$) obtained from the test. The loss of shear strength between the first cycle and the second cycle must be one of the main causes of the high velocity failure that took place at the upper part with steeper slope (meshed part in Fig. 3) of the Galdian landslide during the main shock of the earthquake.

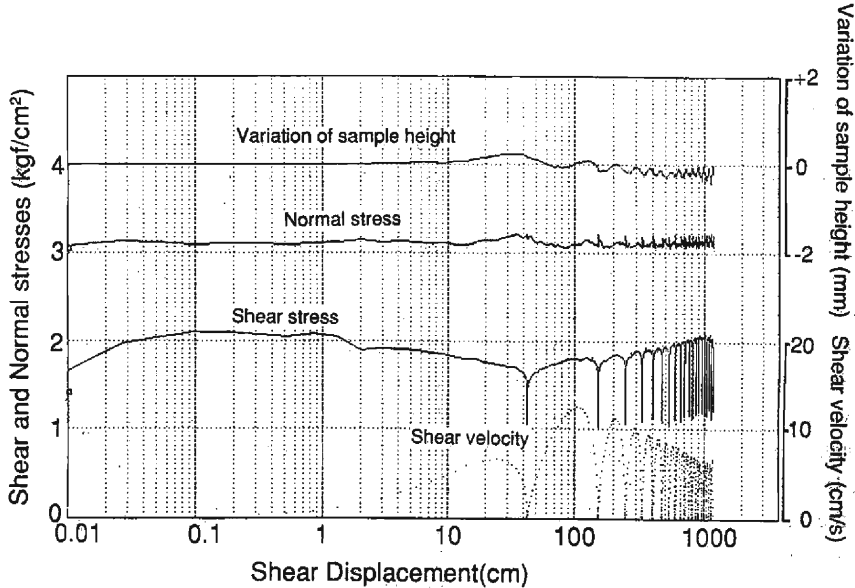
Fig. 13 Shear displacement (Log L) versus variation of sample height, normal stress, shear resistance and shear velocity in the cyclic shear stress loading test of the Galdian sample at the peak strength state (test No. 2-3).

height, normal stress, shear stress and shear velocity. The total shear displacement during the 20 cycles was about 12m. Time series data (test No. 2-3) of the variation of sample height, normal and shear stresses, shear velocity and shear displacement are shown in Fig. 14. Shearing velocity changed in proportion to the value of the cyclic loaded shear stress. In the first cycle, the peak of the shear velocity reached 8 cm/sec and then in the second and the third cycles it increased to 12 cm/sec. The peak velocity then gradually declined due to the increase of soil strength and reached 7 cm/sec in the 20th cycle.

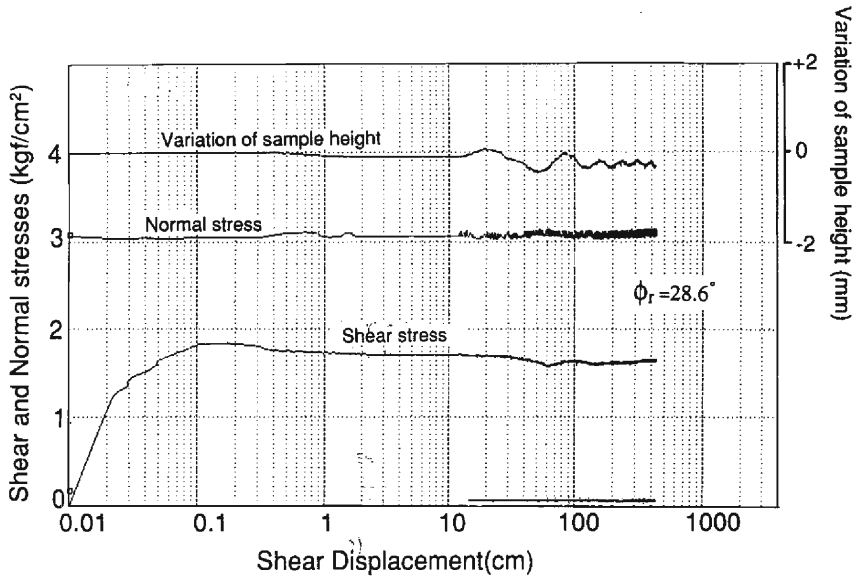
Fig. 15 Shear displacement (Log L) versus variation of sample height, normal stress, shear resistance and shear velocity in the constant speed shearing test of the Galdian sample after test No. 2-3 without changing the sample (test No. 2-4).

After this stage, shearing with constant speed (0.02 cm/sec) was performed without changing the sample (test No. 2-4). Fig. 15 is the result of this test. The residual friction angle was 28.6° after 400 cm displacement. After test No. 2-4, a cyclic shear loading test with constant normal stress was carried out (test No. 2-5). The stress path of this test is presented in Fig. 16. The measured dynamic friction angle was 31.4° . Logarithm of shear displacement versus the variation of sample height, normal stress, shear stress and shear velocity is presented in Fig. 17. Time series data of the variation of sample height, normal and shear stresses, shear displacement and shear velocity are shown in Fig. 18. Failure took place in the first cycle with low velocity and the total shear displacement during 20 cycles was about 80 cm. The maximum shear velocity was 2 cm/sec.

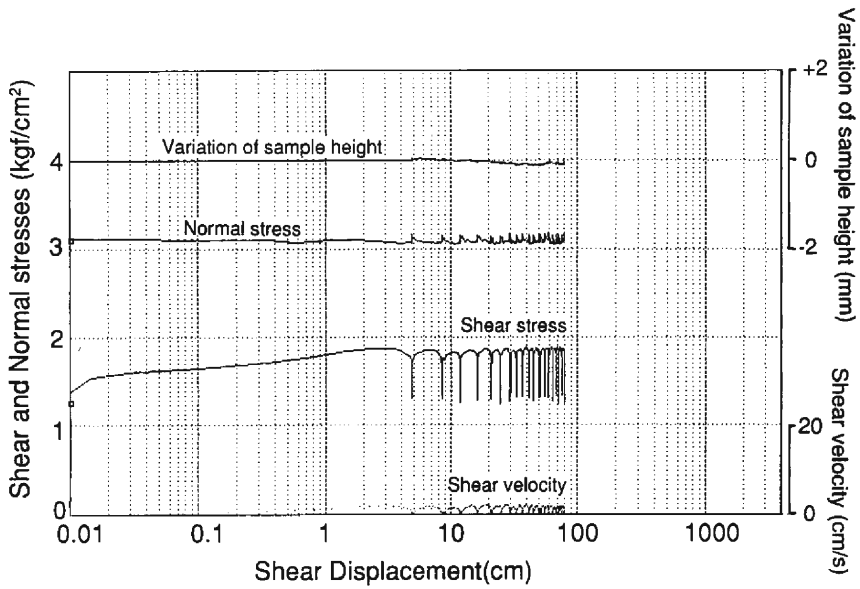
Fig. 17 Shear displacement (Log L) versus variation of sample height, normal stress, shear resistance and shear velocity in the cyclic shear stress loading test of the Galdian sample at the residual strength state (test No. 2-5).

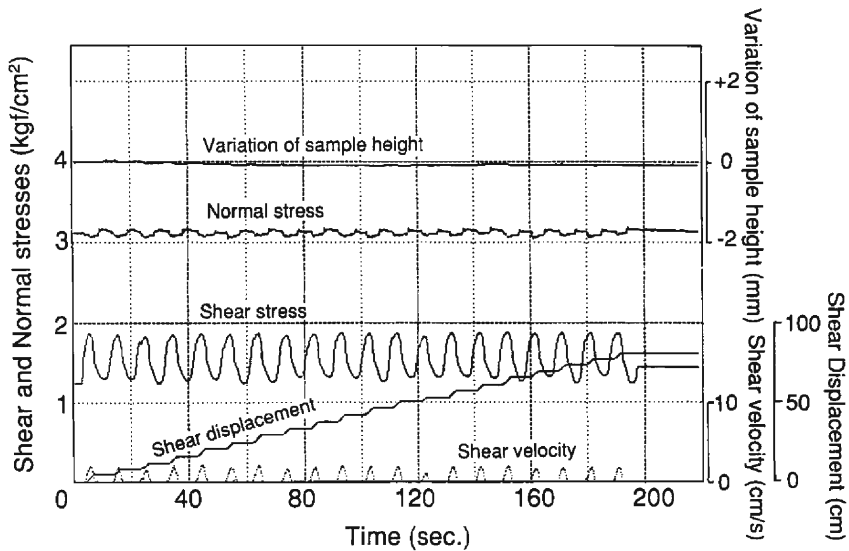
Fig. 18 Time series data of variation of sample height, normal stress, shear displacement, shear velocity in the cyclic shear stress loading test of the Galdian sample at the residual strength state (test No. 2-5).
