Test on Collapse Behavior of 3D Full-Scale Steel Moment Frames Subjected to Cyclic Loading

Dawei LIU*, Tomohiro MATSUMIYA**,
Masayoshi NAKASHIMA,
Keiichiro SUITA

Synopsis

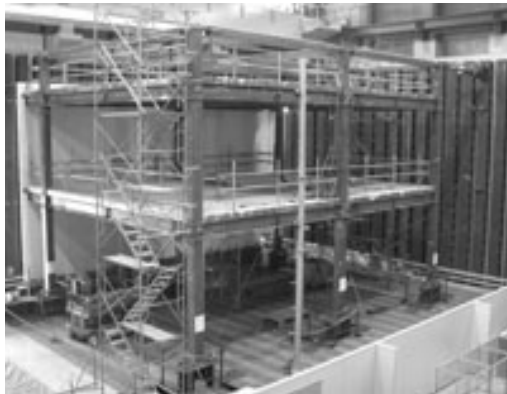
Figure 3: Overview of Test Structure (with ALC Panel)

Another feature of the test structure was the exterior finishes (cladding) installed during the test. ALC (autoclaved lightweight concrete) panels were placed on one edge of the floor to examine the effects of nonstructural elements on the hysteretic behavior of the test structure. The ALC panels were installed along the floor edge of the “South” plane (the one with the overhang) as shown in Fig.3. Material properties of the steel and concrete used for the test structure were obtained by tensile coupon and concrete cylinder tests. The properties thus obtained are listed in Table 1.

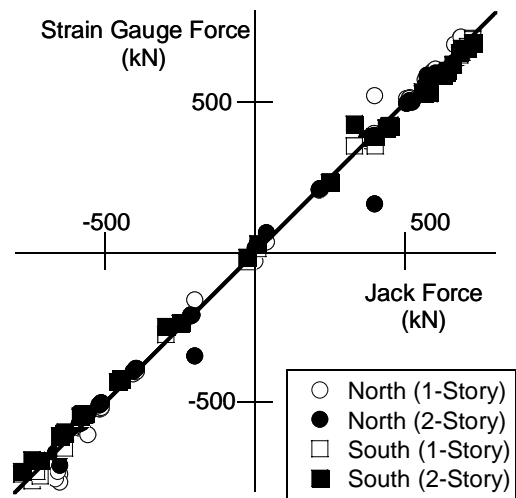
Figure 5: Comparison between Jack Force and Column Shear Estimated by Strain Gauge Reading

A load cell attached to the head of each jack measured the horizontal load applied by the jack. A digital displacement transducer that had a resolution of 0.01 mm was used to measure the displacement of the jack. Four strain gauges were glued on the column surface at two cross-sections, each located at a distance of 1 m inward either from the column top or bottom. The cross-sections remained elastic; thus the bending moments applied at the cross-sections were estimated from the corresponding curvatures. The shear force applied to the column was estimated as the sum of the two bending moments divided by the distance between the measured cross-sections. According to the measured results, the shear force thus estimated was found very reasonable. Figure 5 shows comparison between the story shear measured by the jack's load cell (the horizontal axis) and the story shear estimated from the strain gauge reading (the vertical axis). They are plotted with respect to the story shear force at the peak drift angle (Fig.4) and with respect to the plane ("North" and "South") and

the story (first and second stories). All plots are located on and around the line inclined by 45 degrees of the horizontal axis, meaning that both story shears are very close to each other. The column axial force was estimated from the average of the strains measured by the column strain gauges. The beam shear force was estimated from the difference between the axial forces exerted into the two columns, one located on the top of and the other located underneath the concerned beam. Shear deformations of the panel zones, deformations of the floors in the direction orthogonal to the loading direction, rotations and lateral displacements of the column bases, and out-of-plane rotations and displacements of the beams were also measured by displacement transducers having a variety of gauge lengths. Furthermore, many strain gauges were glued on the beam flanges and webs in the vicinity of beam-to-column connections as well as on the anchor bolts at the column bases. These gauges were used to obtain information on local strains and deformations. Summing all the displacement transducers and strain gauges, a total of 283 data channels were connected to the data logger, which in turn was connected on-line to PC for Operation.

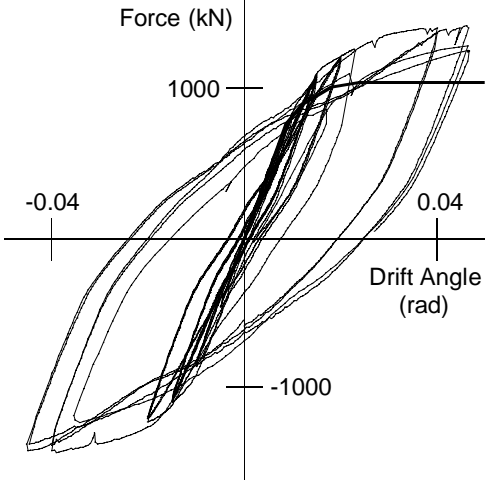
Figure 6: Total Load versus Overall Drift Angle Relationship

Figure 6 shows the relationship between the total force versus the overall drift angle, plotting the curves for loading from the amplitudes of 1/200 to 1/20 rad. Here, the total force was the sum of the loads applied by the two jacks. The solid monotonic line was an analytical curve obtained from pushover analysis, which was conducted in the course of designing the test structure. In the analysis, the effect of composite action between the wide-flange beam and RC floor slab was allowed for by multiplying the beam bending capacity by 1.5 times for positive bending (the bending in which the RC slab sustained tension). The analytically predicted initial elastic stiffness matched closely the experimental initial elastic stiffness, with the difference not greater than 8%. The analytical maximum strength was reasonably close to the experimental maximum strength, although the experimental strength revealed significant cyclic hardening (by about 30% beyond the yield strength). The results of Fig.6 suggest that nonlinear pushover analysis commonly used for seismic design practices is reasonable to predict the elastic stiffness and to estimate the maximum strength with some conservatism.

Small but visible cracks started during the cycles of the 1/25 amplitude and grew either from the toe of the weld access hole or from the edge of the runoff tab at a few beam ends. These cracks had no visible effects on the global behavior as shown in Figs.6 and 7. During the first cycle in the positive loading of the 1/20 amplitude, the “North” plane’s second floor beam was fractured from the beam bottom flange at the connection to the exterior column located on the loading jack’s side (Fig.8). The fracture caused a sudden drop of the “North” plane’s resistance by about 15% [Fig. 7(a)] but the incremental stiffness for the succeeding loading was positive again. Figure 9 shows the moment diagrams of the “North” plane just prior to the fracture of the beam flange [Fig. 9(a)] and right after the fracture [Fig. 9(b)]. The bending moments at member ends were estimated from the column shear and axial forces, as noted in Section: Measurement. The numbers inserted in the figure indicate the bending moment values at respective positions. A significant reduction in the bending moment is naturally observed at the fractured beam end, which also induced significant reduction in the bending moments at the first story’s column top and second story’s column bottom, both connected to the

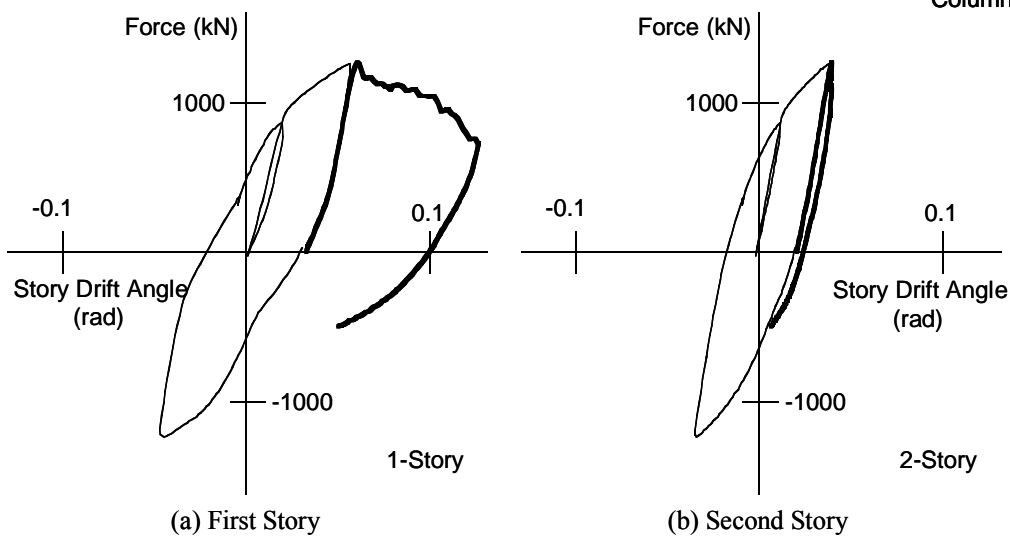
(a) First Story (b) Second Story
 Figure 10: Unstable Behavior in Formation of First-Story Collapse Mechanism

Figure 10 shows the story shear versus story drift angle relationship for the last portion of loading with large drift angles. The first story shear decreased significantly with the increase in story drift angle from 1/20 to 1/8 rad [Fig. 10(a)], whereas the second story was unloaded [Fig.10(b)]. Formation of a

first-story collapse mechanism was the primary reason for the drop in resistance. The moment resistance of the column bases decreased seriously during the last-stretch of loading, because of the combined effect of plastic elongation of anchor bolts and the crash of concrete placed underneath the column base plates. This decrease moved the

(3) Although the column-to-beam strength ratio was not smaller than 1.9, the final failure occurred by the formation of a first-story collapse mechanism. The mechanism was formed as a result of significant reduction in strength and stiffness of the column bases under large rotations and accelerated by local buckling of the column tops in the first story.

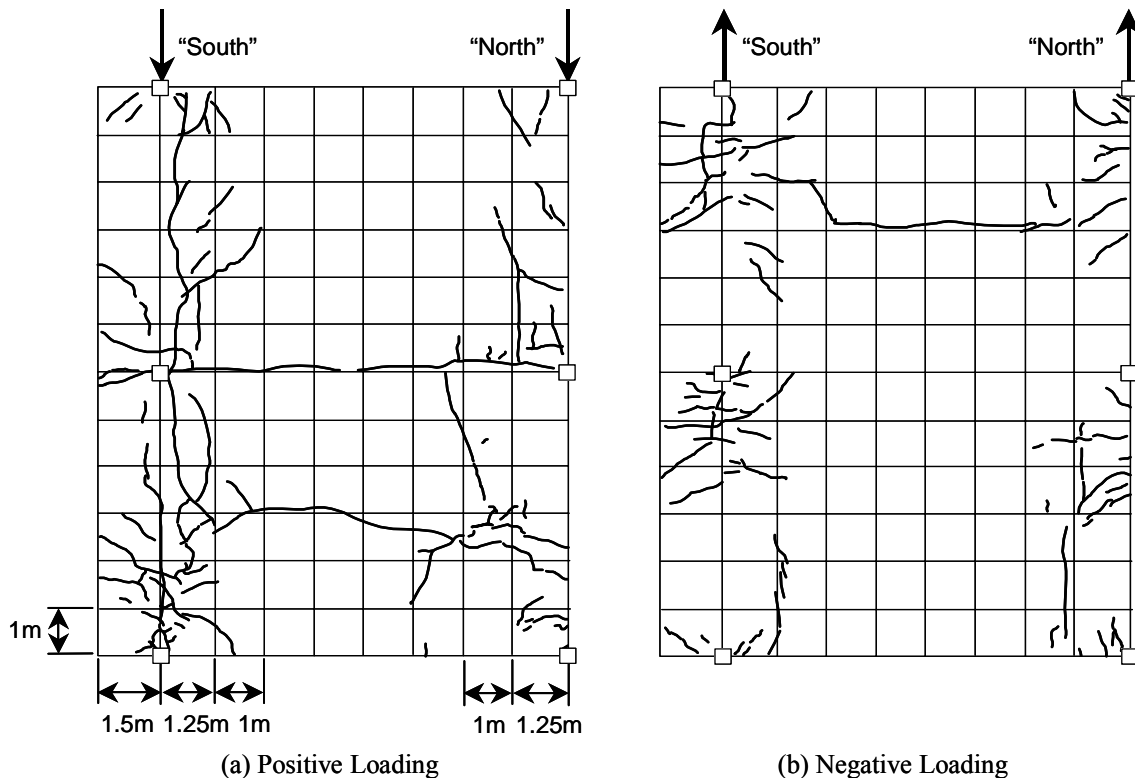
Figure 12: Cracks Formed During Loading

Figure 12 shows the crack patterns observed up to the overall drift angle of 1/25. The three lines of cracks running horizontally (from “North” plane to “South” plane) were the shrinkage cracks present prior to loading. These cracks ran on top of the orthogonal beams where shear studs were arranged. To the overall drift angle of 1/25, cracks were accumulated along the longitudinal beams and extended approximately 1 m on both side of the beam. Although preliminary, the effect of composite action was estimated as follows. The difference in stiffness and strength between the “South” and “North” planes was taken to be half the composite effect in that the “South” plane had the floor slab on both sides of the beam, whereas the “North” plane had the floor slab only on one side. Thus, the “North” plane’s strength (or stiffness) minus the difference of strength (or stiffness) between the two planes was taken to be the strength (or stiffness) of the bare steel frame (without

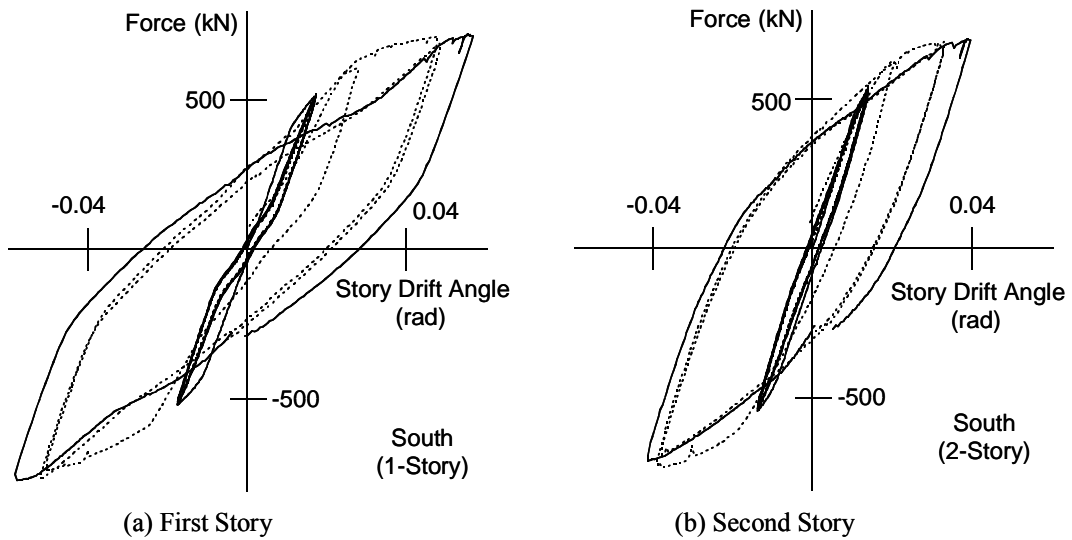
Figure 14: Effect of ALC Panels on Hysteretic Behavior (Solid Lines = without Panels; Dotted Lines = with Panels)

Figure 14 shows the “South” plane’s story shear versus story drift relationships obtained for the two amplitudes, with the solid lines without the ALC panels and the broken lines with. As evidenced from the figures, the ALC panels did not affect either the stiffness or strength for both amplitudes. Product specifications of ALC panels commonly specify an allowable story drift of 1/75 to 1/50 for use in practice. The test results showed excellent performance of the ALC panels and adequacy of the attachment details [Fig. 13(b) and (c)]. No visible cracks were observed in the ALC panels except for minor cracks and spalling of concrete at the bottom of the panels in the first story (Fig.15). At this location, there were inevitable contacts between the panels and the pedestal angle when the panels rotated.

(5) The effect of ALC panels (used for exterior finishes) on the structural behavior was nearly null up to the story drift angle of 1/25 rad, indicating that the attachment details adopted for installation of ALC panels were very satisfactory in terms of the detachment of the panels from the frame response.

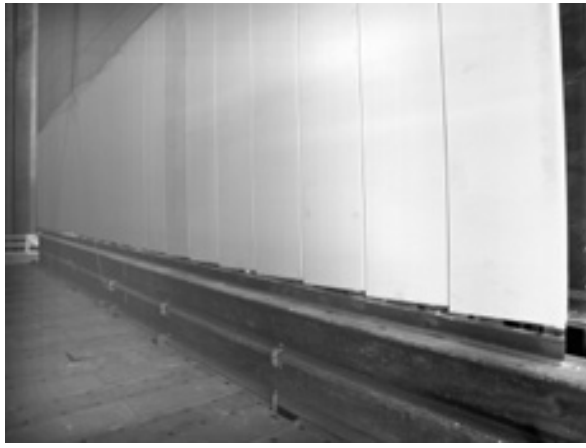
Figure 15: Deformation of ALC Panels

(a) Inclination of ALC Panels
(1/25 rad Drift)

(b) Cracks and Spalling of Concrete
at Panel Bottom
