## Evaluation of Seismic Performance of Wooden Houses during the Northern Miyagi Earthquakes of July 26, 2003

### Synopsis

## 2003年7月26日宮城県北部の地震における被災木造建物の耐震性能評価

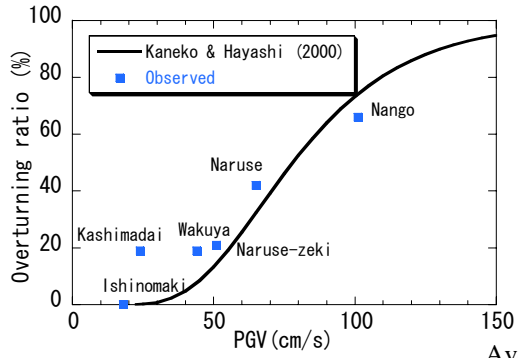
Fig.3 Relation of PGV and overturning ratio of tombstones

where  $F$  is the standard normal distribution function,  $P$  and  $V$  denote the overturning ratio and the PGV, respectively, and  $V_0 = 10(B/H^{0.5})(1+B/H)^{2.5}$ . Here  $B$  and  $H$  are the width and height of the top stone of a tombstone, respectively (see Fig. 3). Eq. (1) shows that the overturning ratio of tombstones is affected by the shape and size of the rigid top stones, and slender tombstones (small  $B/H$ ) tend to topple down easily. In this study,  $B$  and  $H$  are assumed to be 29cm and 74cm, respectively, according to the average size of the measured tombstones. The relationship (1) between the PGV and the overturning ratio  $P$  is shown by a solid line in Fig. 3. Also depicted in the figure by solid square marks is the relationship of the maximum PGV value during three earthquakes at a seismic observation station listed in Table 1 and the overturning ratio of tombstones at the nearest grave to the station. The two relationships show good agreement as seen in Fig. 3. Therefore, we can estimate the PGV in terms of the overturning ratio in the same area. Consequently, in the areas with severe damages near the Asahiya flexure, the PGVs are estimated to be 85 to 100cm/s according to the overturning ratios of 60-75%.

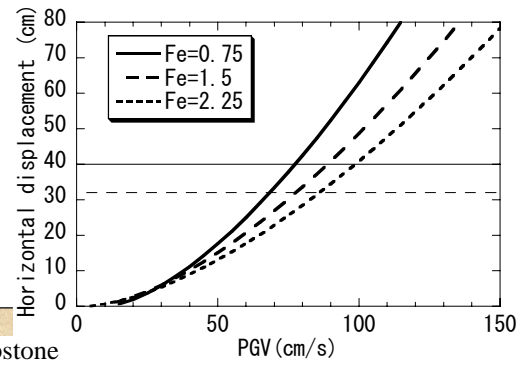
Fig.4 Relation of PGV and horizontal displacement of tombstones

where  $D$  denotes the sliding displacement,  $\mu$  is the friction coefficient,  $V_1 = mg/(2\pi Fe)$  is the minimum velocity needed for sliding. In our estimation,  $\mu$  is assumed to be 0.05 in order to avoid overestimation of the PGV. In addition, considering the predominant frequency of recordings shown in Fig. 2,  $Fe$  is varied parametrically as 0.75, 1.5, and 2.25 Hz. Fig. 4 shows the sliding displacement with respect to the PGV for three different values of  $Fe$ . It is seen that the displacement  $D$  increases as  $Fe$  becomes smaller. For most cases in which the soils are not soft, the predominant frequencies are estimated to be greater than 1.5Hz. If a tombstone moved more than 40cm, the PGV is estimated to be more than 90 cm/s. It turns out that PGVs estimated from the toppling ratios or displacements of tombstones are more than 90cm/s in the areas where the wooden house suffered serious damages.

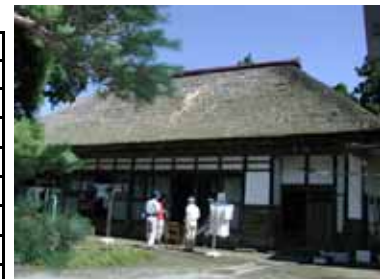
Fig. 5 A typical one-story house house (KII)

Structural properties and damages have been investigated for wooden houses in the Yamoto town, Kanan town, and Nango town, where severe damages occurred to many houses. We selected 21 typical houses in the regions without serious damages in order to find why they avoided serious damages under the same strong ground motions. These houses are listed in Table 2. Two different types of roofs were found in the houses. The old houses built 100 years ago are one-story houses or one-story houses partially extended to two stories. Roofing of these houses was originally thatch, but some have changed to tiles or steel sheets. The relatively new houses are covered by steel sheets. Fig. 5 shows a typical one-story house with thatch roofing. Beams in the roof truss were very thick, and consequently the weight of the roof is heavy.

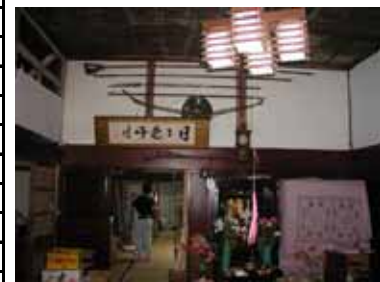
Fig.6 Hanging walls (NMH)

An important feature in the one-story houses is that they usually have hanging walls as shown in Fig. 6,

and the heights of the story and the hanging walls are quite high. The story height ranges from 2.6m to 3.9m, mostly higher than modern houses with heights about 2.7m.

In applying the method of response limit strength design, the force-deformation curve for the hanging wall was obtained from test specimens in the lab. However, the heights of the hanging walls in the 21 houses are much larger than that used in the tests. Thus, the shear failure shown in Fig. 6 will not occur in the lab. To improve the method for evaluating the seismic performance of existing buildings, the force-deformation relationship of the unit elements should be obtained through tests on real scale specimens.

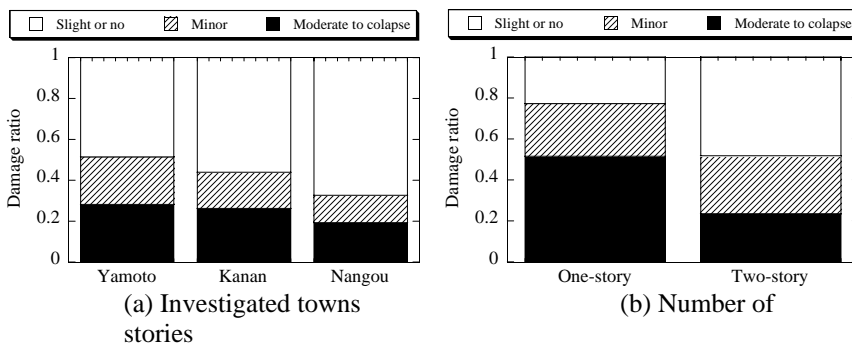
To catch a general trend of the damages, surveys were carried out for houses in the three towns to obtain damage statistics. Fig. 7(a) shows damage ratios of the three towns. As the distance from the epicenter of the main shock increases in the order of the Yamoto town, Kanan town, and Nango town, the damage ratio reduces. The ratio of moderate damage to collapse is about 20% in the Nango town, and about 28% in the Yamoto town. The damage ratio is clearly related to the number of stories, as shown in Fig. 7(b). The ratio of one-story houses with moderate damage to collapse is about 50%, 2.5 times as high as that of two-story houses. While Fig. 7(a) gives an expected trend, the result shown in Fig. 7(b) is surprising, and needs to be investigated.

direct cause of the damages, the maximum drift angles  $R$  less than  $1/30\text{rad}$  correspond to a low ratio of severe damages at the location. This result is consistent with the statistics shown in Fig. 7(b).

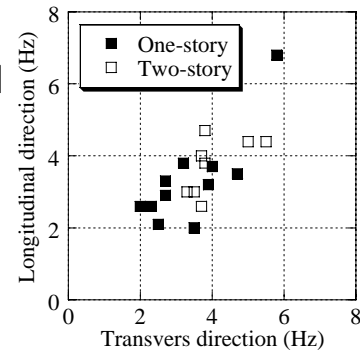
Fig. 8 Fundamental frequencies of one- and two-story houses

Fig. 8 shows fundamental frequencies of the wooden houses in the transverse and longitudinal directions. They were obtained from micro-tremor measurements, and therefore, only corresponding to

small deformations. The solid and hollow symbols correspond to the one-story and two-story houses, respectively. It is interesting that the fundamental frequencies of the one-story houses are lower than those of two-story houses. This may be due to the differences in roof weights and/or heights of stories, and may be related to the difference in the damage ratios. However, the natural frequencies of wooden houses that are highly nonlinear vary substantially as their deformations increase; thus we would explain the phenomenon in terms of the deformation drift angle.

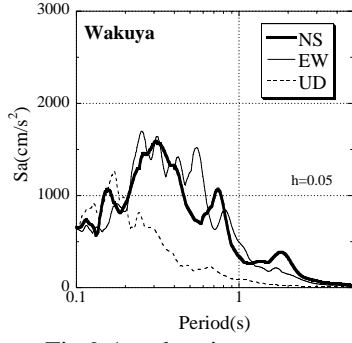
Fig.9 Acceleration response spectra during the main shock

The maximum drift angle  $R$  can then be estimated by equating the equivalent acceleration response spectrum given by Eqs. (3)-(5) to the response spectra of the measured accelerations such as those in Fig. 9. In this study, we assume that  $M_e/M=1.0$ ,  $H_e=3.3\text{m}$  for a typical one-story house, and  $M_e/M=0.9$ ,  $H_e=5.5\text{m}$  for a typical two-story house, and  $C_y$  varies between 0.3 and 0.6. Fig. 10 shows the estimated maximum drift angles corresponding to the recorded ground accelerations at the Wakuya station during the main shock. It is seen that the maximum drift angle of a typical one-story house is larger than that of a typical two-story house. Since the large deformation is the

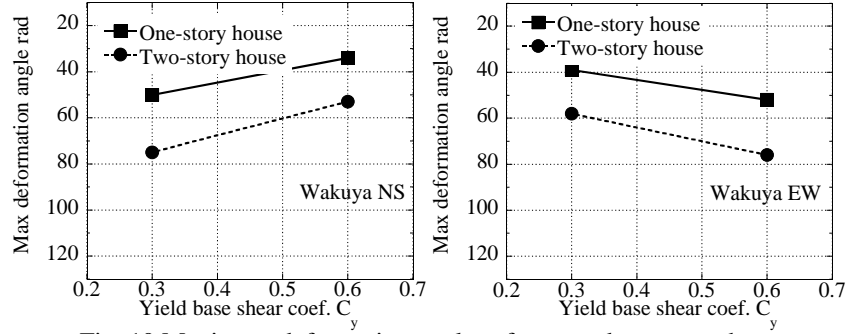
Fig. 10 Maximum deformation angles of one- and two-story houses

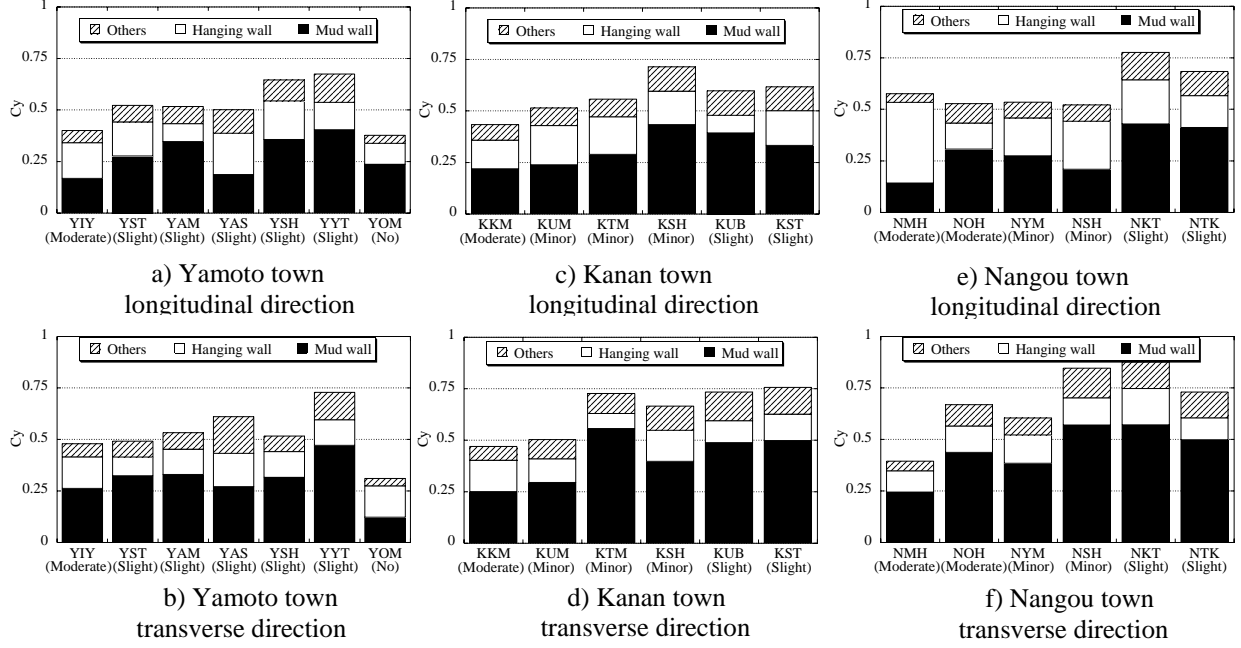
Fig. 11 Yield base shear coefficient

general,  $C_y$  ranges from 0.4 to 0.8 in both the longitudinal direction and transverse direction. Fig. 11 shows the contributions of three different structural elements to  $C_y$  for the 21 houses in two directions. One third to half of the total yield shear is loaded to mud walls, and another one third to half is loaded to hanging walls. Thus, the hanging walls play very important role in the seismic performance.

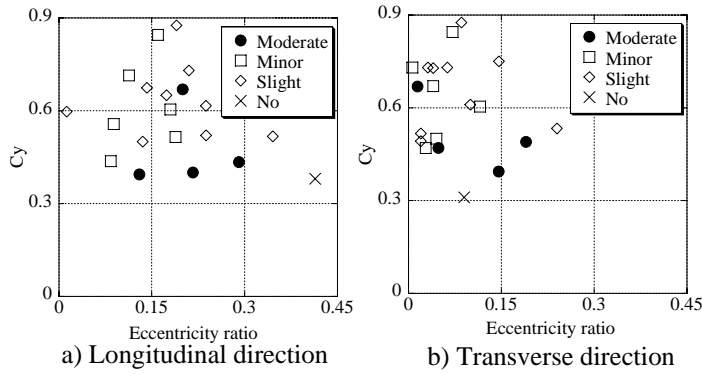
Fig. 12 Yield base shear coefficients and eccentricity ratios of houses

Besides the strength represented by the yield base shear coefficient  $C_y$ , the structural asymmetry of the houses may be also an important factor for the damages. Fig. 12 shows both the  $C_y$  and eccentricity ratio of the first story in the transverse and longitudinal direction, respectively, for the selected wooden houses. In calculating the eccentricity ratio, the center of gravity of a wooden house was determined by taking the maldistribution of the 2-story into consideration. Although not very clear, Fig. 12 does give a general trend that a wooden house with a large eccentricity ratio and a low yield base shear coefficient is more likely to be damaged during

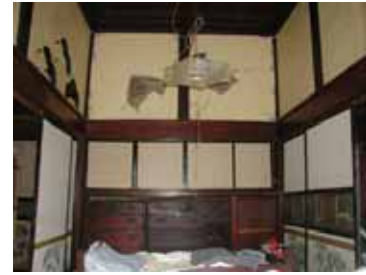
Fig.13 Cracks in hanging wall (YIY)

Fig. 13 shows cracks in a hanging wall in YIY house, while Fig. 14 shows the separation of a lintel from its connecting column. Since site conditions of the seven houses in the Yamoto town are similar, differences in damage level are mainly due to the differences in their seismic performance. This is substantiated by the analytical results shown in Fig. 11(a), that the strength of the YIY house is the second lowest in the Yamoto town in the longitudinal direction. Fig. 17(a) shows the ground plan of the YIY house, where most cracks in the hanging walls and the damage in a lintel-column joint were observed in the longitudinal direction. The damages were concentrated in the southwest part of the house due to the eccentricity and also indicated insufficient walls in this part.

Among the four houses with moderate damages, the YIY and NMH houses had frame damage. In both houses, frame damages occurred at the lower joint of lintels and columns. Since frame damages are crucial for a wooden house, these two houses need to be investigated in more details.

The damages at the joints of the hanging walls (lintels) and the columns in both YIY and NMH houses point out that the over concentration of the strength in the hanging walls may be a reason for the frame damages.

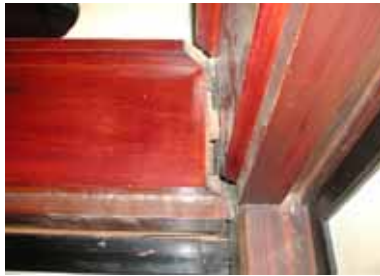
Fig.14 Separation of lintel-column joint (YIY)

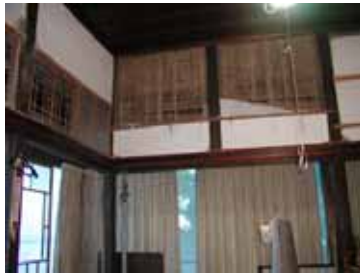
Fig.15 separation of hanging wall (NMH)

For the NMH house, the separation of the hanging walls and the break of a column are shown in Figs. 15 and 16, respectively. The damages can also be explained by the weak seismic performance of the structure. The strength of the NMH house in the transverse direction is the lowest in the Nangou town, as shown in Fig. 11(f), and about 70% of the total strength in the longitudinal direction was provided by hanging walls, as shown in Fig. 11(e). The ground plan of the NMH house is shown in Fig. 17(b), where most of the damages took place in the south part and west part due to the asymmetry of the house.

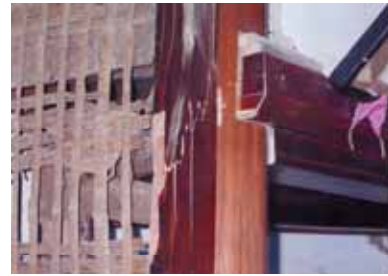
Fig.16 Break of column (NMH)

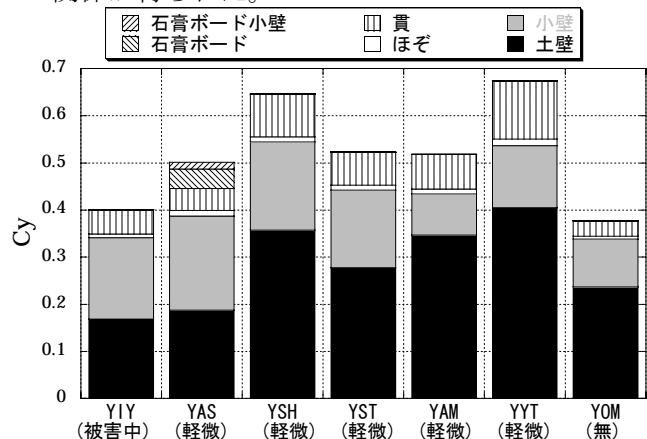
1/30rad時のベースシア係数Cにおける矢本町、桁行き方向の各耐震要素負担率 $C_y$ を図1に示す。地震被害との整合性では、無被害のYOM邸が最も低い $C_y$ を示した。しかし、7棟すべての結果より、被害程度と耐震性能評価結果は、良い対応関係が見られた。また、小壁は耐震要素として有効であり、 $C_y$ に占める割合が大きいことを確認した。

図1 桁行き方向の耐力負担割合

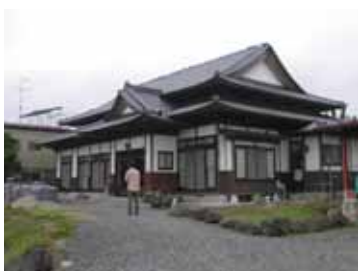
この地域の構造的特徴として、写真1に示すような、平屋建物が多く、調査した建物中、12棟が平屋建てであった。また、写真2のように、階高が高く、小壁高さも高い建物が多く見られ、この地域では、小壁は重要な耐震要素と考えられる。

写真1 平屋建物の一例
