Geo-disaster Prediction and Geo-hazard Mapping in Urban and Surrounding Areas

Susumu IAI, Shinya INAZUMI*, Masahiro CHIGIRA, Toshitaka KAMAI,
Roy, C. SIDLE, Mamoru MIMURA, Hiroshi SUWA, Takashi SAITO,
and Tetsuo TOBITA

Synopsis

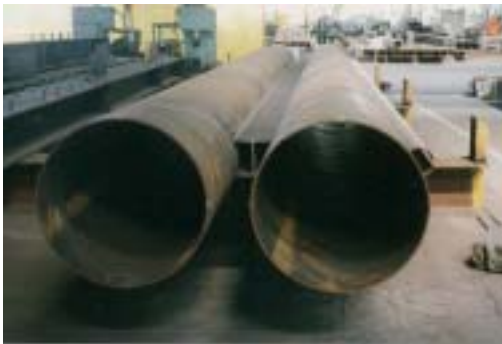
Fig. 3 H-joint SPSP

(a) H-joint alternating with P-P joint

(b) Photograph H-jointed SPSP

Clearly, the H-joint satisfies permeability and bearing capacity requirements. The only point of contention is the fact that it will still alternate with the traditional joints. The authors are proposing H-H joint, described below, to alleviate this condition.

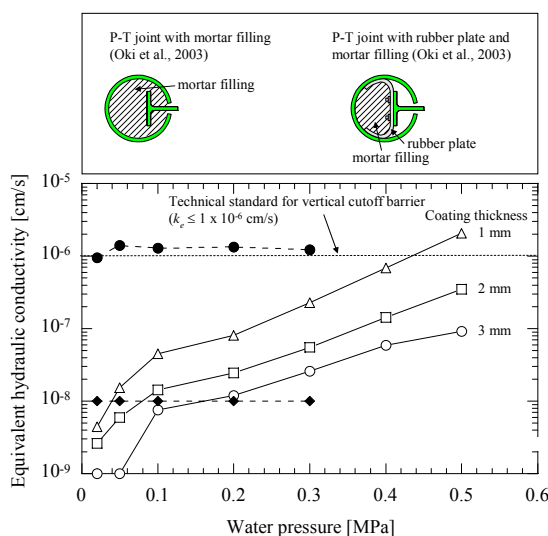
Fig. 7 Equivalent hydraulic conductivity versus resisted water pressure

Figure 7 shows measured hydraulic conductivity for H-jointed SPSP with H-H joint sealed with water-swelling paint sheets of thickness 1, 2, and 3 mm against water pressure; also shown are equivalent hydraulic conductivity for P-T joints sealed by mortar and rubber (Oki et al., 2003). It is observed that k_e for H-H joints depends on water pressure; it increases with increasing water pressure, this may be because of the elastic nature of the water-swelling paint sheet. Paint sheets with thickness of 2 mm and above meet specified hydraulic conductivity of $k_e \leq 10^{-6}$ cm/s (Kamon and Inui, 2002) for water exclusion structures up to water pressures of 0.5 MPa. On the other hand a 1 mm paint coat meets the standard k_e of $\leq 10^{-6}$ cm/s up to a water pressure of 0.4 MPa.

From Fig. 7, k_e for H-H joints coated with 1 and 2 mm paint sheets was very low in the order of 10^{-8} cm/s at a water pressure of 0.05 MPa; k_e for the 3 mm paint coated joint was too small and could not be measured, since there was not effluent flow collected in the 6 hour test duration, k_e can be said to be below 1×10^{-9} cm/s. The authors propose use of $k_e = 10^{-8}$ cm/s in design of H-H joints sealed with this water-swelling paint.

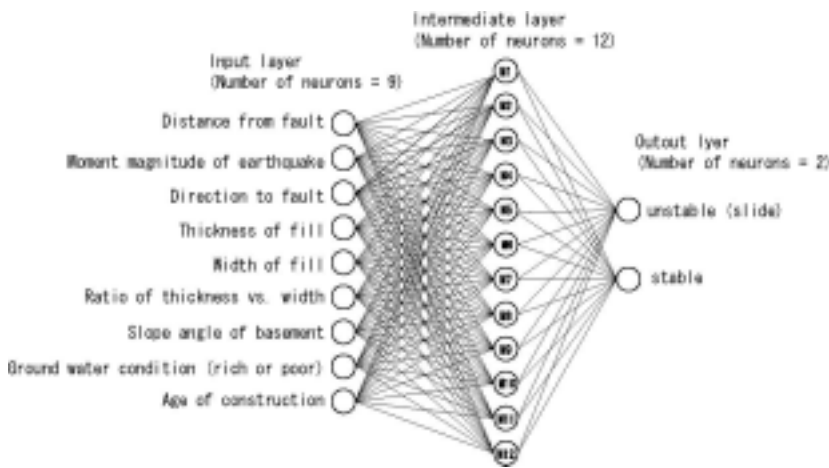
Fig. 12 Neural network structure of the prediction model

The developed neural network model includes both causative factors (shape of fills, groundwater condition, age of construction) and the triggering factors (distance from the fault, moment magnitude, direction to fault). The model consists of nine input factors, twelve intermediate neurons, and two output items (stable or unstable) as shown in Figure 12. Back propagation method (BP method) was used to investigate most appropriate set of the weight of connections between the three layers of the model. The control parameters of BP method, learning ratio, number of intermediate neurons, and number of learning times, were determined to minimize the total error between the input and the output.

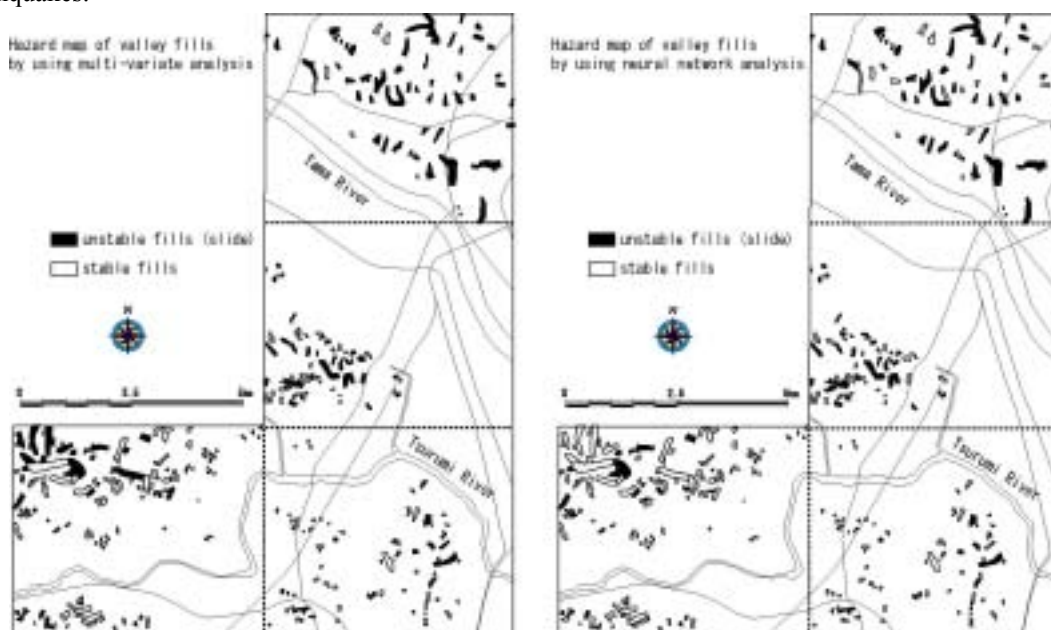
Fig. 14 Maps showing the results of the stability assessment of valley-fill type landslides in Tokyo-Yokohama district by using both the multivariate analysis and the neural network analysis

Figure 14 shows a result of hazard mapping of valley fill type landslides in Tokyo-Yokohama district.

More than half of the fill-slopes should be classified into a high-risk group. The regional difference of risk

on the fill-slope landslides is obviously depends on geology. Vertical elevation drop between alluvial plain and terrace surface controlled the depth of valleys in this district. Shallow dissected valleys developed widely in the northern part from the Tama River (named the Musashino terrace) that is lower (younger) than the terraces in southern part (named the Shimo-sueyoshi terrace, the Tama hills). Valley fills in the Musashino terrace are shown in high-risk compared to the fills in southern part because of its shape of valley fills.

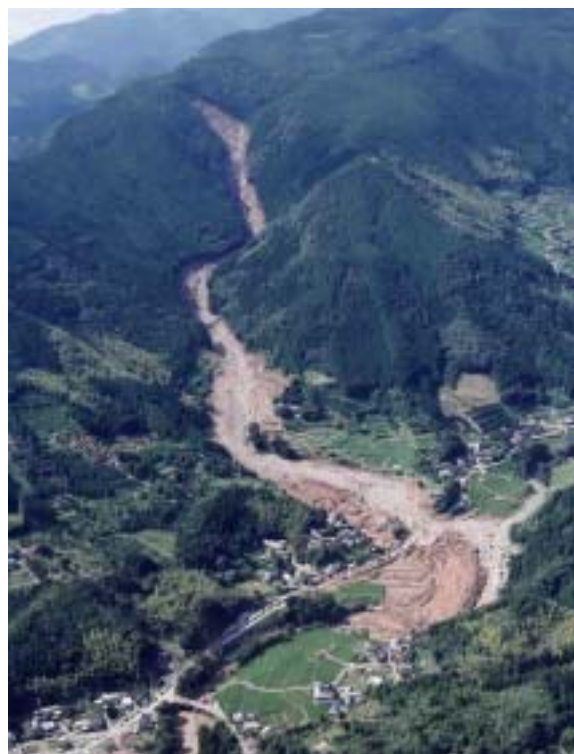
Fig. 15 Landslide and debris flow at Hogawachi in Minamata, Kyushu, on 20 July 2003; 15 people killed and 13 homes destroyed.
