1 **Doppler Ultrasonography and CT Angiography Demonstrate Positional Occlusion of**
2 **Vertebral Artery Associated with One-sided Destruction of the Atlantoaxial Lateral Mass**
3 **Caused by Rheumatoid Arthritis: A Case Report**

20 **Abstract**

21 **Study Design.** Case report of a patient with rheumatoid arthritis (RA) and a positional
22 occlusion of the left vertebral artery (VA).

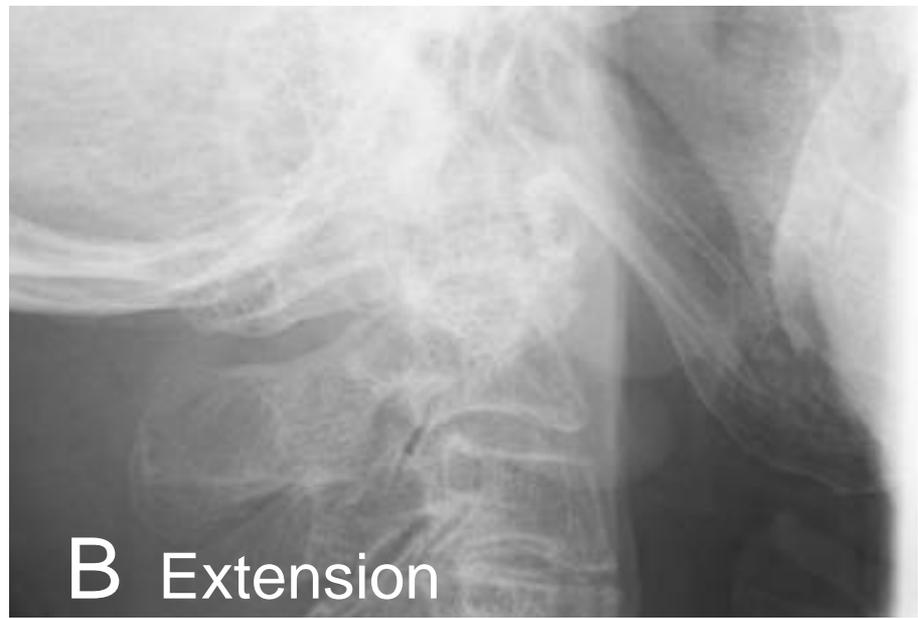
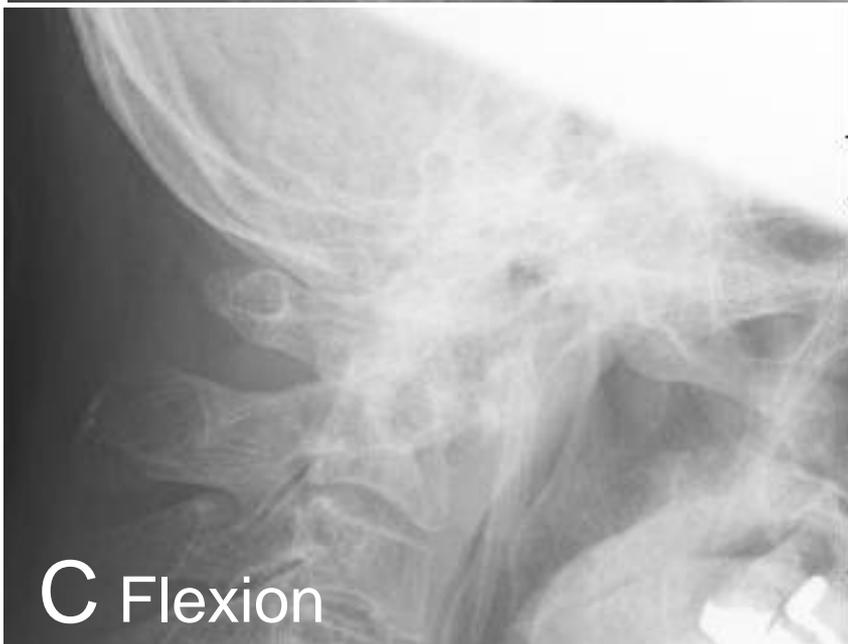
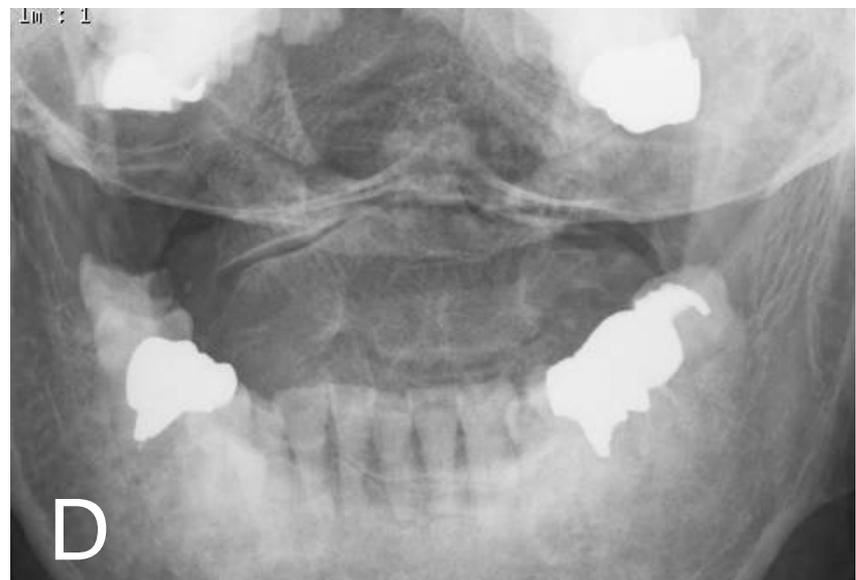
197 Figure 1

198 Lateral radiographs in the neutral (**A**), extension (**B**), and flexion (**C**) positions, and an
199 open-mouth view (**D**). Atlantoaxial instability and vertebral instability were mild. Note
200 that the left C1/2 joint space is not clear (**D**).

78 There was no sign of a neurological defect, including cervical myelopathy or brain
79 infarction, in the neutral position. Lateral radiographs indicated mild AAI: the atlantoaxial
80 distances in the neutral, flexion, and extension positions were 4 mm, 5 mm, and 0 mm,
81 respectively, and his Redlund–Johnell value in the neutral position was 27 mm, indicating
82 mild AAI with mild vertebral subluxation (Fig. 1A–D). Enhanced cervical CT in the neutral

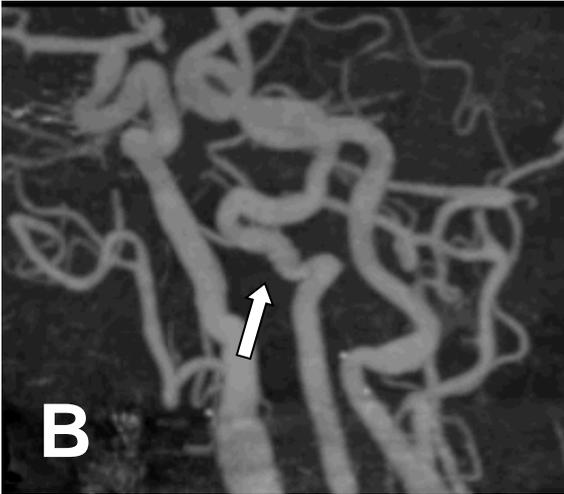
219 Figure 4

220 A lateral radiograph (**A**) and CT angiograph (**B**) after surgery. The arrowhead indicates the
221 decompressed left VA.

92 We performed a posterior O–C2 fusion at the reduced position with an iliac bone graft
93 (Figure 4A) instead of a C1–C2 fusion. It was difficult to achieve a secure grip on both C1
94 and C2 because of the severe destruction of the left lateral masses of C1 and C2. Therefore,
95 a posterior transarticular screw was inserted on the right, and a C2 laminar screw and
96 hook was used as an anchor because there was no space for a left transarticular screw or a
97 C2 pedicle screw. The patient's severe vertigo disappeared in all positions immediately
98 after the operation and there was no sign of postoperative infection or neurological defect.
99 The patient was allowed to walk with a Philadelphia collar. The occlusion of the left VA
100 disappeared completely (Figure 4B) and the PSV of the left VA recovered to 72 cm/s. Three
101 months later, the O–C2 fusion was confirmed on CT and the patient reported no occipital
