Rethink of failure of underground construction- lessons learned from Taiwan

B. Hsiung

Department of Civil Engineering, National Kaohsiung University of Applied Sciences, Taiwan

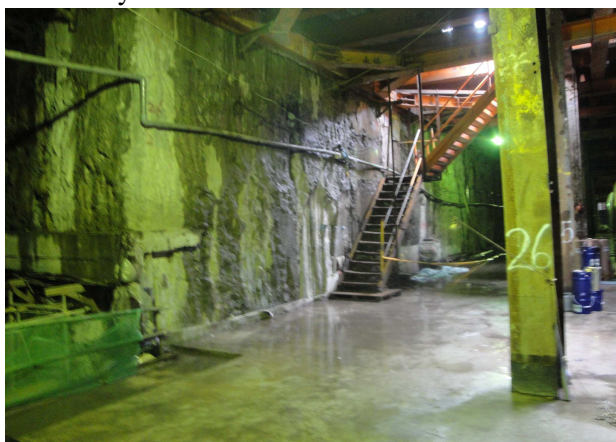
Fig. 3 Quality of diaphragm wall

Wall deflections were measured at an excavation located in eastern Taipei. The maximum excavation depth of the site is 22.85 m and it was retained by a 43 m deep, 1.2 m thick diaphragm wall. Eight- level internal bracing were adopted to provide additional horizontal supports. It is also noted that depth of bedrock on site was various, from 28 m to 40 m below surface level. It was found that a large wall displacement (up to 115 to 135 mm) was measured and Figure 3 presents a comparatively poor quality of wall constructed on the site. It was constructed using hydraulic- grab type machine and it was reported by the contractor that appearance of rock affects the quality of the wall. Observations here did reflect the quality of wall

and this might not be pointed out during the design stage.

Further, as shown in Figure 3, the quality of wall could not be predicted before commence of the design but could possibly be detected after wall installation. The design of the excavation should thus be revised after wall installation because of the quality of wall. Moreover, conducting independent check could increase the reliability of the design and it cost less for design change before commence of construction of an underground project. It is thus recommended that independent checks shall be delivered and revision of design should be concerned from time to time in order to reduce the risk. The employer might not be capable to carry out tasks stated above and it is suggested

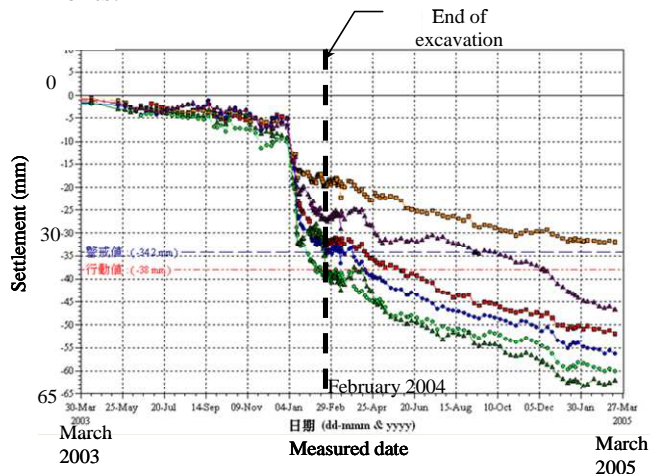
Fig. 4 Settlements of the buildings

Figure 4 presents the settlement of the buildings next to excavation of O6 Station in KRTS. Similar to the example taken from Taipei, activities of excavation were completed but the building continued to settle. As indicated in Figure 5, it was observed that pore pressure of ground continued to decrease, though the excavation was completed long time ago and this was thus thought to be the main reason for generation of additional settlements.

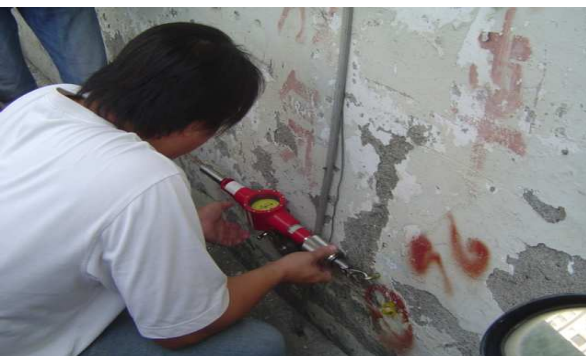
Fig. 7 Measurement using tape extensometer

At last, the other example also in Kaohsiung Metro was raise here to demonstrate the effectiveness of instrument. A 37-year-old building stood 1 to 4 m from a 20.1- m deep excavation and the excavation was retained by 0.8 m thick and 42.0 m deep diaphragm walls. The horizontal props using H- type steel were adopted to stiffen the excavation. Except monitoring of ground performances caused by the deep excavation, structure performance were measured and taken as base of damage assessment. Boscardin and Cording (1989) recommended that the damage to the structure is closely connected with horizontal strain and angular distortion and the device like horizontal tape extensometer, as shown in Figure 7 was used to measure the distance between two nails on façade of the building and expansion or shortening in comparison with previous measurement for the distance between two nails could thus be determined. Horizontal tensile or compressive strain could be interpreted also.
